PIT STATUS EVALUATION FORM

Facility ID: 115122

Pit Name: MYERS 12-3 1

S.S. PAPANOPULOS & ASSOCIATES, INC.

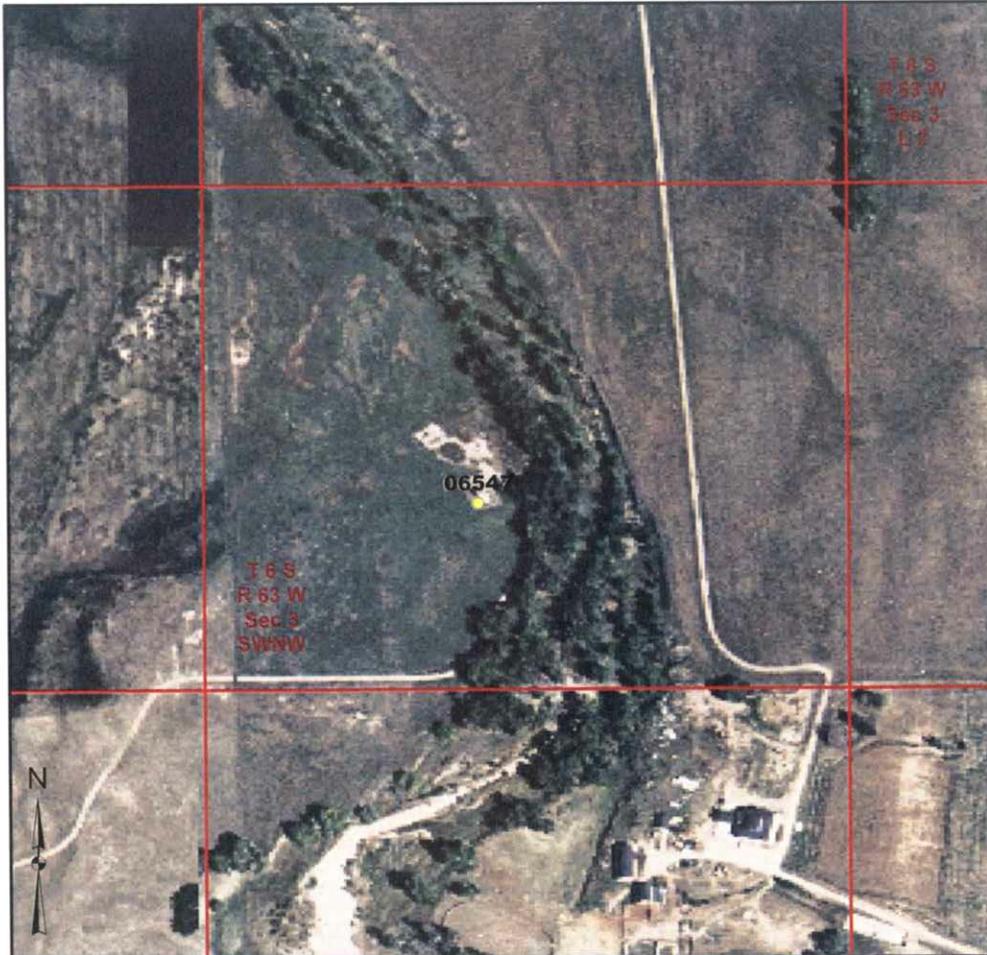
Notes: LIF(8-18-87) #00 BBL Fiberglass Tank. No mention of Pit. FIR (2007) no mention of pit.
FIELD VERIFICATION! 6-3-2008: FIELD INSPECTOR VERIFIED NO PIT ON SITE.

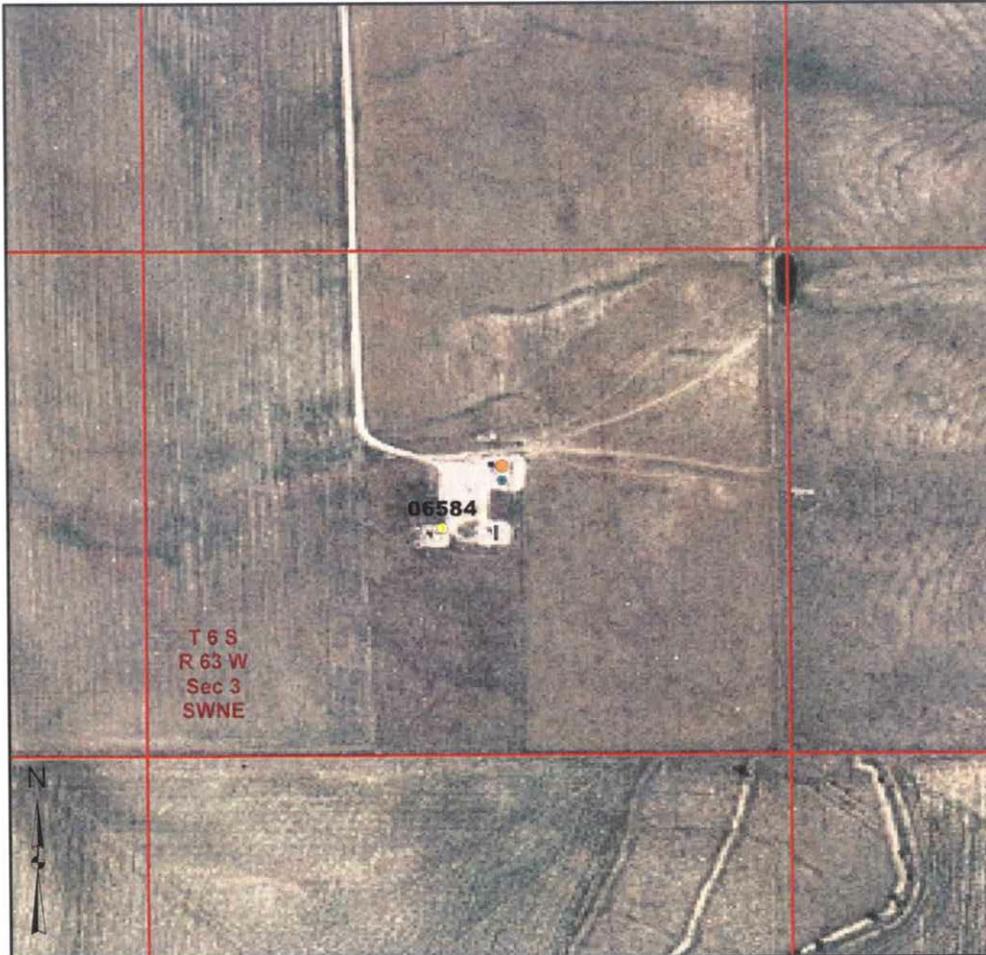
Pit Name: MYERS 32-3 2

Notes: WSIF (1987) Skimpit. no earthen pit. WSIF (1995) indicates to "check for pit closure".
FIR (2007) no pit inventoried; one, 300 BBL Upright.
FIELD VISIT 6-4-2008: PIT CLOSED. Using fiberglass tank.

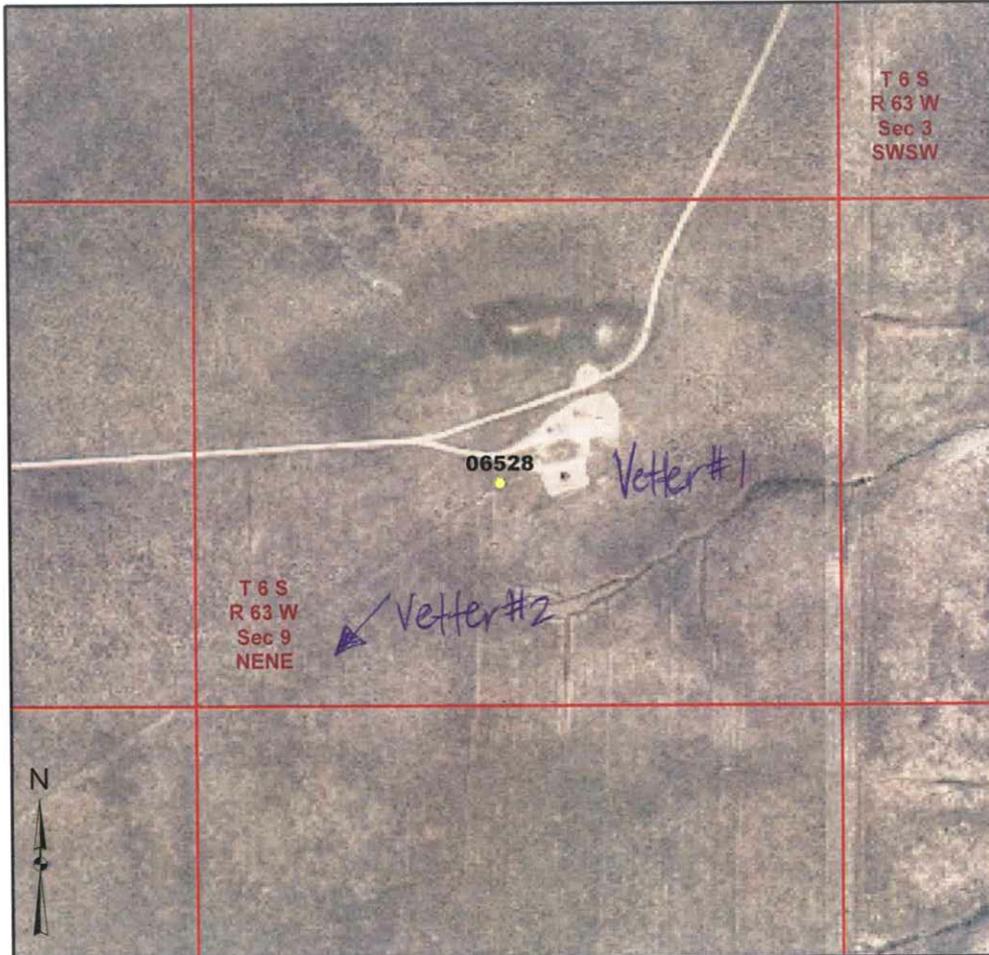
Pit Name: VETTER 1-9-6-63K

Notes: Common Use battery tank site with Vetter #2 (05-039-06555)
FIR (1995) requested to backfill pit & replace w/cement vault for permit skip pit
FIELD VISIT 6-3-2008: PIT BACKFILLED

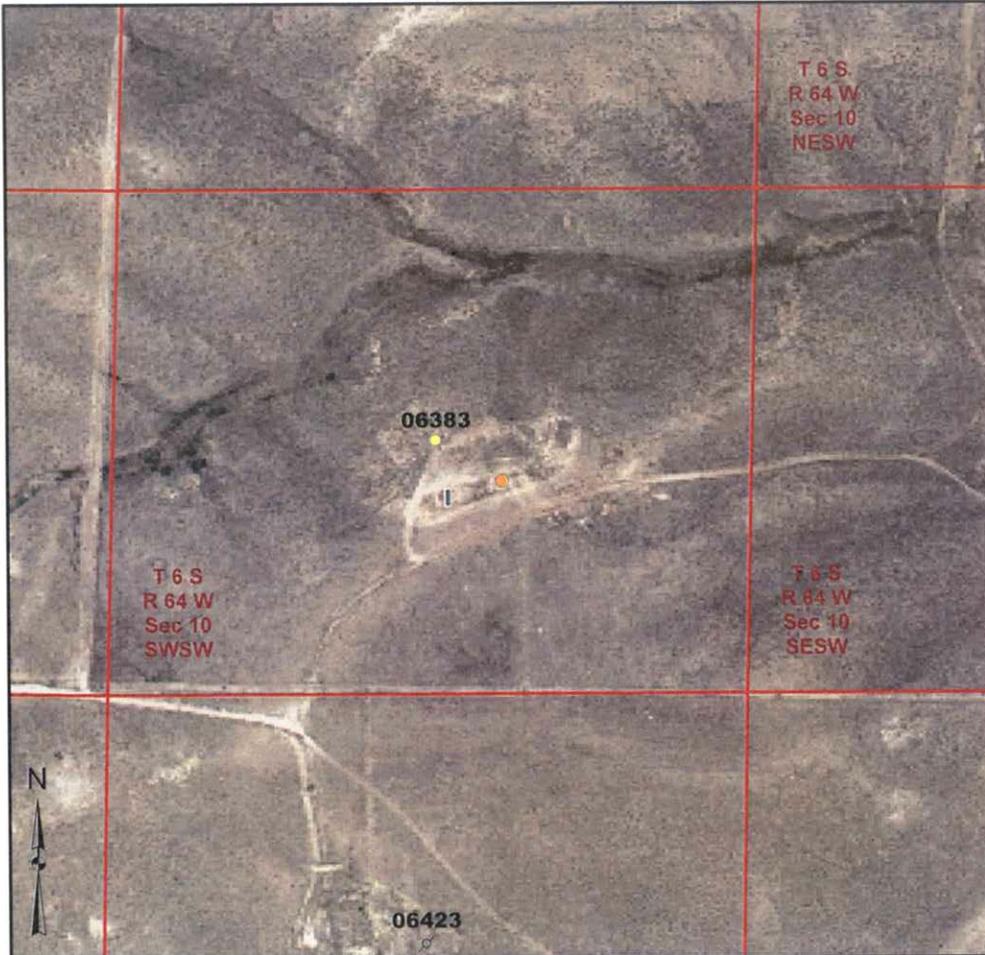
Pit Name: COGGINS 1-10

Closed Form 27: Remediation Workplan _____
 Form 4: Sundry Notice _____
 Rule 903a.(2)B _____
 Evidence pit(s) existed, no closure docs & well not PR, AC or SI
 Well API Seq #(s) _____
 Other documentation FIR # 20088218 (1-30-06) no pit found

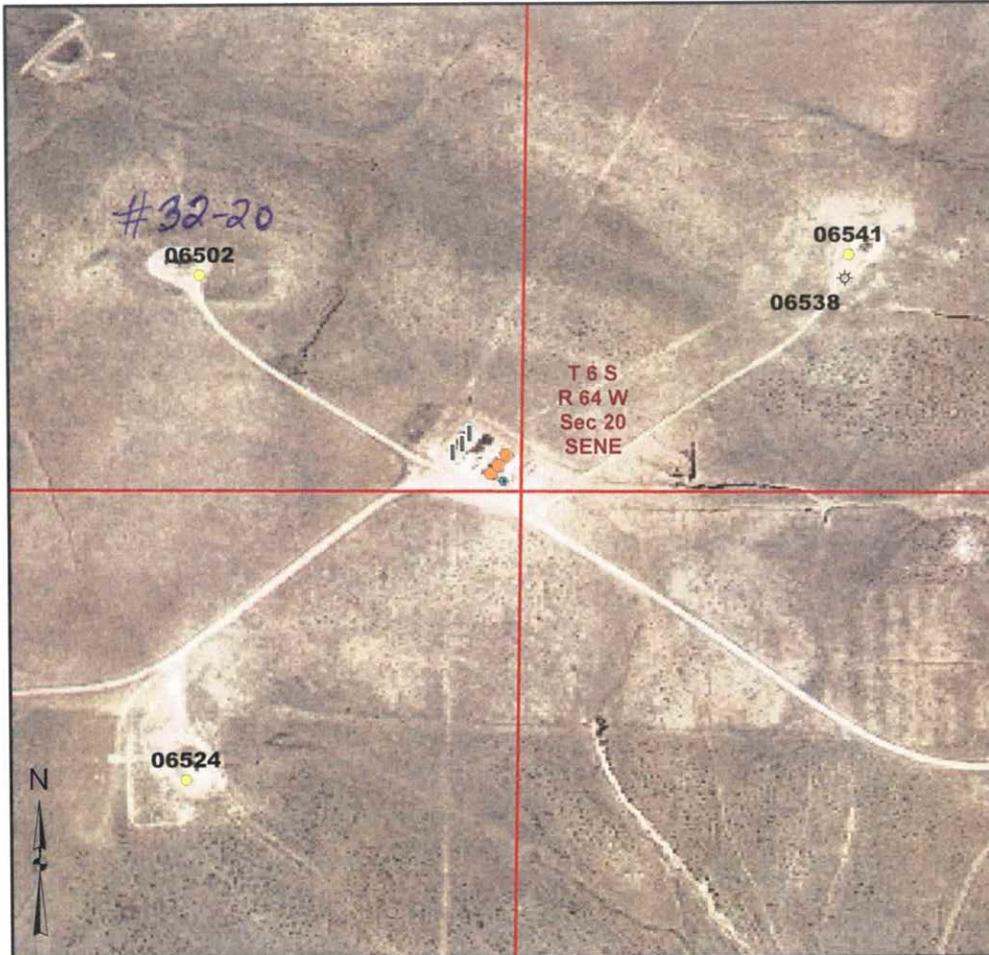
Notes: Common Battery Tank Site for Nordman Trust 42-20X & 33-20
FIR (1996) "earthen pit w/ screen needs repair"
FIELD VISIT 6-3-2008: NO SIGN OF PIT, PIT BACKFILLED

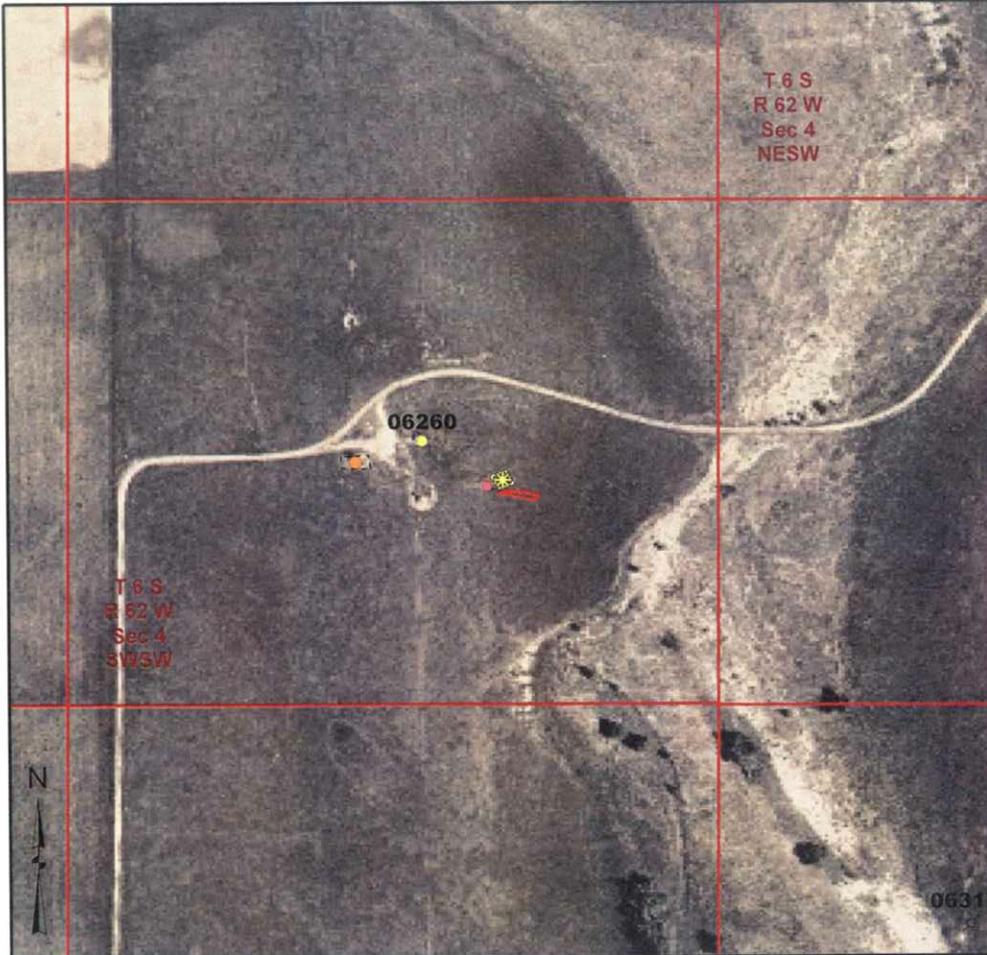
Pit Name: WHITEHEAD 4-13

Notes: LIF(1987) 1250 GAL SKIM TANK & 30'x30' pit
FIELD VISIT 6-4-2008: EARTHEN PIT & CONCRETE VAULT FOUND WITH
OIL SATURATED SOILS & VEGETATION DISTURBANCE TO SOUTHEAST. PIT COVER
UNSATISFACTORY.
