SUNDRY NOTICE

1. OGCC Operator Number: 100185 4. Contact Name: DeAnne Spector
2. Name of Operator: ENCANA OIL & GAS (USA) INC
3. Address: 370 17TH ST, STE 1700 City: DENVER State: CO Zip: 80202
5. API Number: 05-077-09420 OGCC Facility ID Number:
6. Well/Facility Name: Orchard Unit 7. Well/Facility Number: 20-12H (K20OU)
8. Location (Qtr/Qtr, Sec, Twp, Rng, Meridian): NESW Sec. 20-T8S-R96W 6th PM
9. County: Mesa 10. Field Name: Orchard
11. Federal, Indian or State Lease Number: COC-64191

Well: Orchard Unit 20-12H (K200U)

5.5" Casing & Cementing Remediation

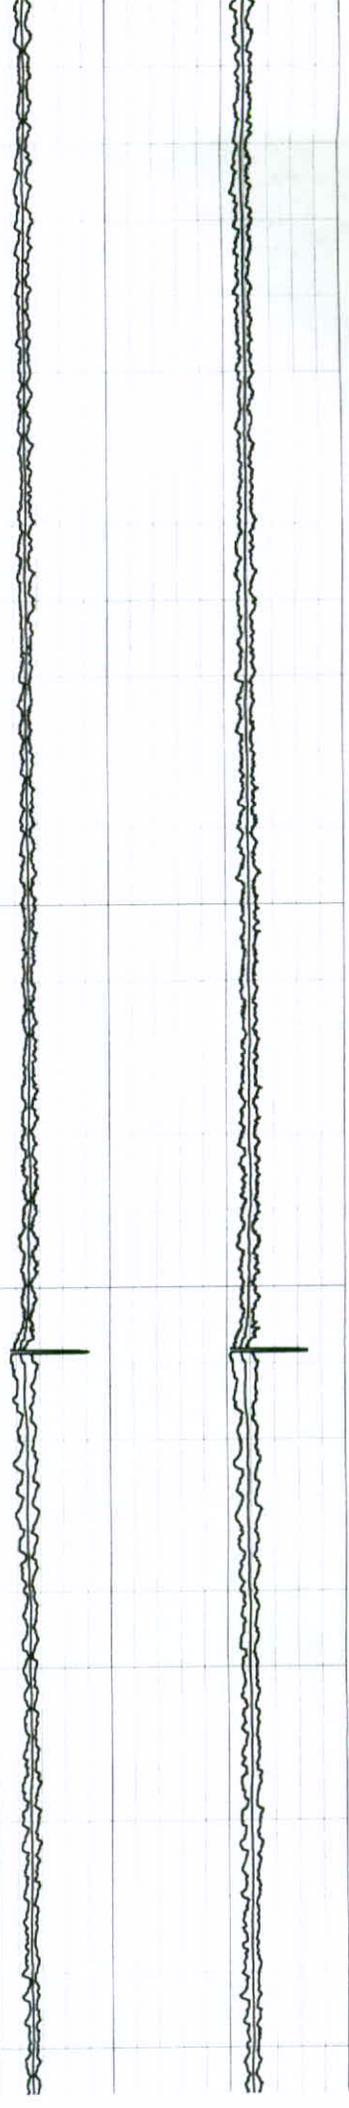
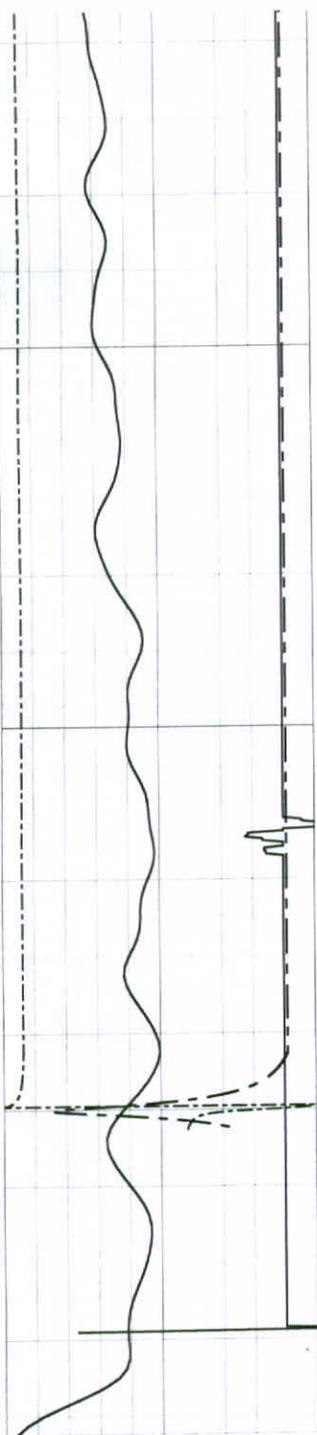
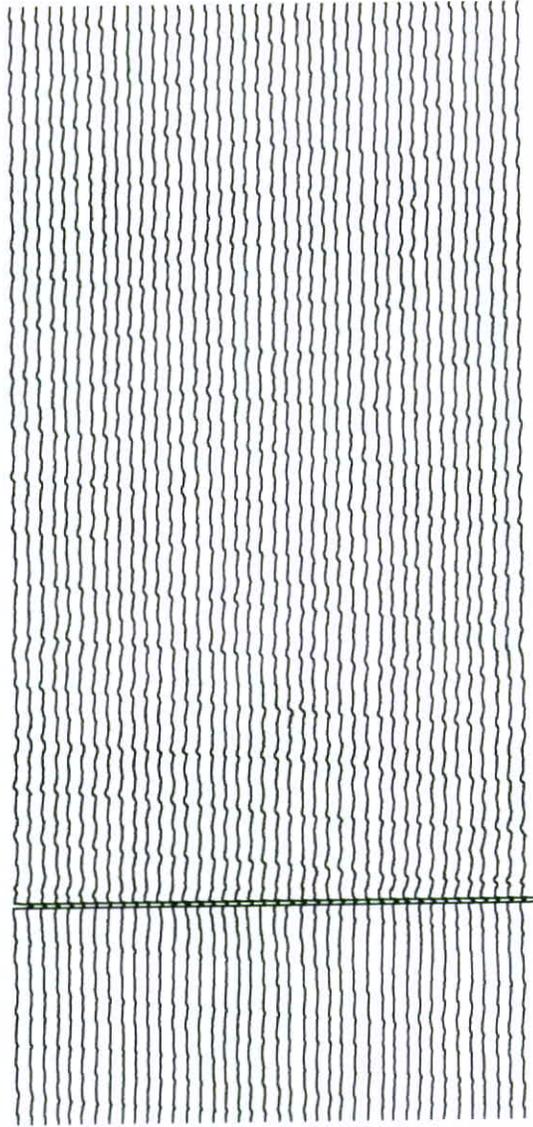
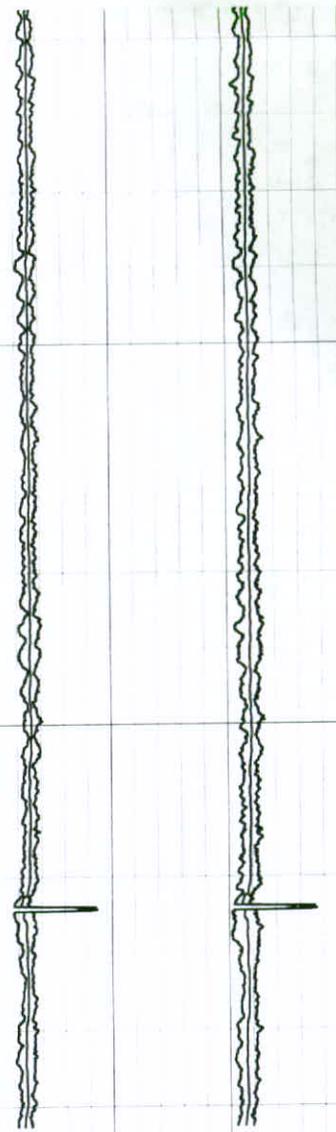
As we discussed yesterday, we had a shallow casing failure (2069') right above a collar during the very beginning of one of our horizontal Niobrara fracs on the Orchard Unit 20-12H (K20OU). During the beginning of the Stage 5 completion, surface treating pressure decreased sharply which was matched by an increase in Intermediate CSG pressure. Surface CSG pressure increased as well. The job was shut down, a CBP was set at 8020', and all pressures were bled down to zero psi where they have remained since the plug was set. A 2nd CBP + cement was set at 7400' MD for additional well control and safety.

I've attached the 5.5" CSG inspection log which is zoomed in at the point of failure.

5 1/2" CSG
FAILURE →

**Casing will be sent in for inspection to determine reason for failure.*
 - 6 RIH w/ overshot on 3 1/2" 9.3# EUE N-80 TBG and latch on to 5.5" CSG stub.
Note: Confirm joint yield strength of 3.5" workstring prior to fishing 5.5" CSG; confirm total string weight before latching on to 5.5" CSG stub.

- 8 Load 9 5/8" CSG and Pressure test to 1500 psi. Record for 15 minutes. If pressure test fails, a 40-arm caliper log will be run (See step 10).
 - 9 RIH w/ 3.5" workstring & skirted mill. Dress off 5.5" CSG stub to prepare for CSG patch.

I've attached the frac graphs from the point at which casing failed. I've also attached the specs/diagram of the Logan 10K psi overshot CSG patch we're planning on running with new 5.5" CSG.
