# Interim Reclamation Inspection

3/3/2016

Operator: Whiting Oil and Gas

Location ID: 431782

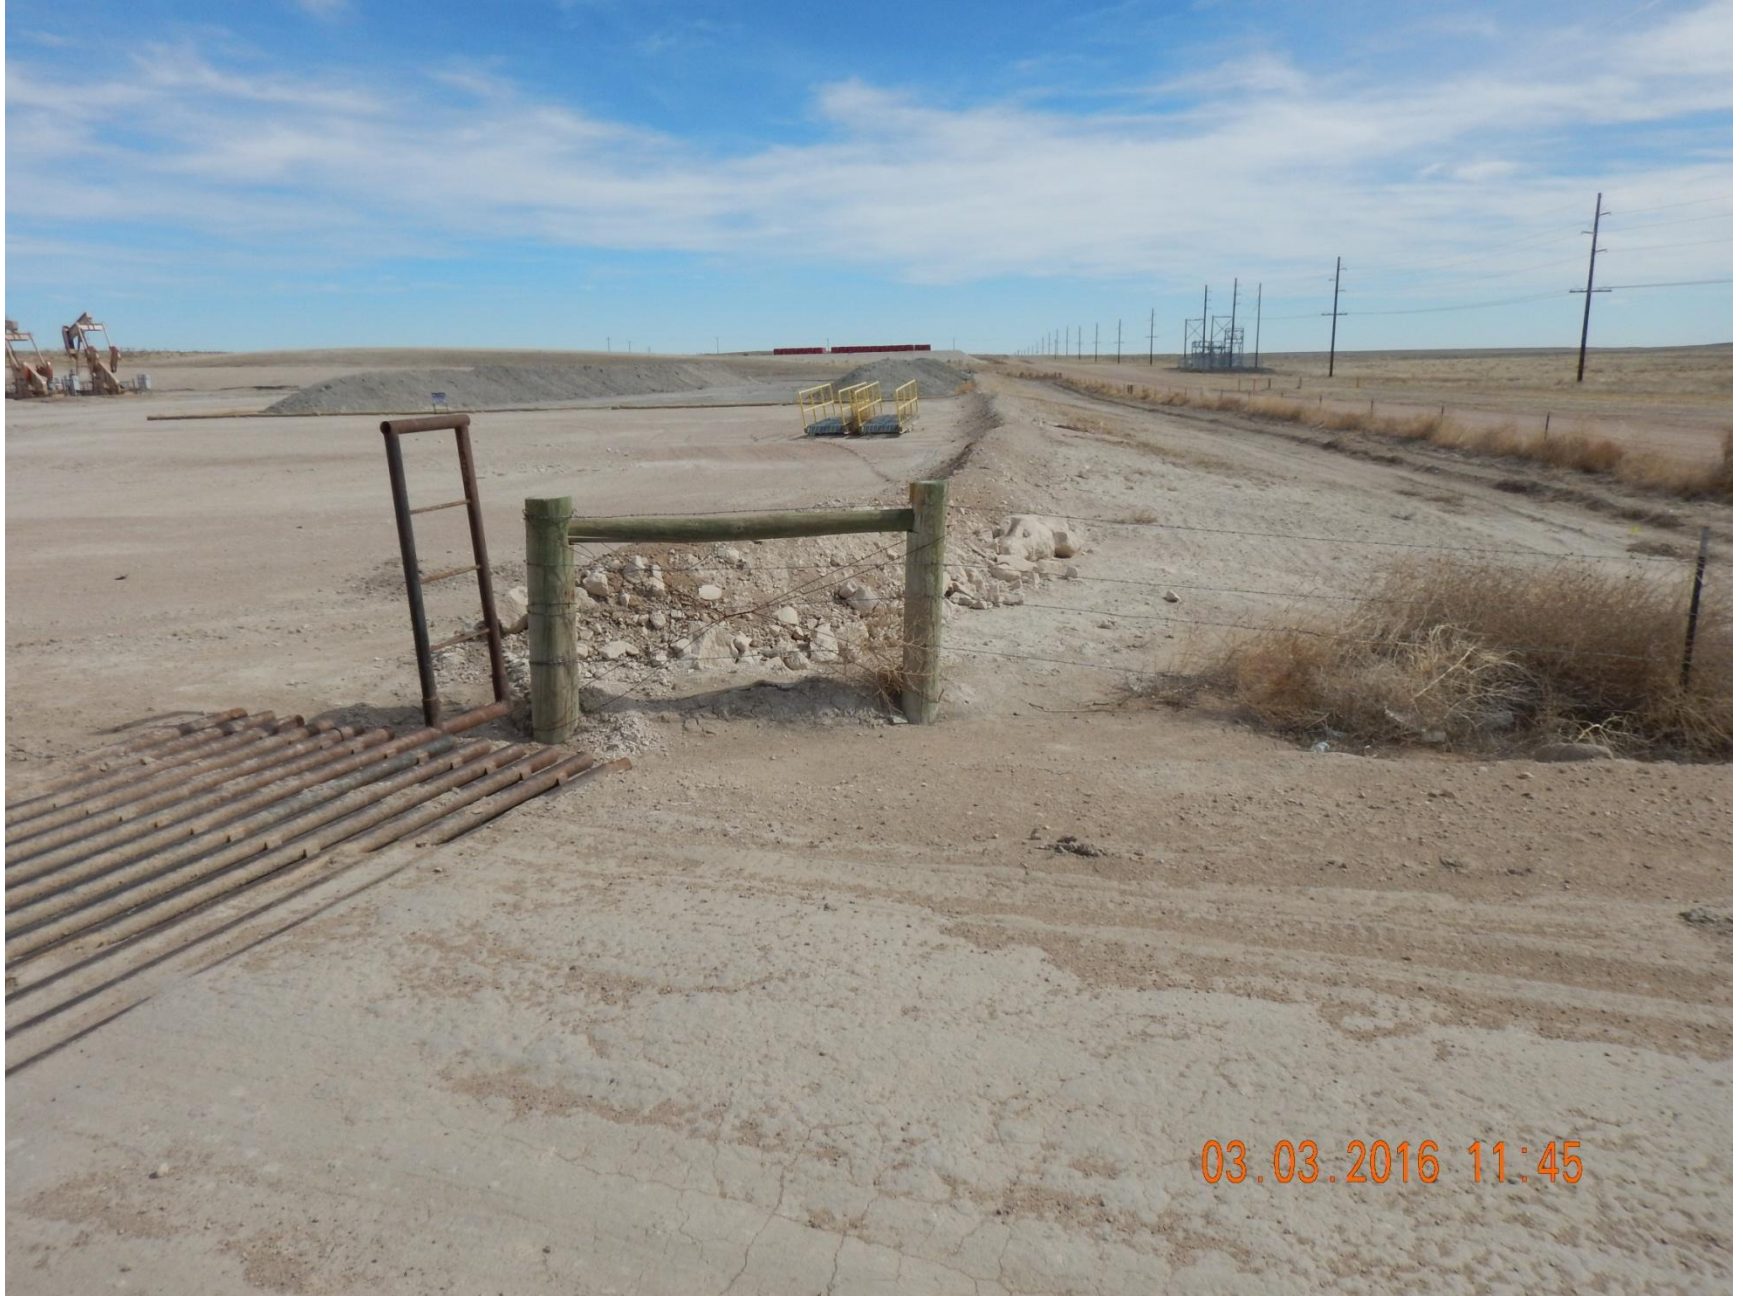
**Figure 5:** Photo taken from the access road, on the southwest end of location, facing east. Photo shows interim and project areas.

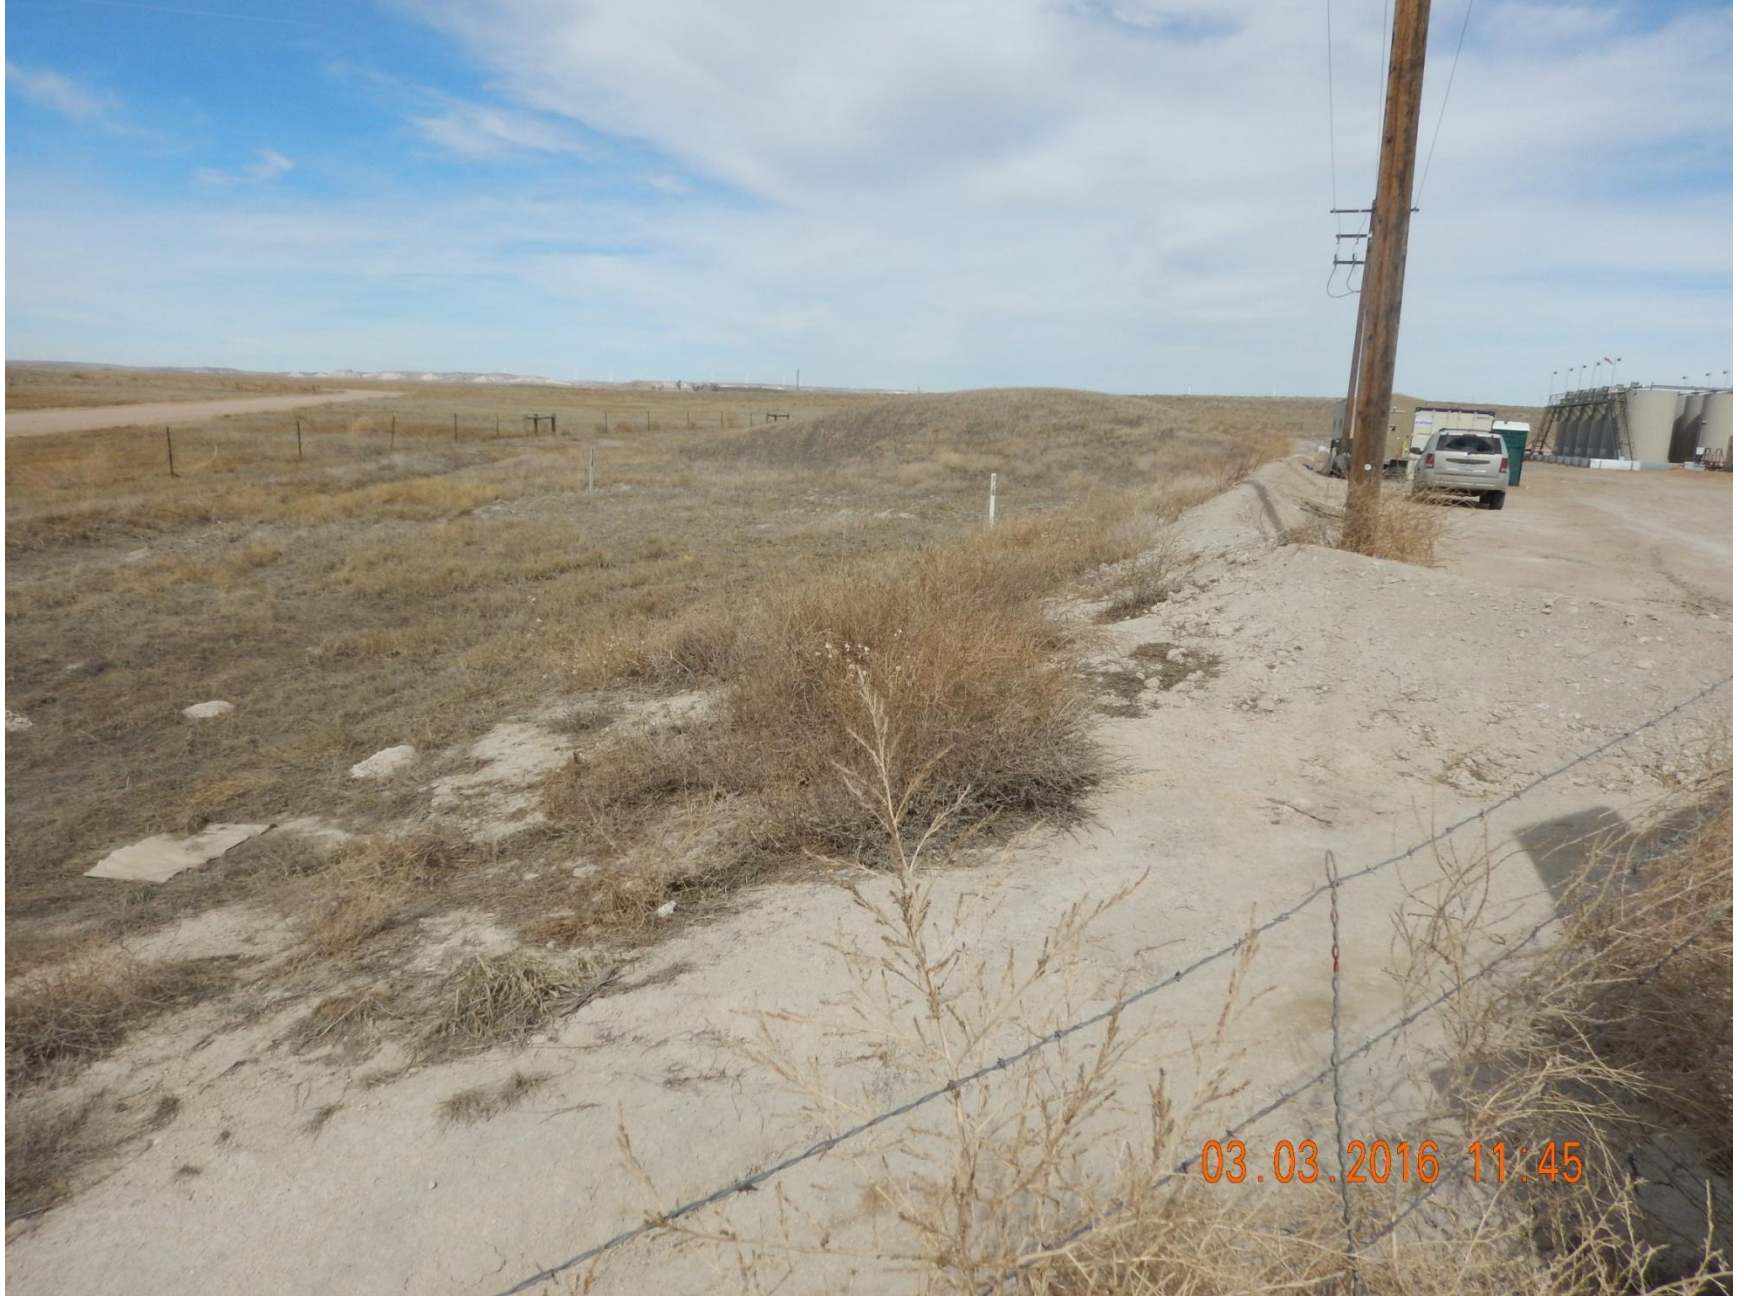
**Figure 6:** Photo taken from the access road, on the southwest end of location, facing north. Photo shows interim and project areas.

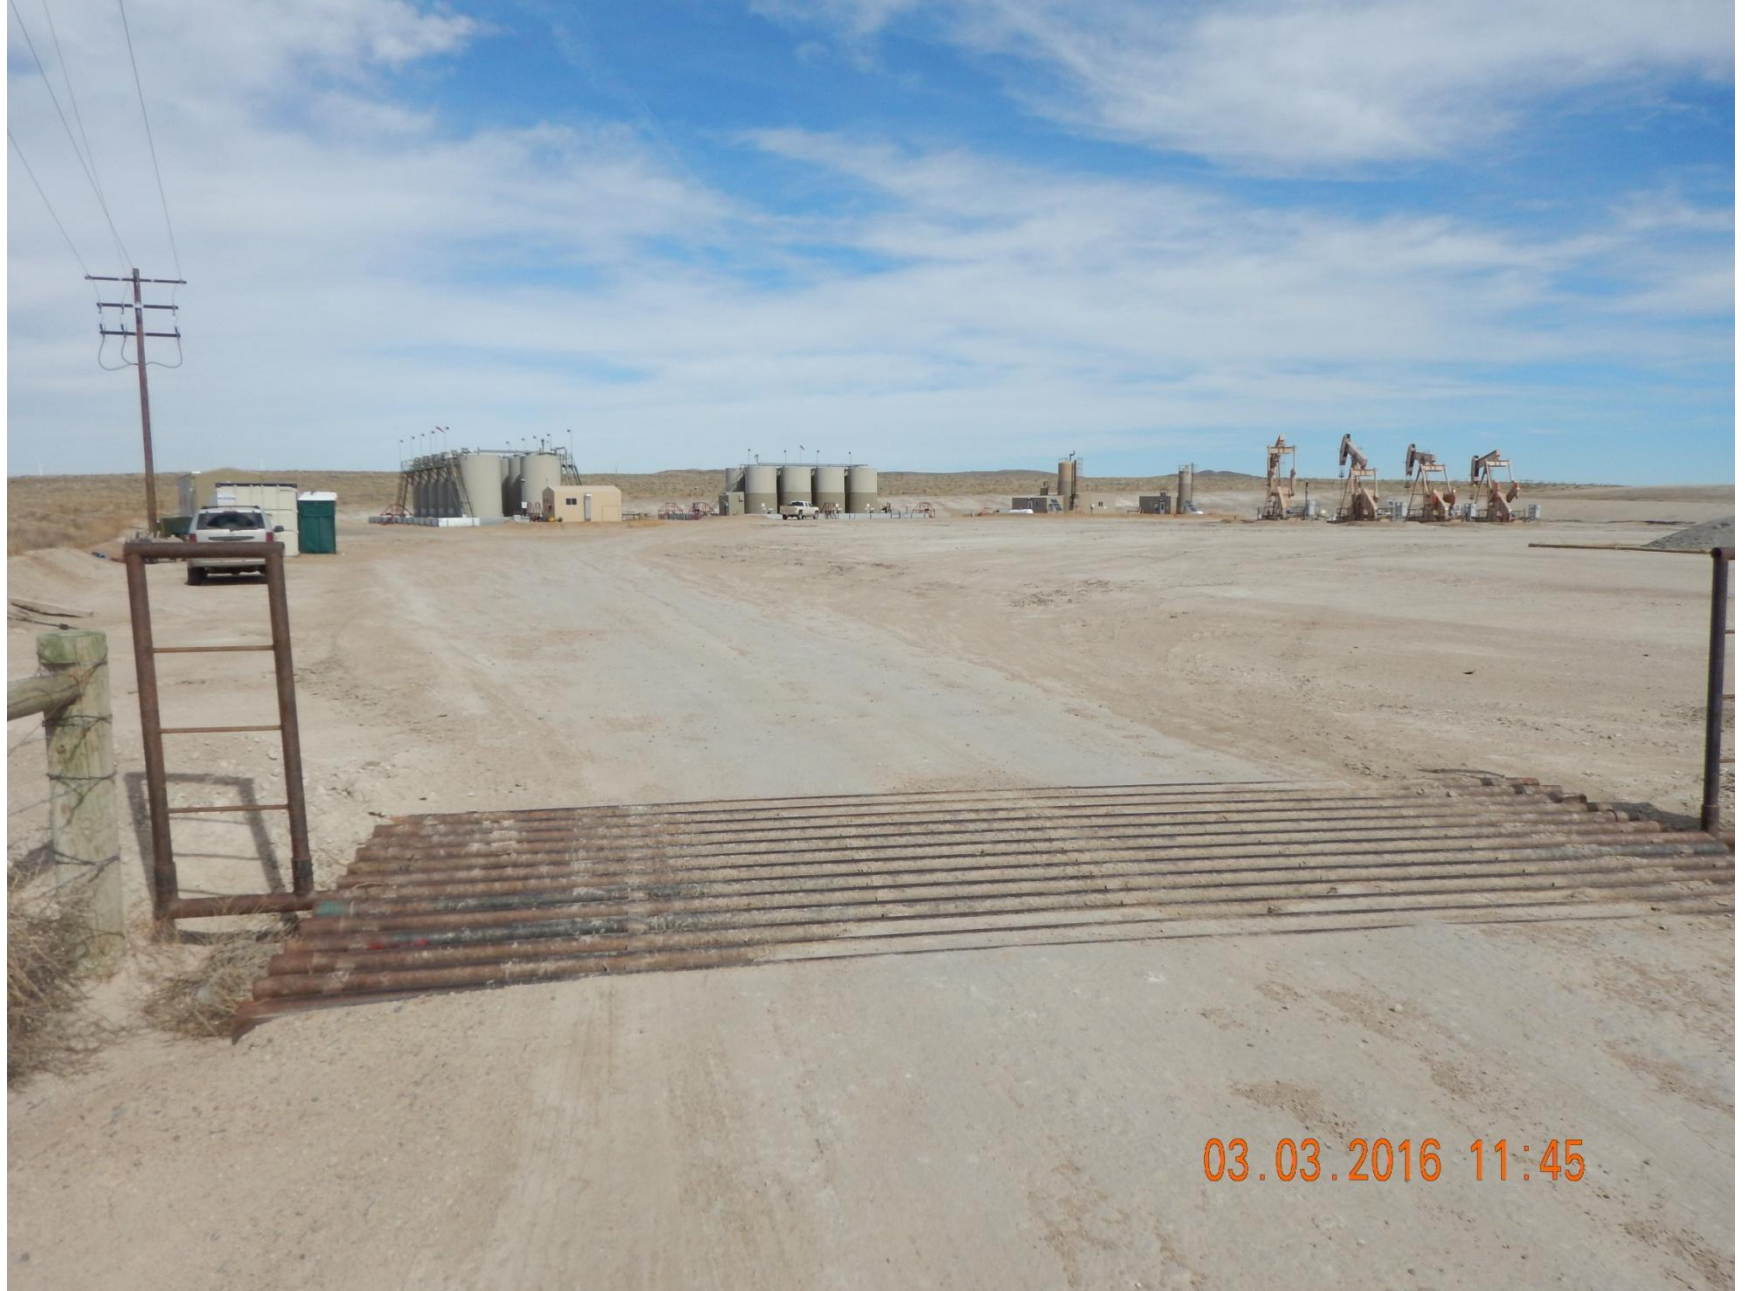
**Figure 7:** Photo taken from the access road, on the southwest end of location, facing north. Photo shows project area.

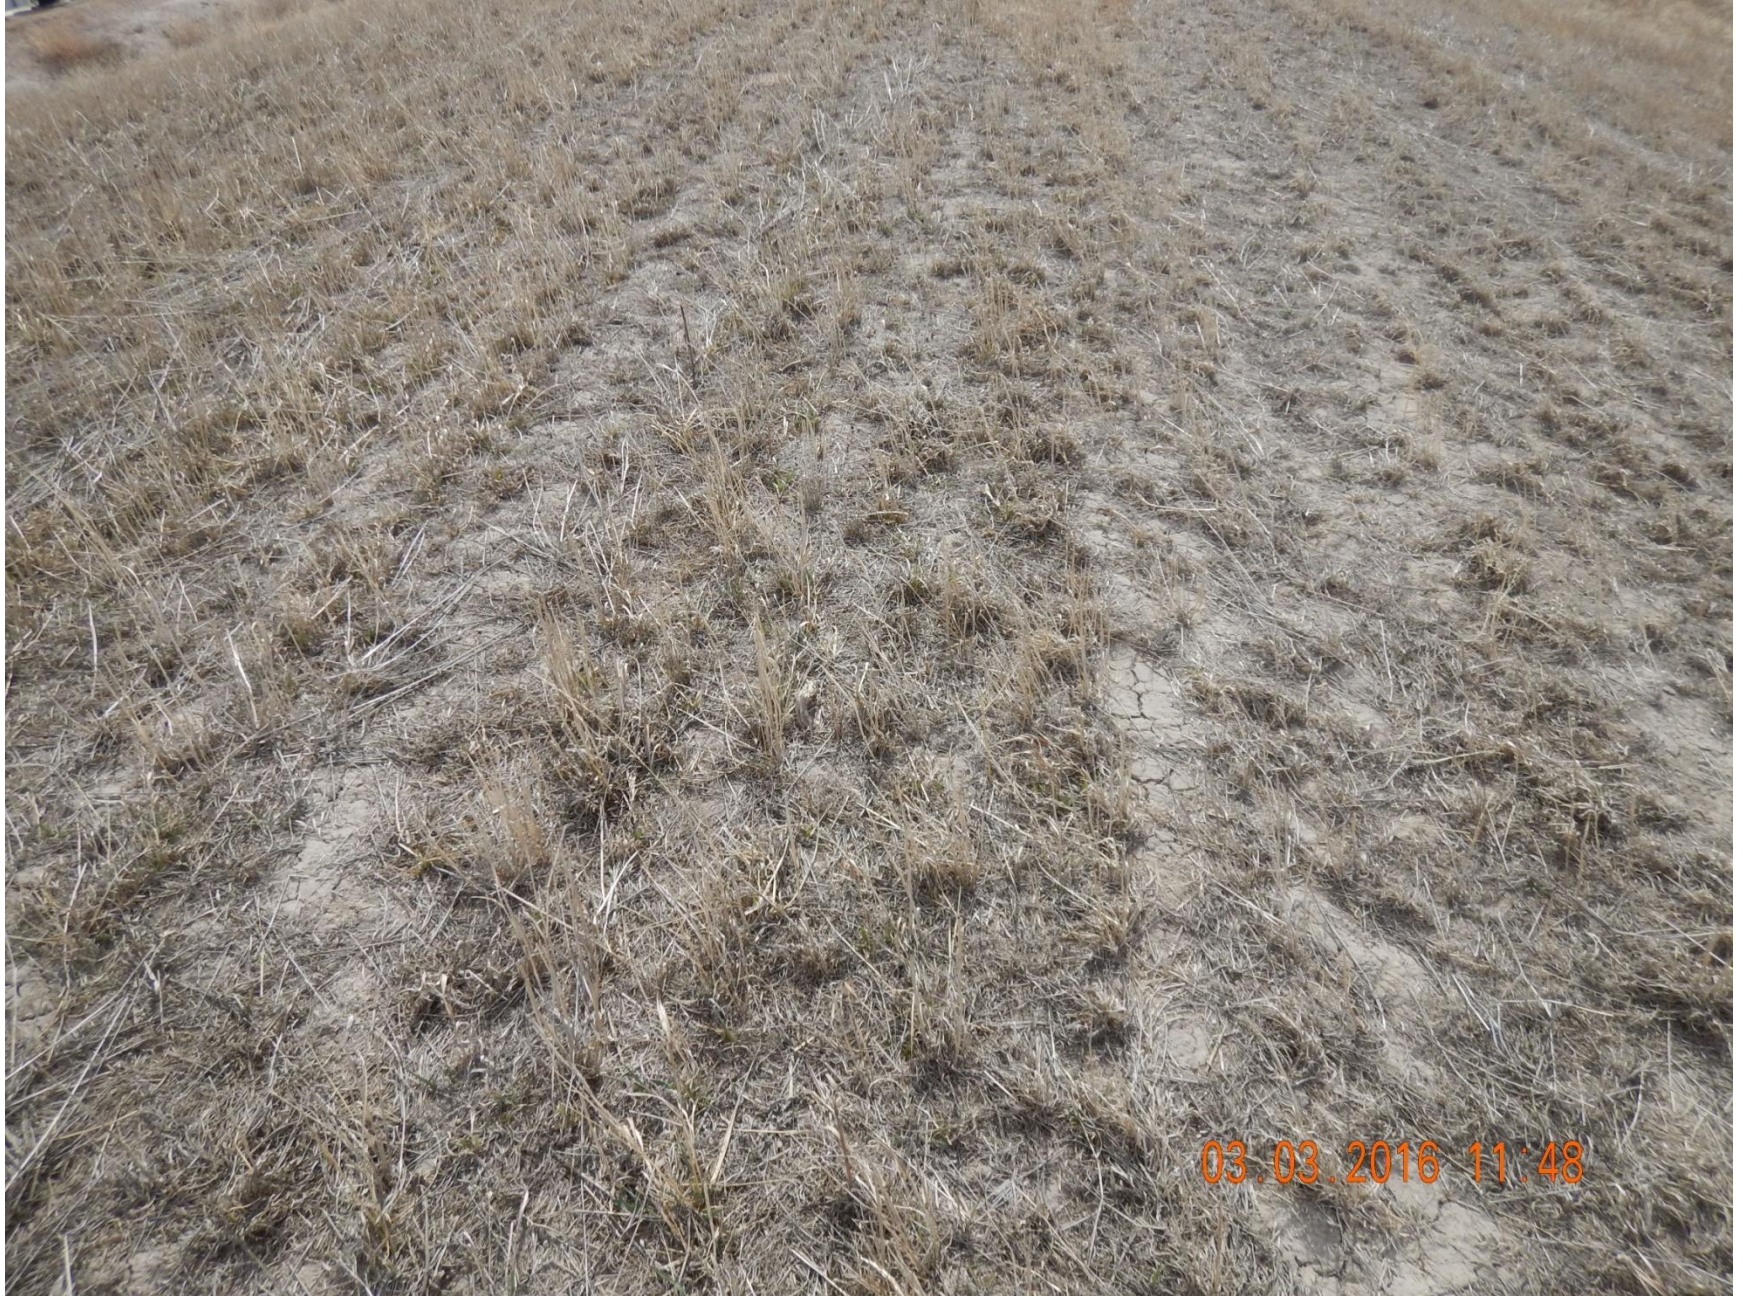
**Figure 8:** Photo taken from the topsoil berm on the west end of the location. Photo of vegetation on interim area.

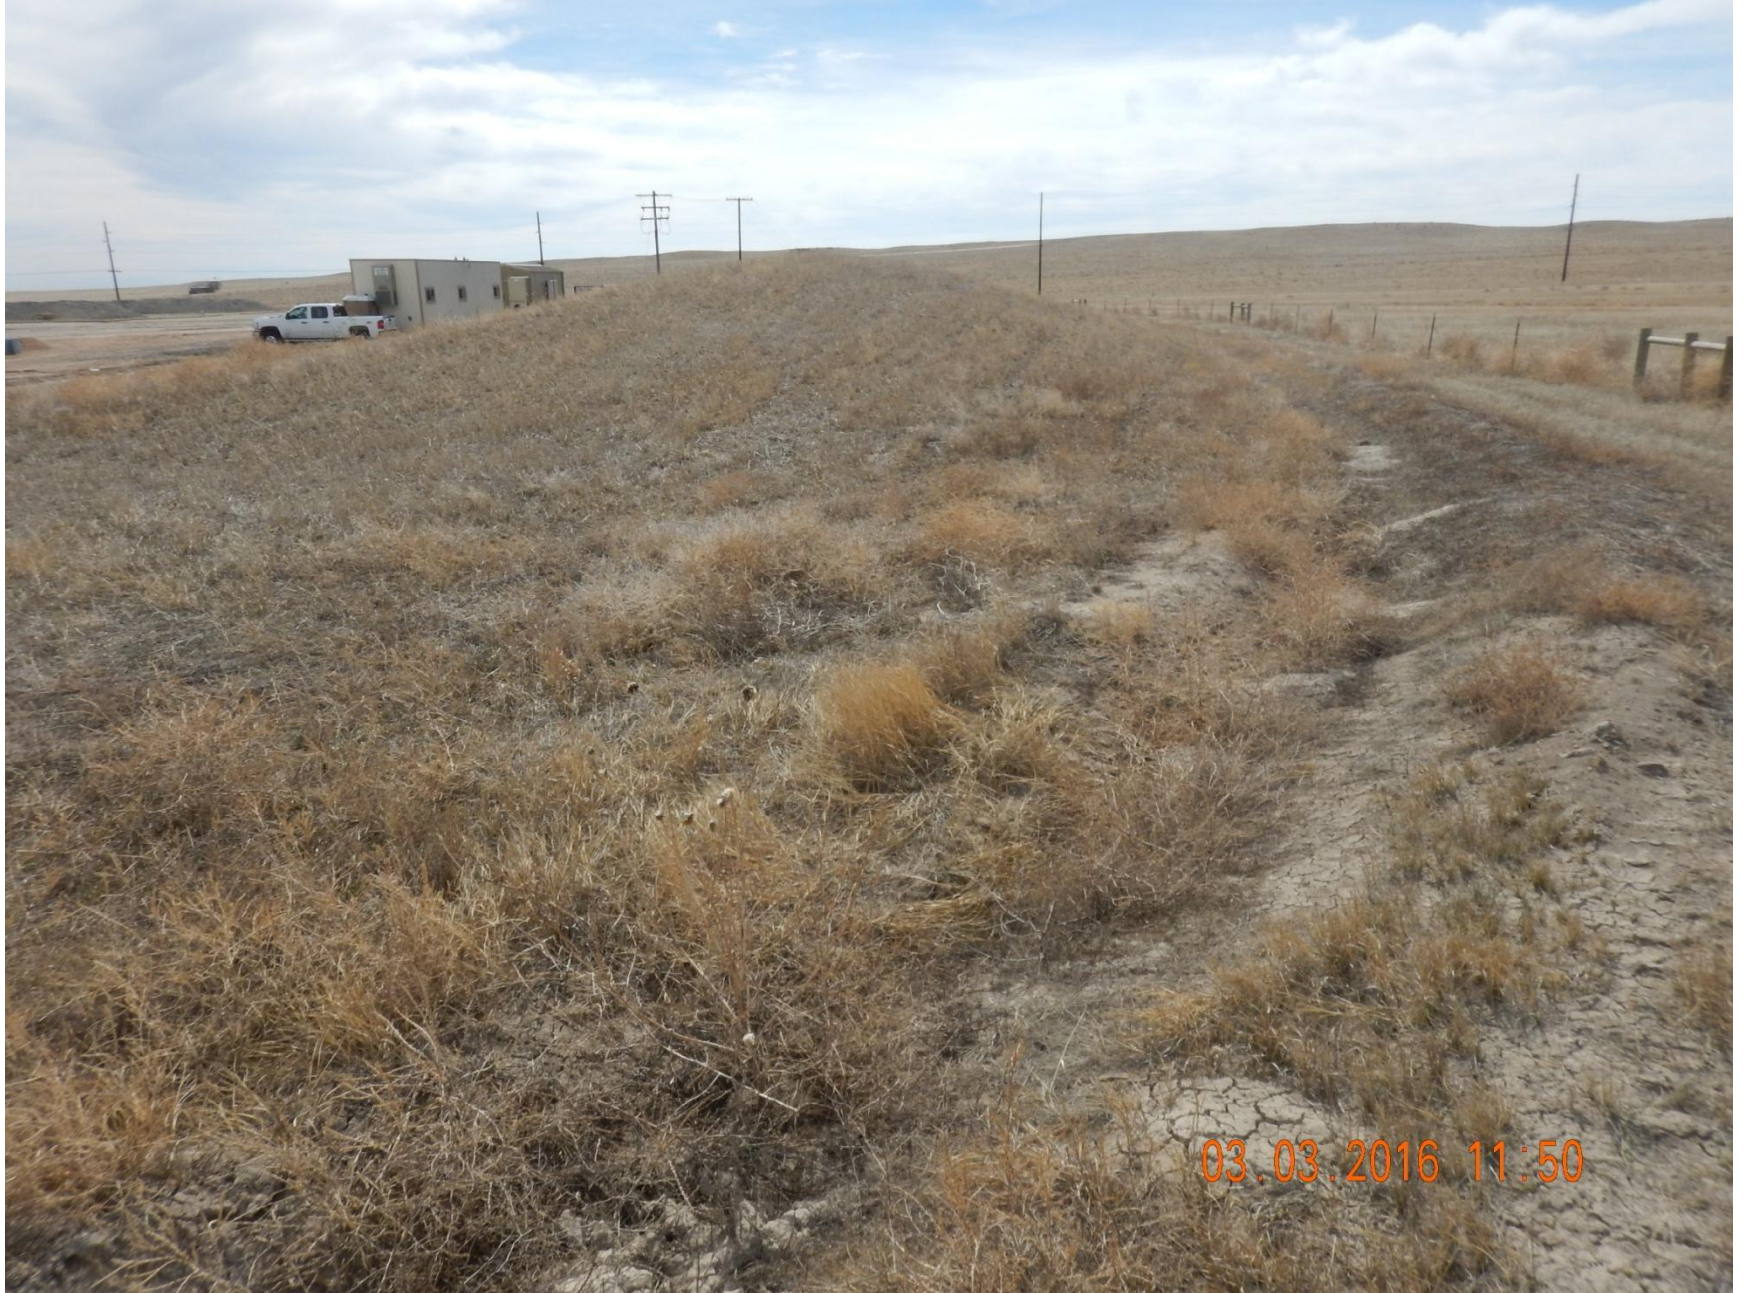
**Figure 9:** Photo taken the northwest end of location, facing south. Photo shows topsoil berm center of photo, stormwater and sediment control ditch to the right, and western interim area.

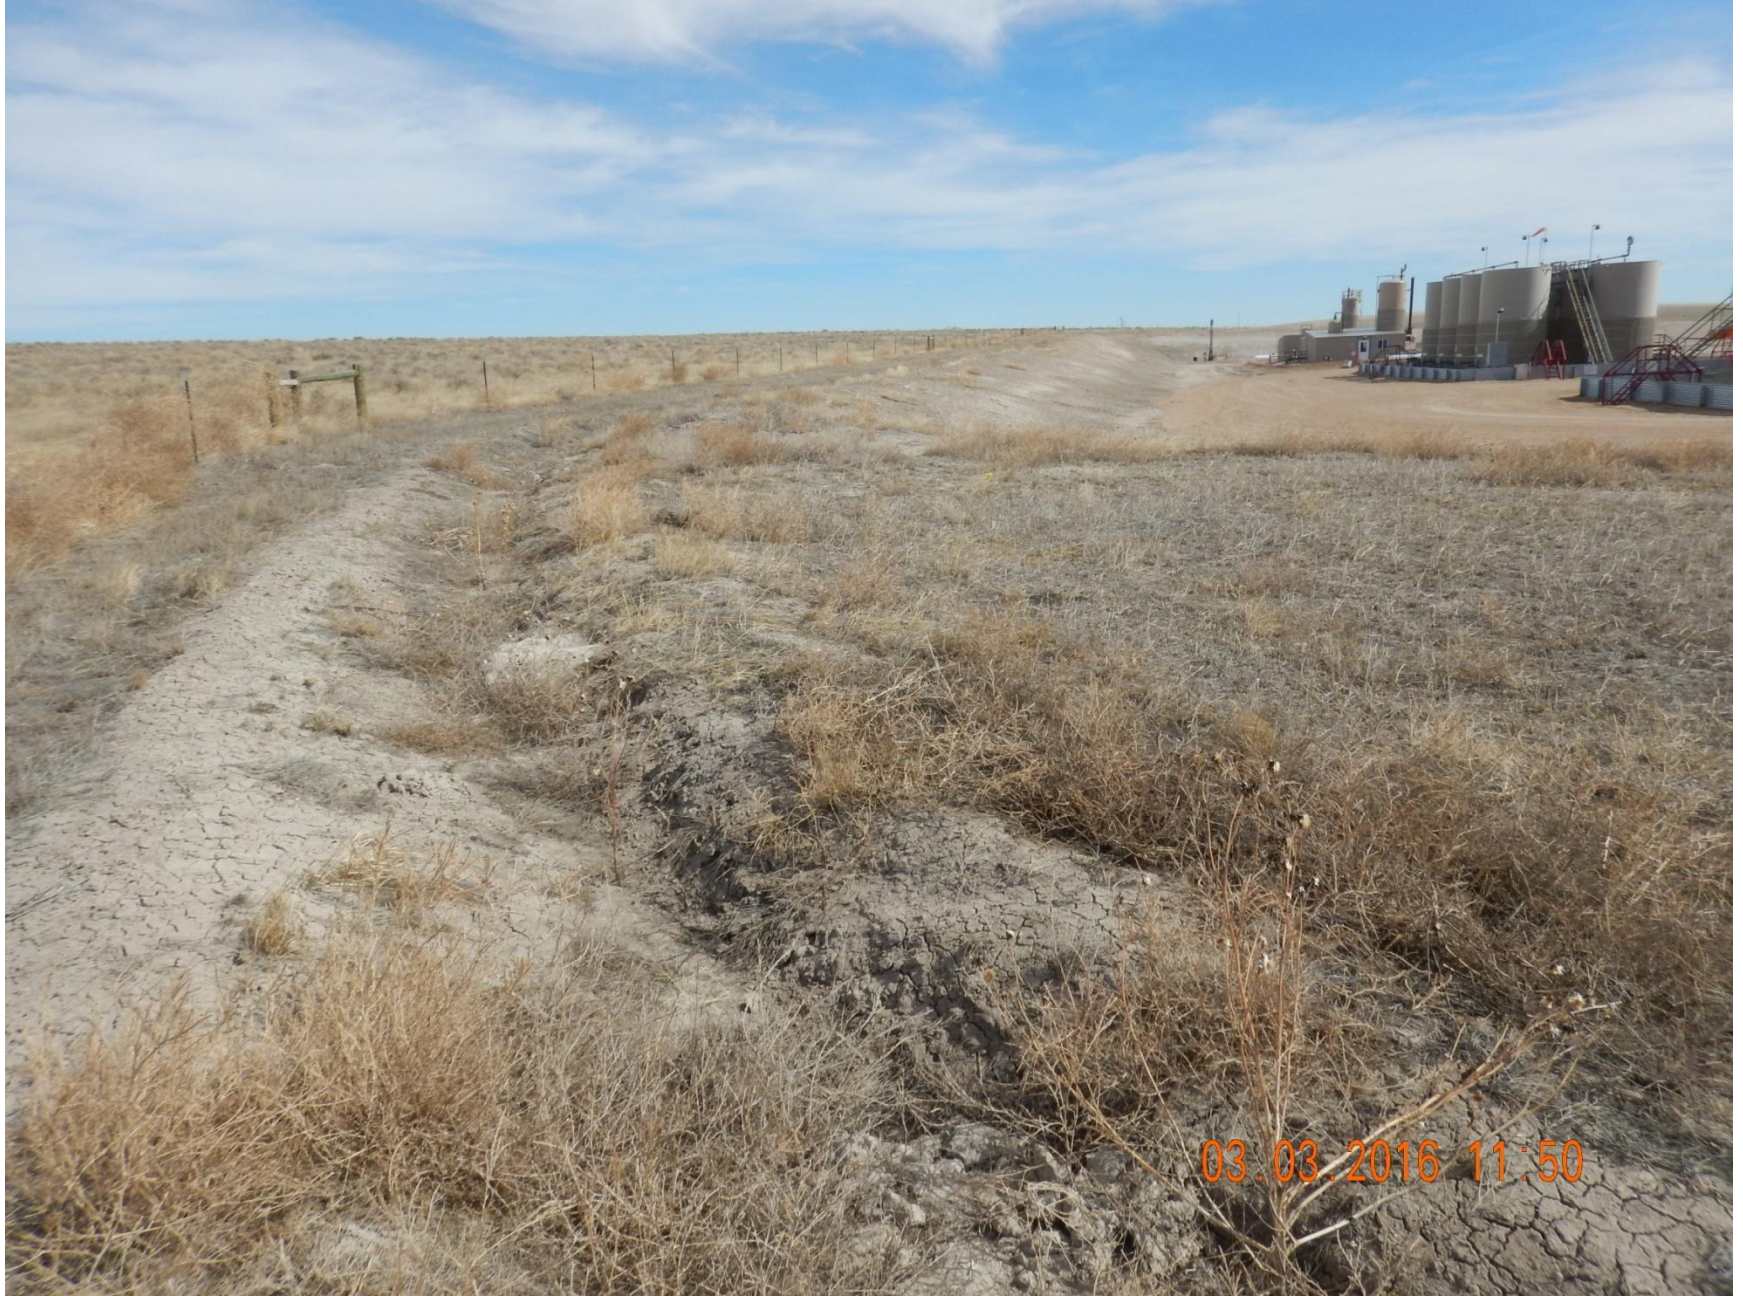
**Figure 10:** Photo taken the northwest end of location, facing northeast. Photo shows stormwater and sediment control ditch and the northern interim area.

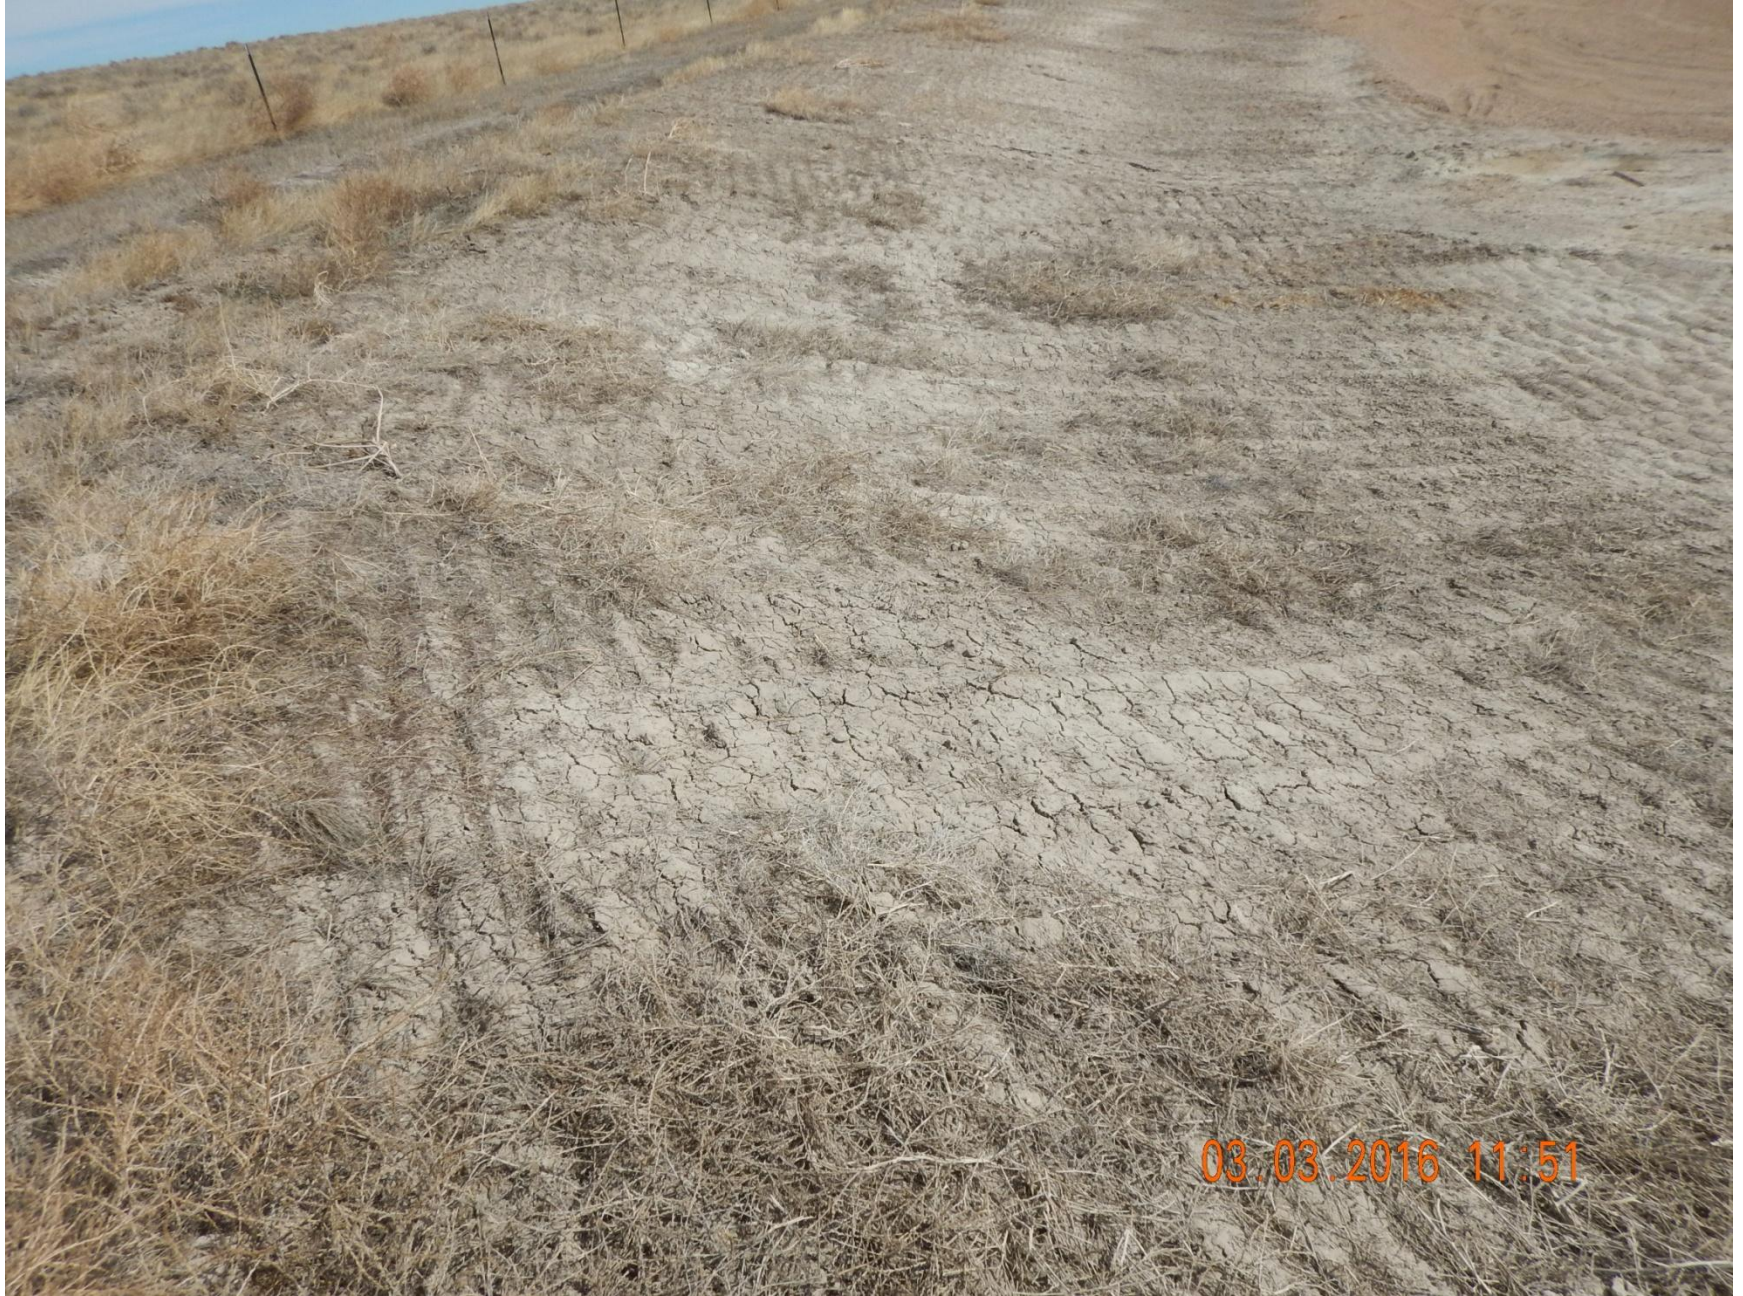
**Figure 11:** Photo taken from the northwest corner of project area. Photo shows vehicle tracking used as a stormwater and sediment control BMP.

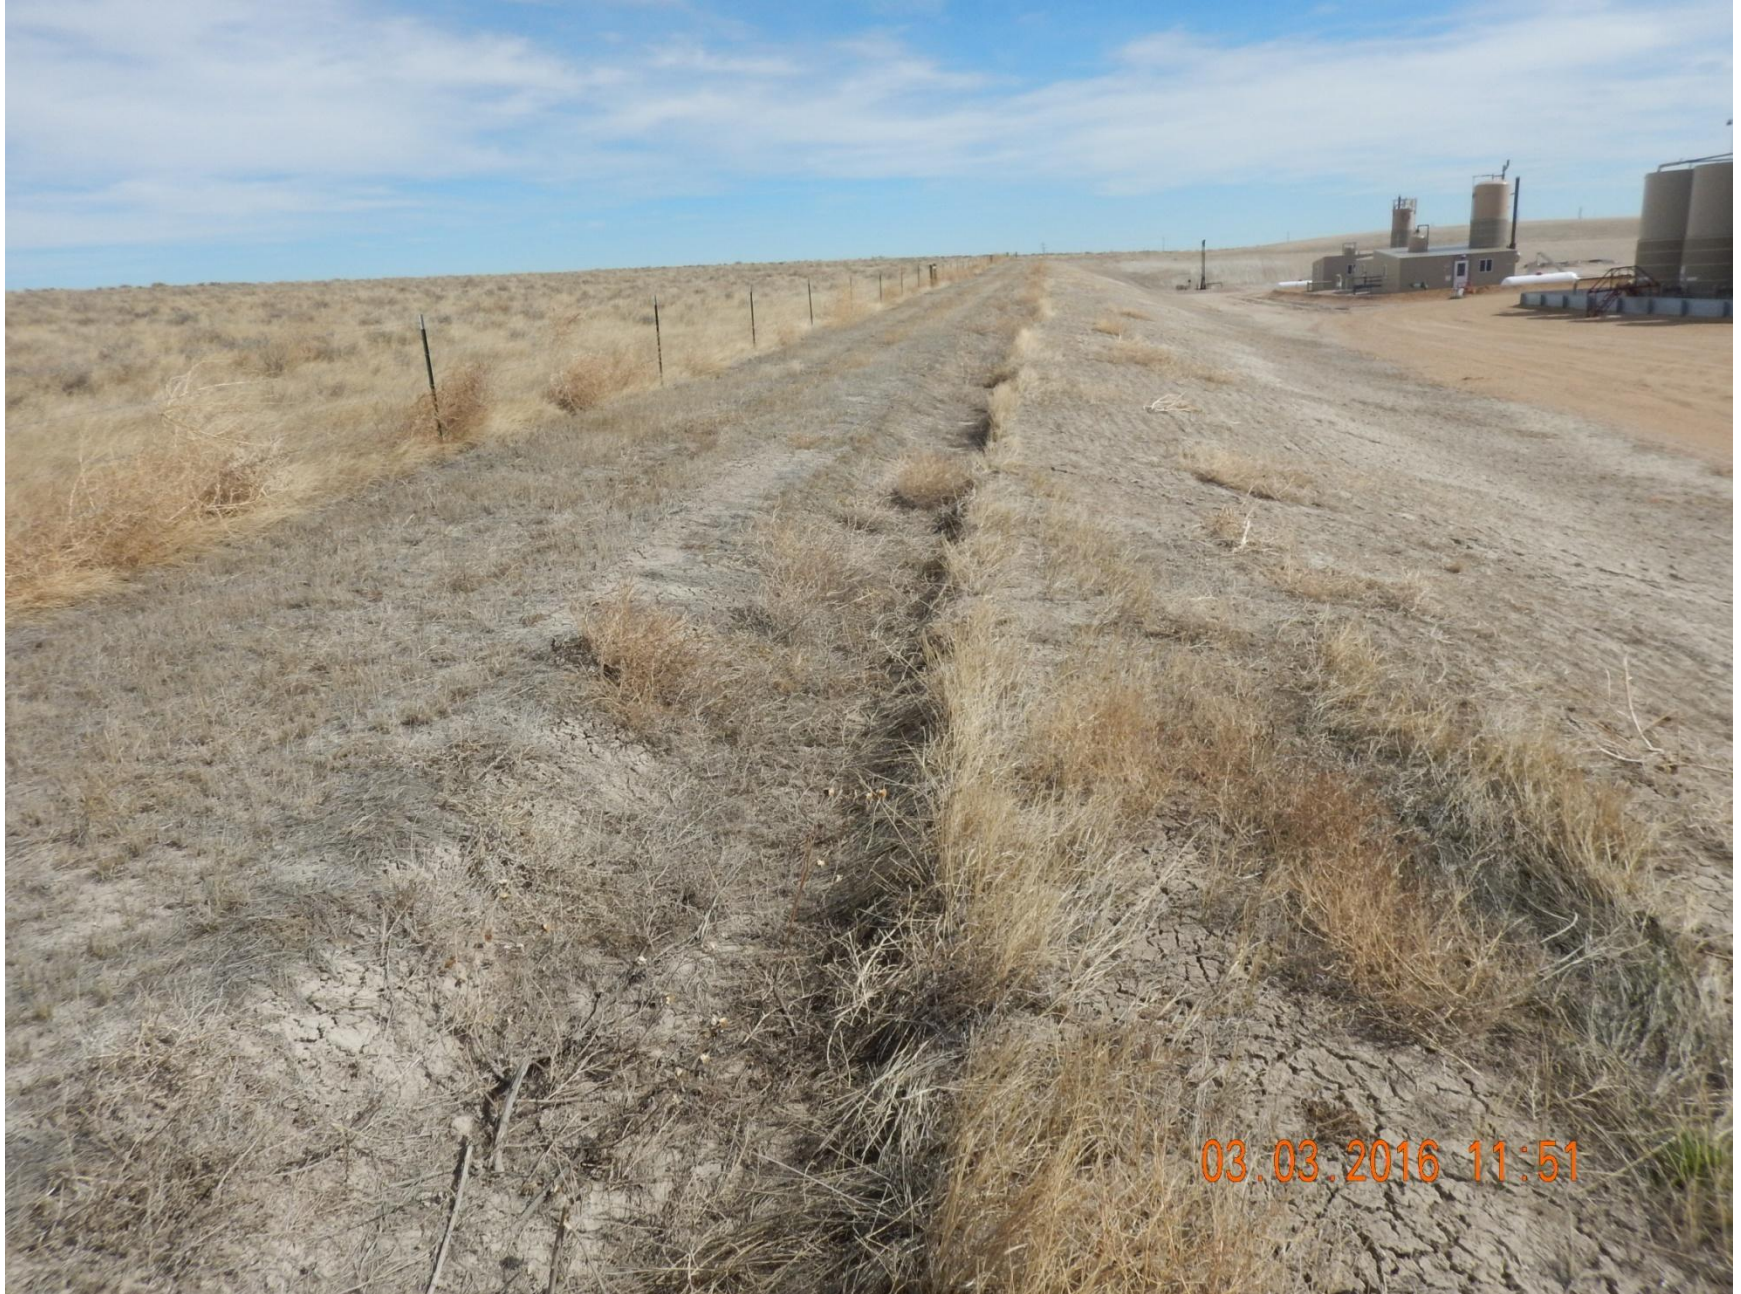
**Figure 12:** Photo taken from the northwest end of location, facing east. Photo shows stormwater and sediment control ditch used to divert stormwater on the northern perimeter of the location.

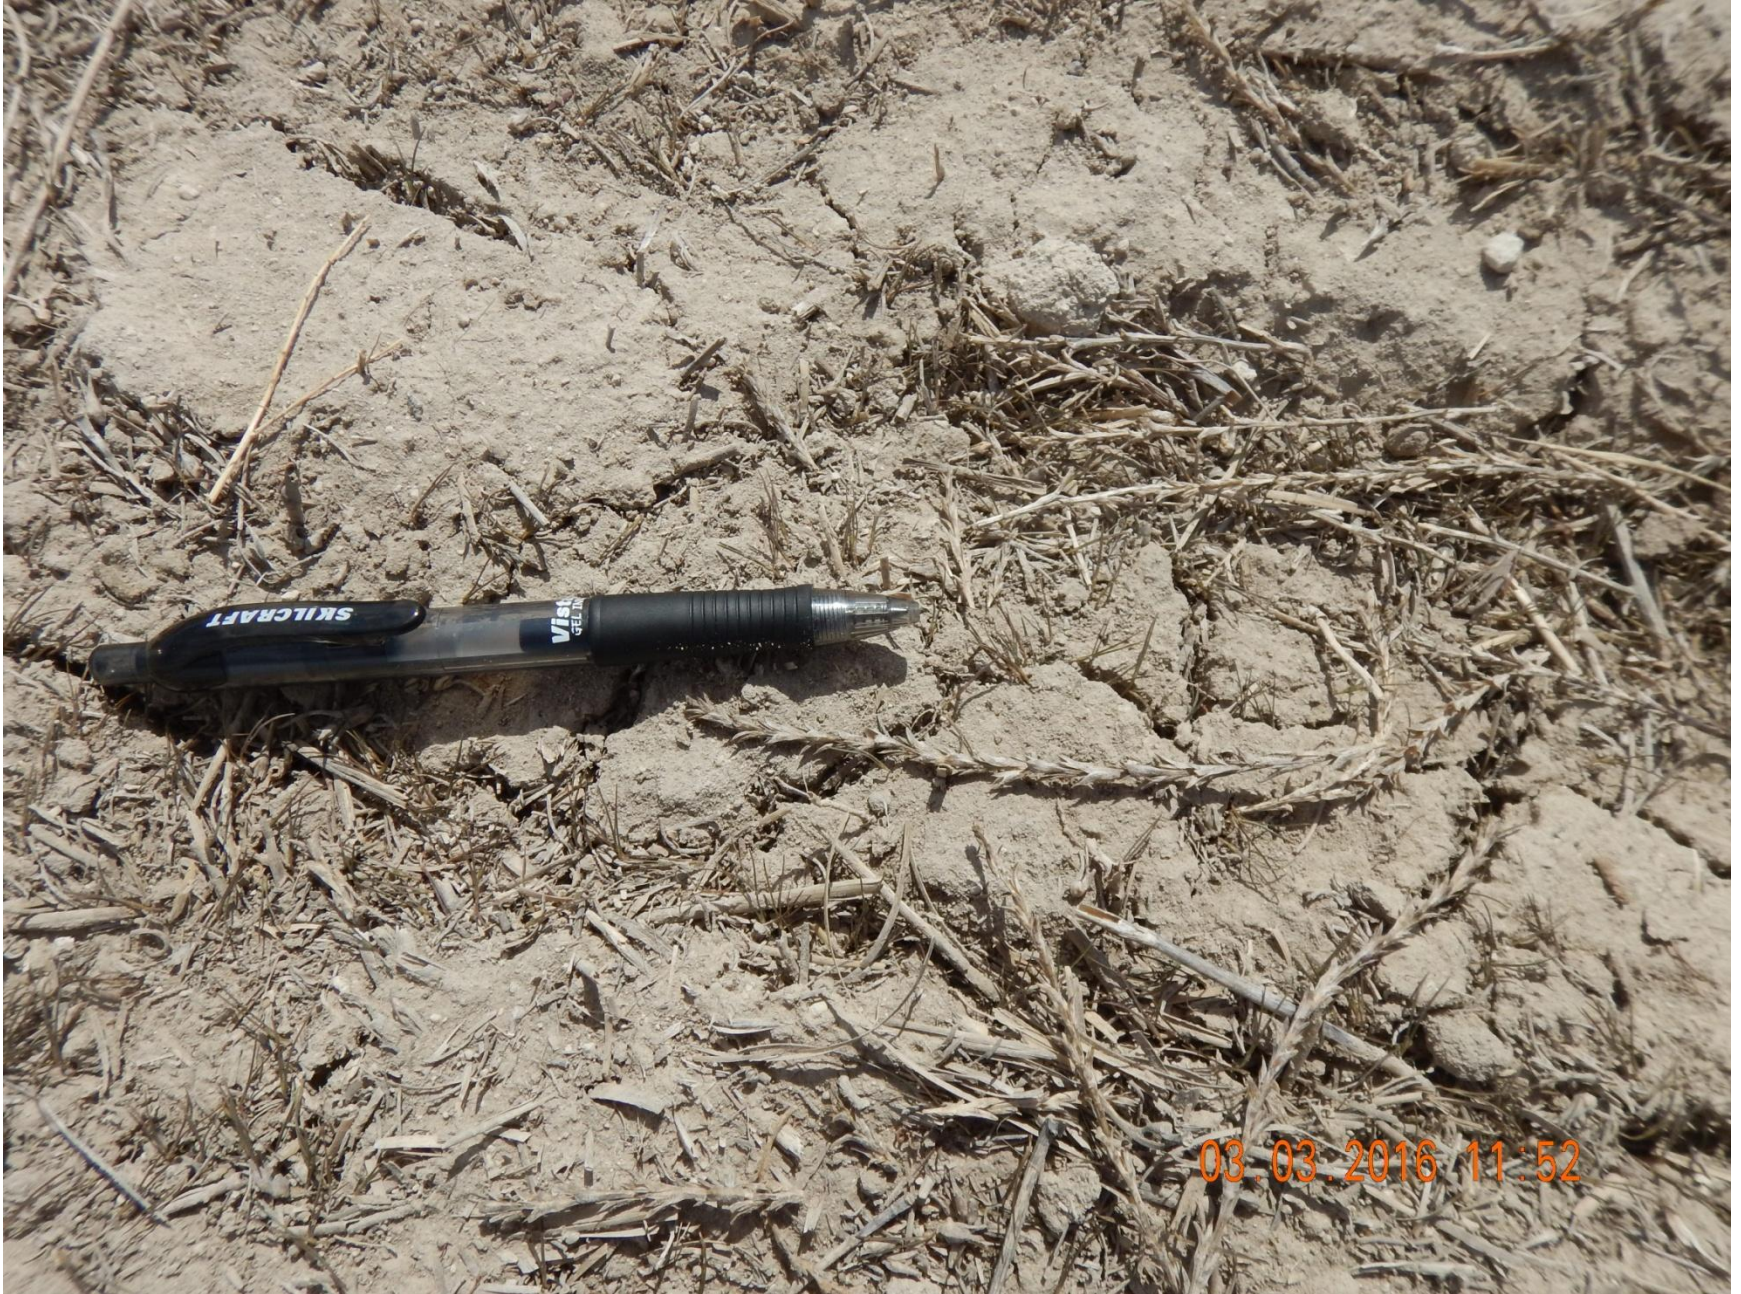
**Figure 15:** Photo taken from the slope, on the north end of the location. Photo shows evidence of germination.

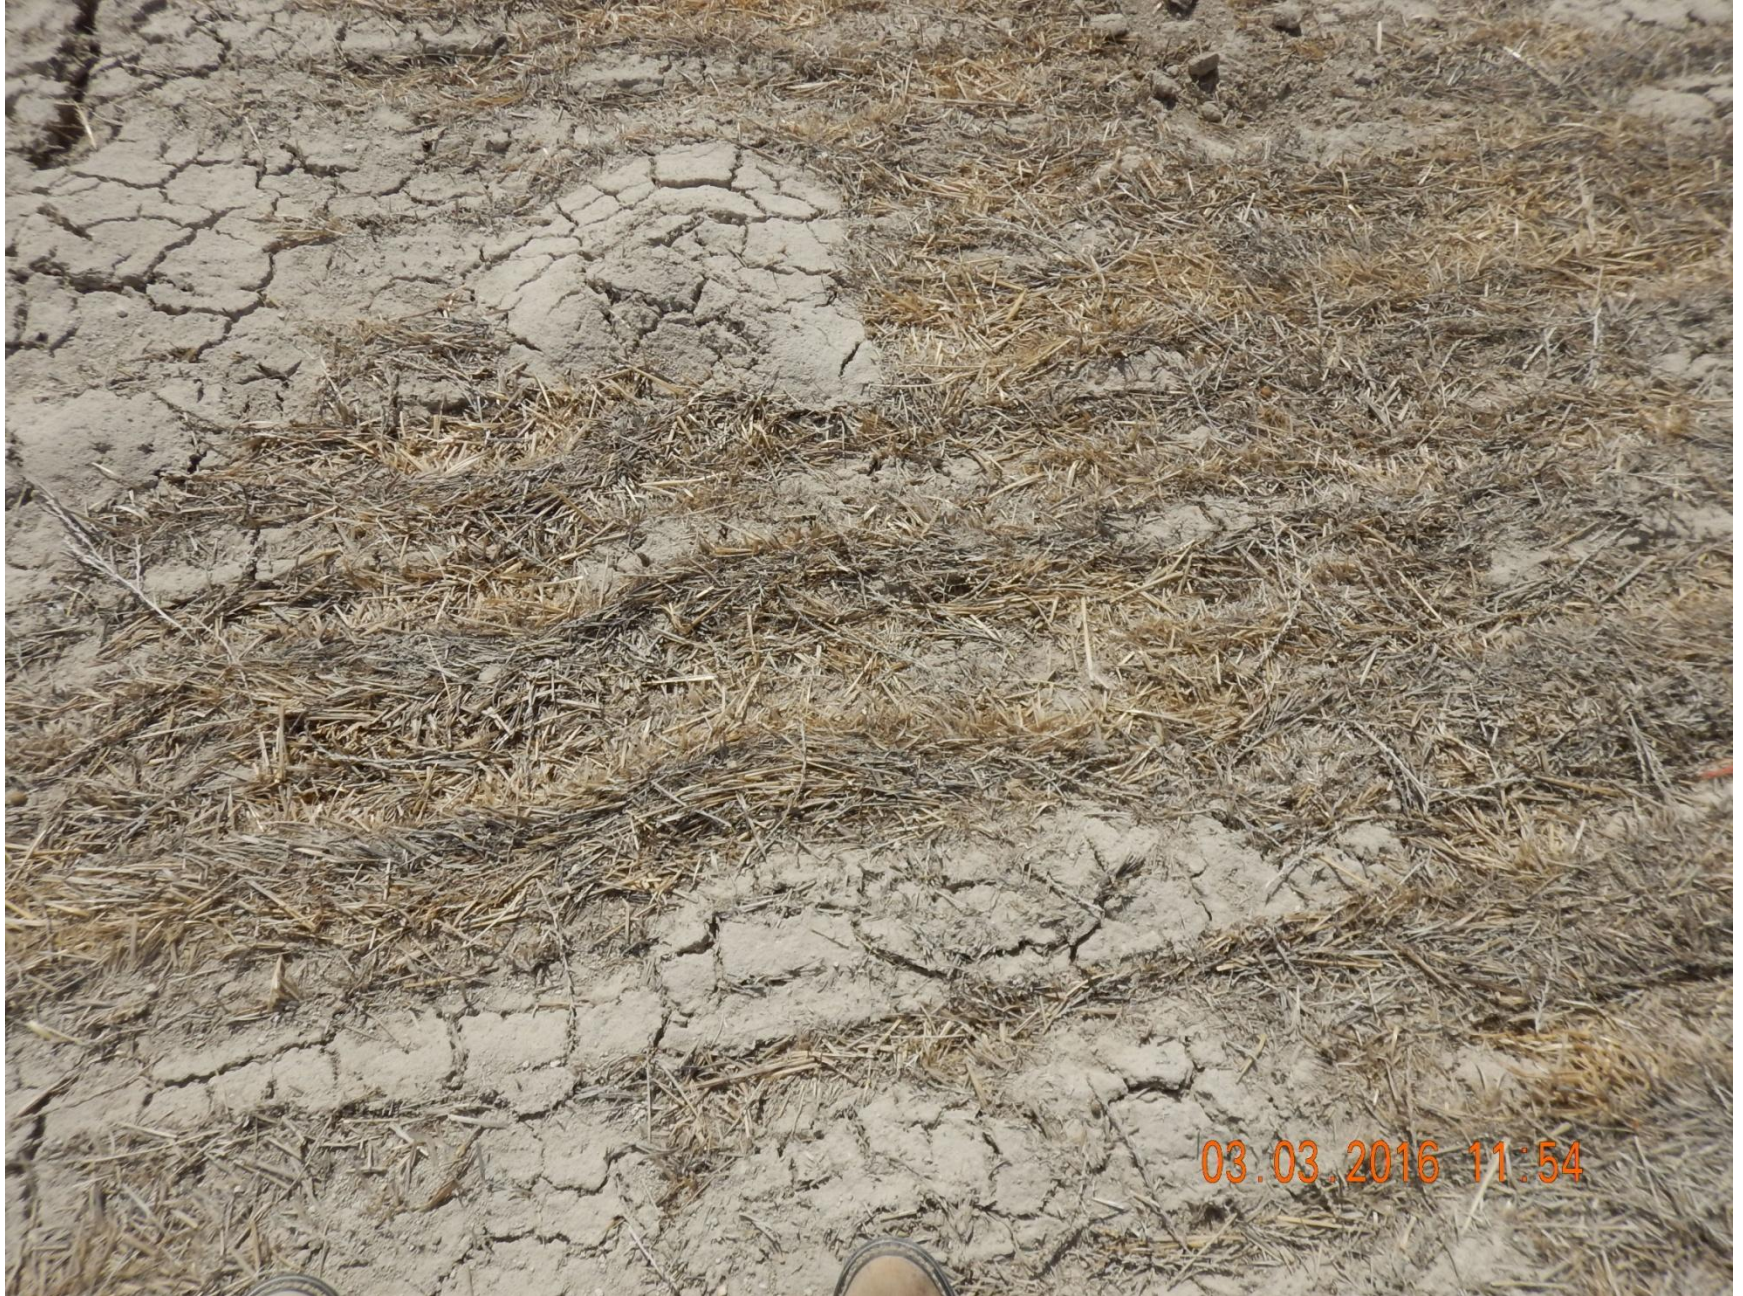
**Figure 16:** Photo taken from the north end of the location. Photo shows straw mulch crimped into slope.
