# Interim Reclamation Inspection

3/3/2016

Operator: Whiting Oil and Gas

Location ID: 431782

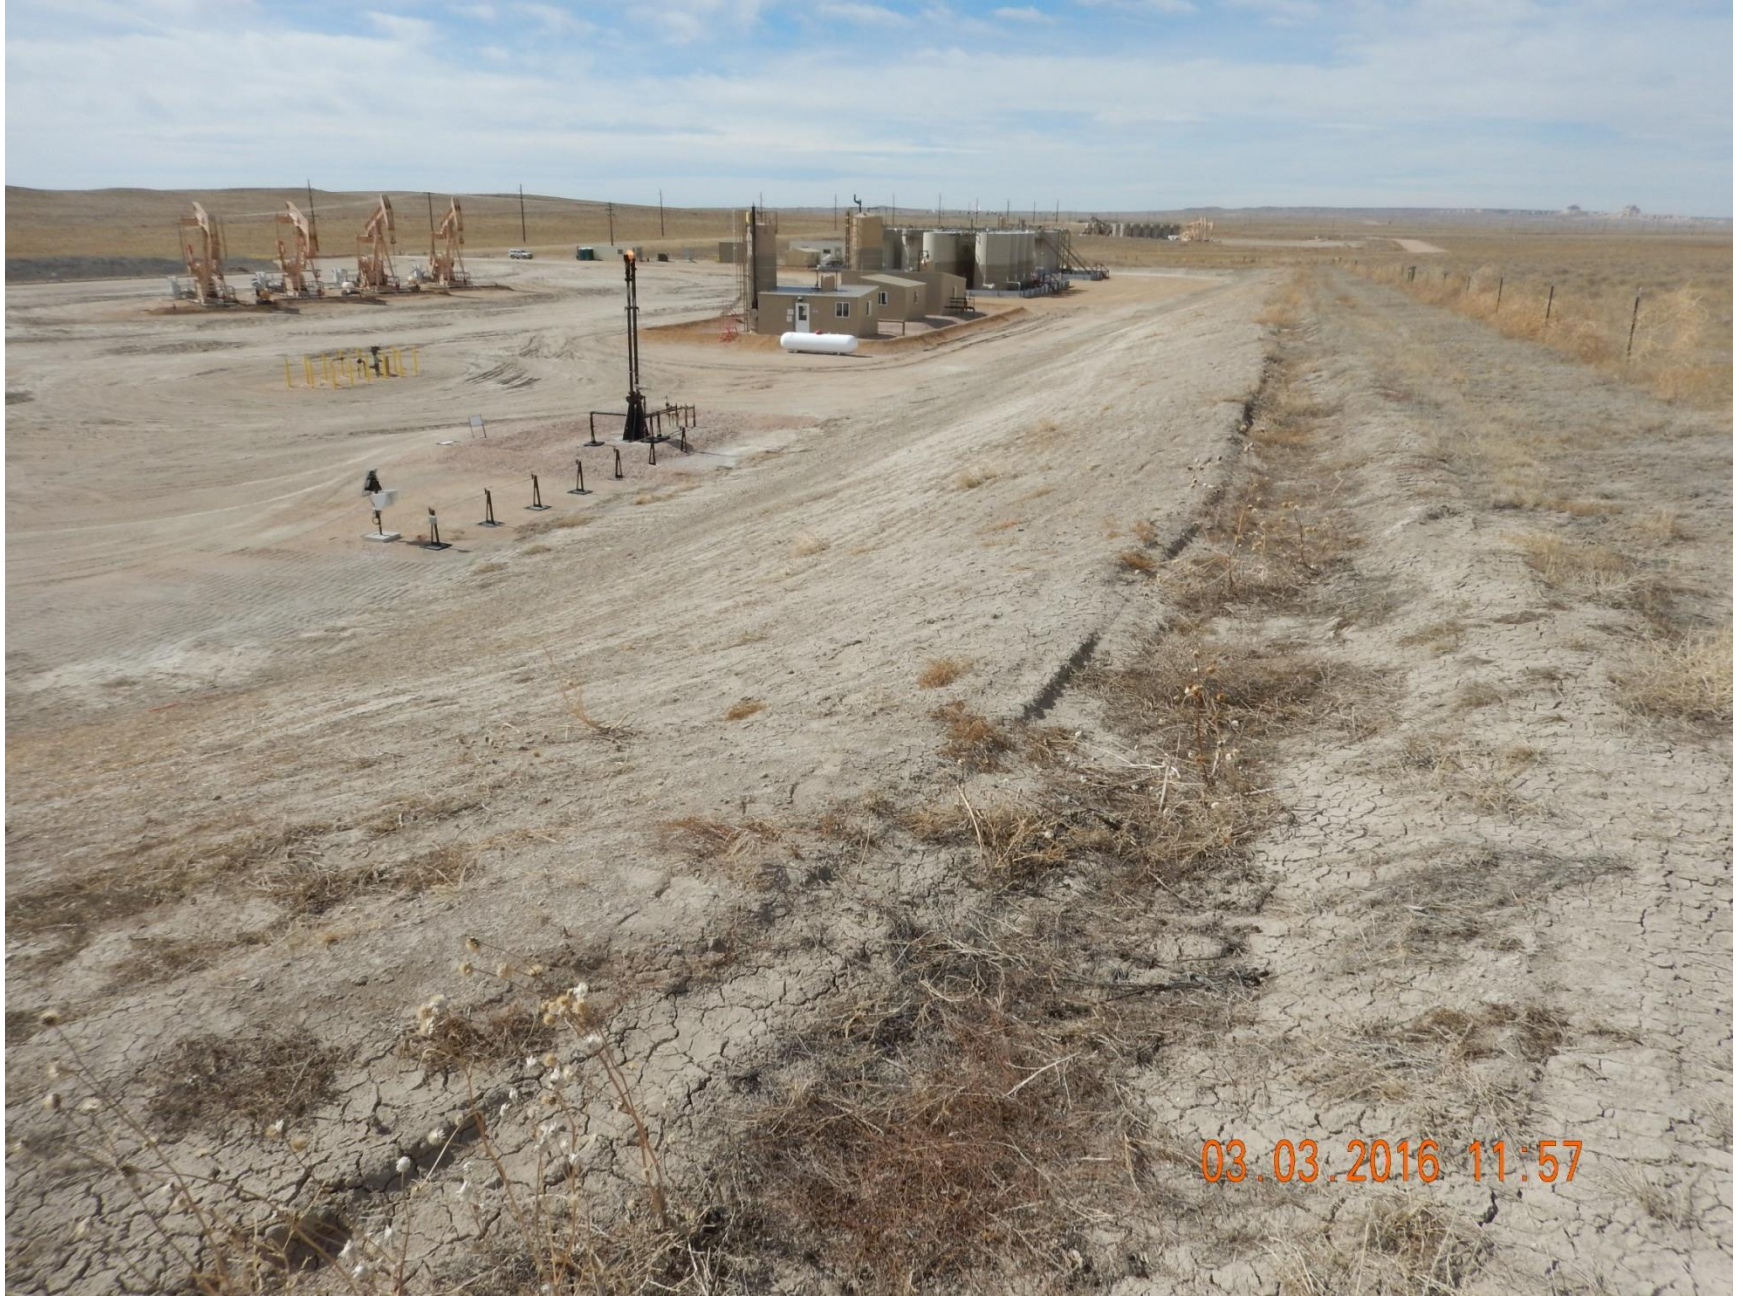
**Figure 22:** Photo taken from the northeast end of location, facing west. Photo shows project and interim areas, and stormwater and sediment control ditch on northern perimeter.

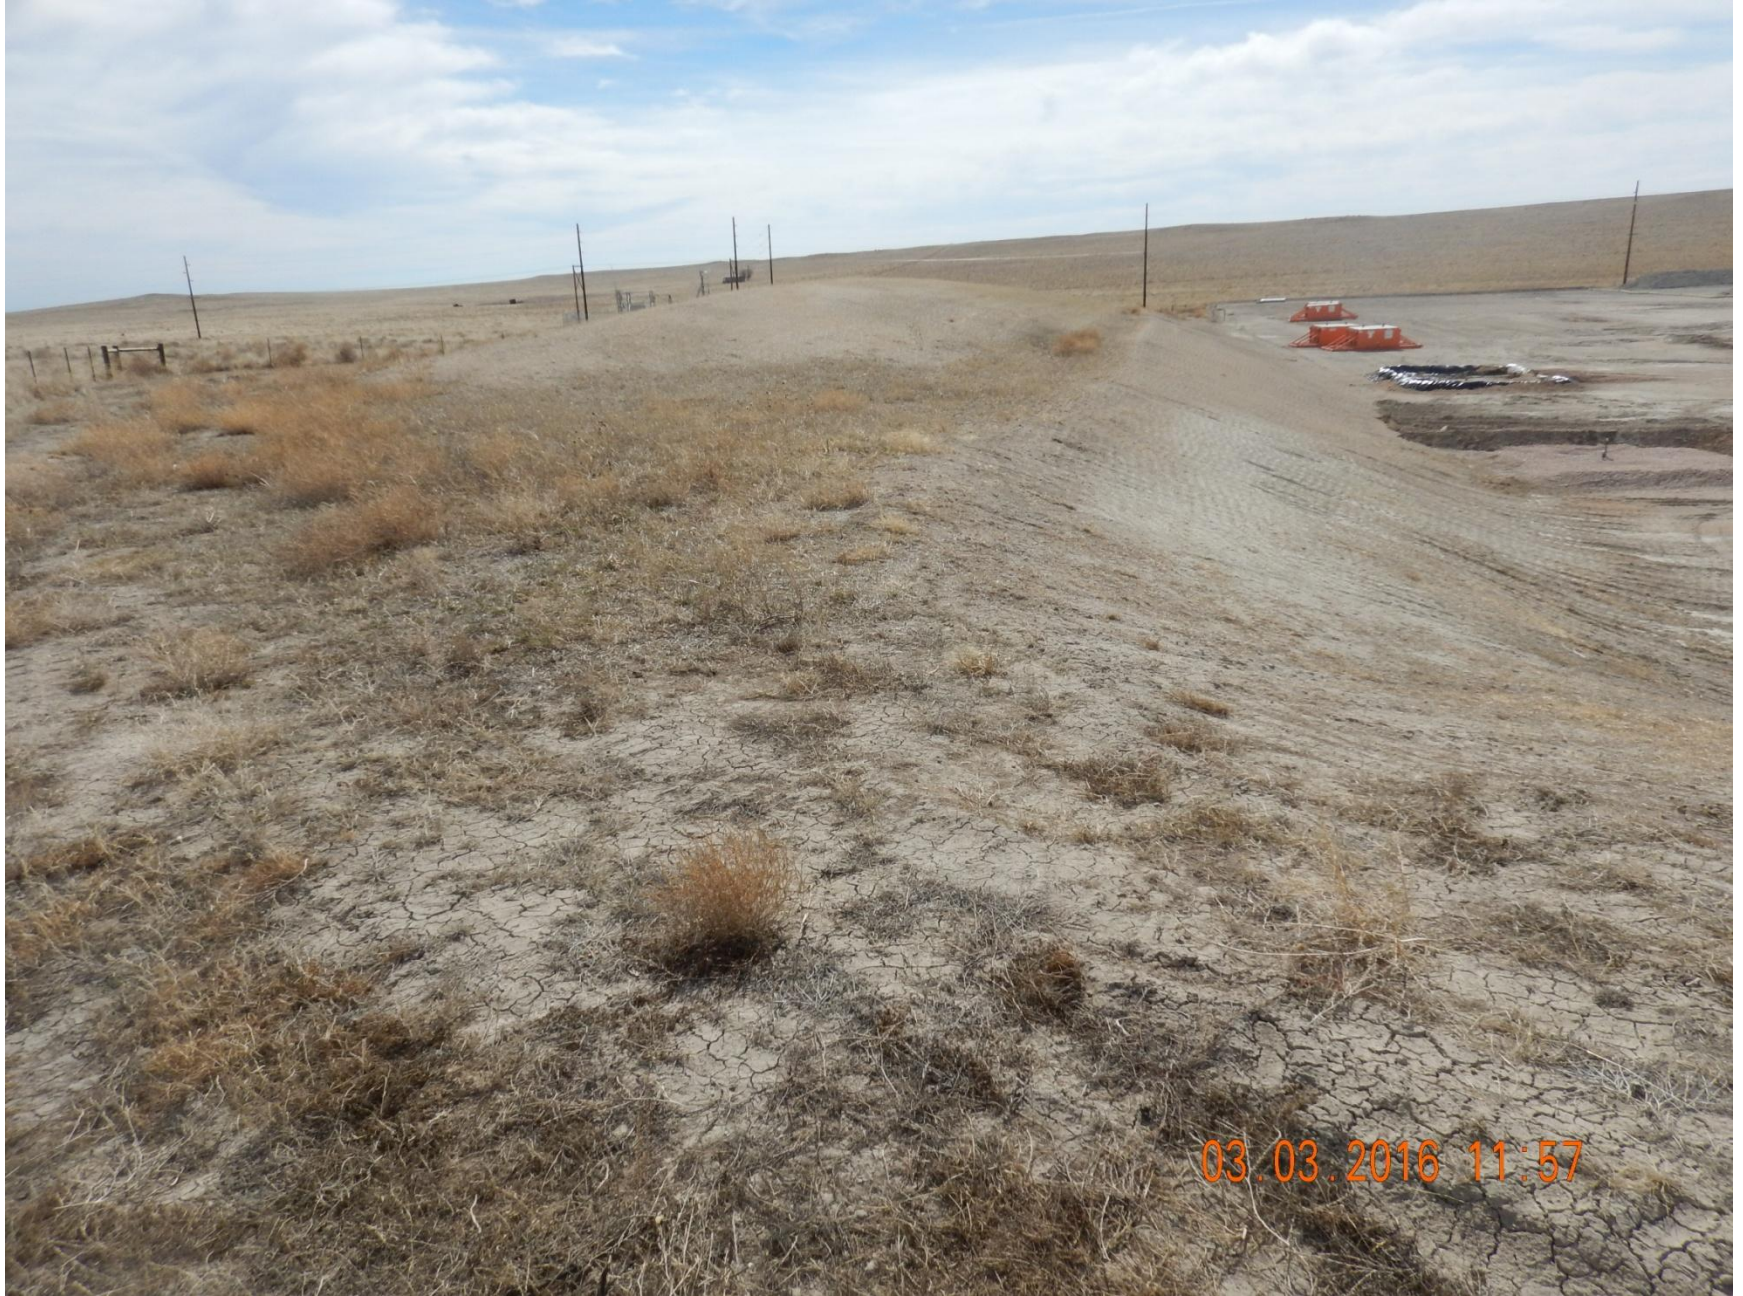
**Figure 23:** Photo taken from the northeast end of location, facing south. Photo shows vegetation on interim area, and steep slope on the east end of the location.

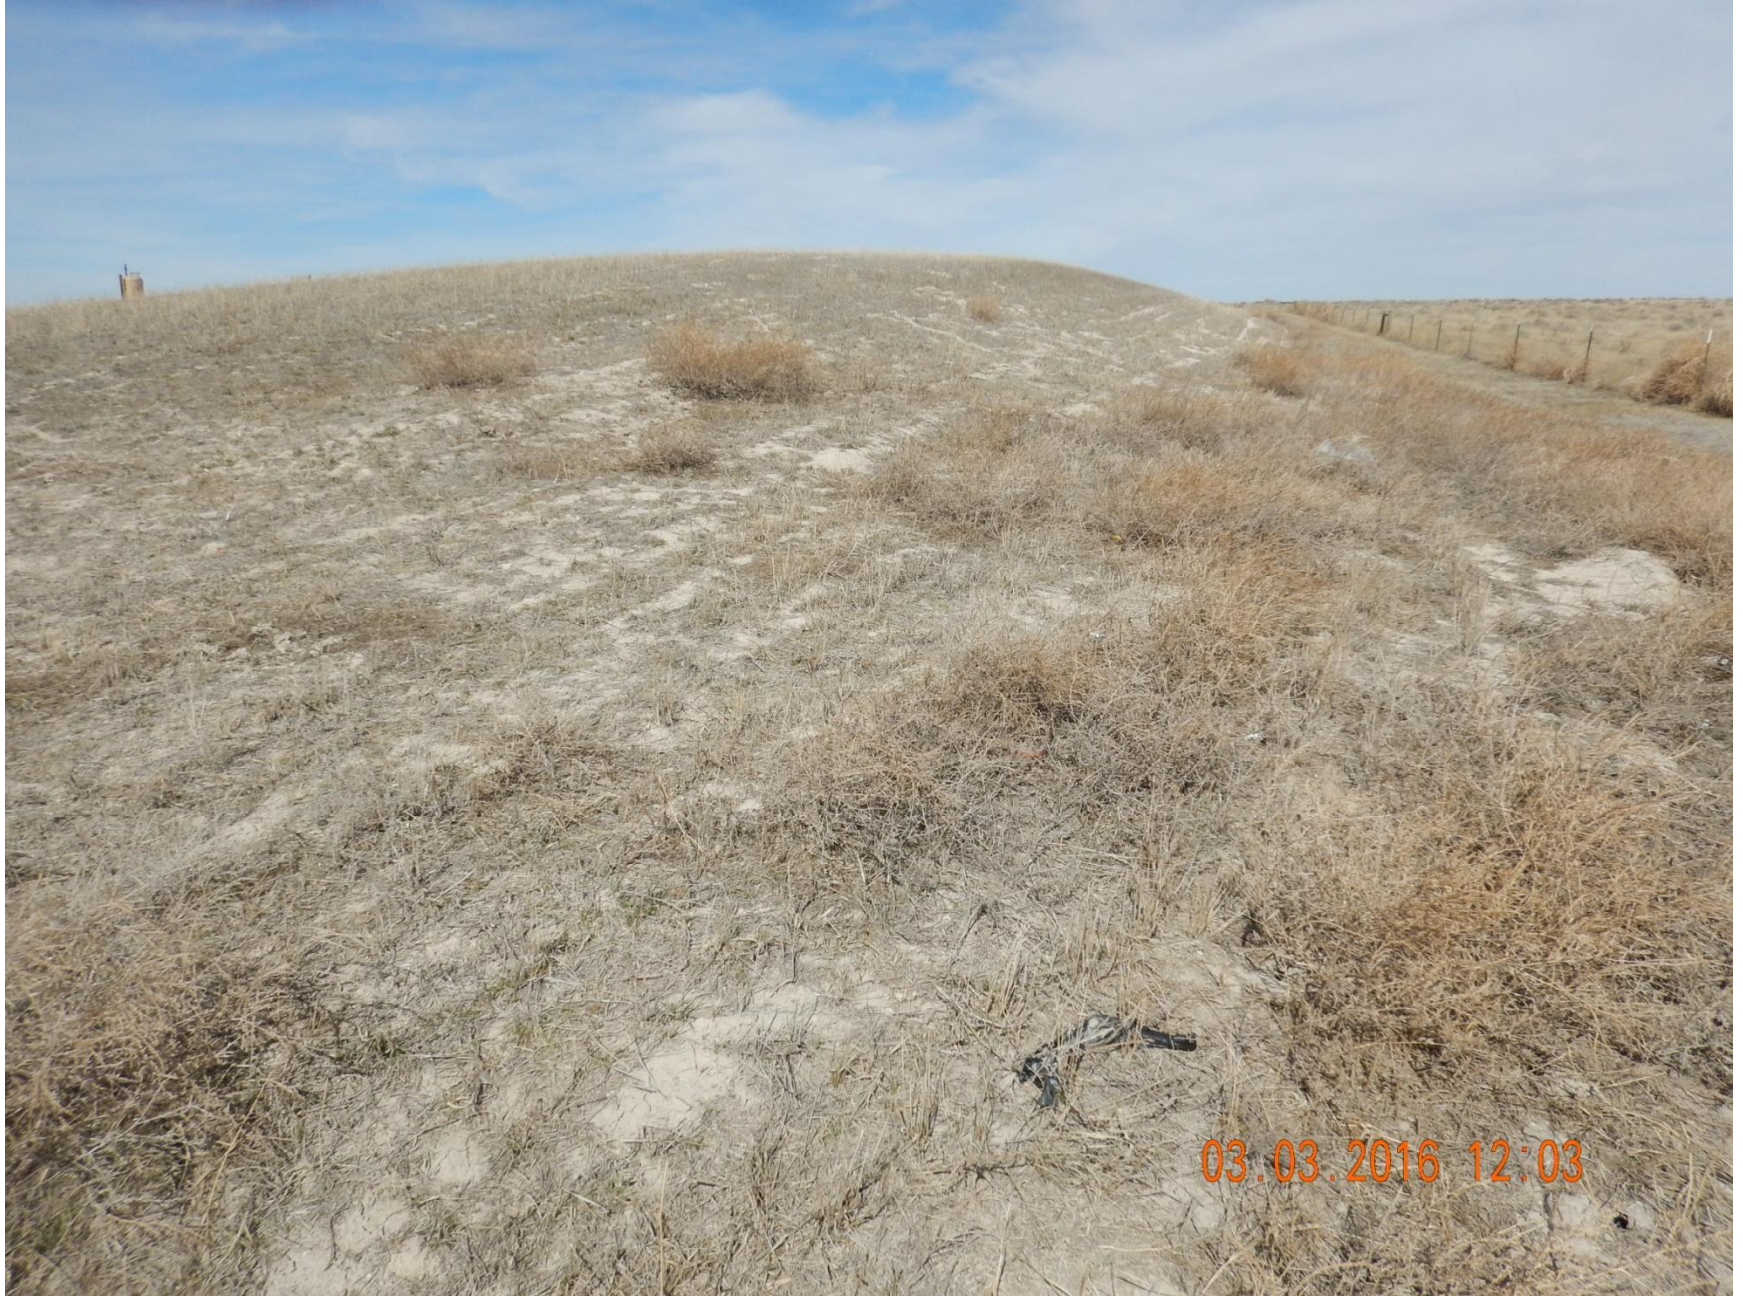
**Figure 29:** Photo taken from the southeast end of the interim area, facing north. Photo shows vegetation on interim area.

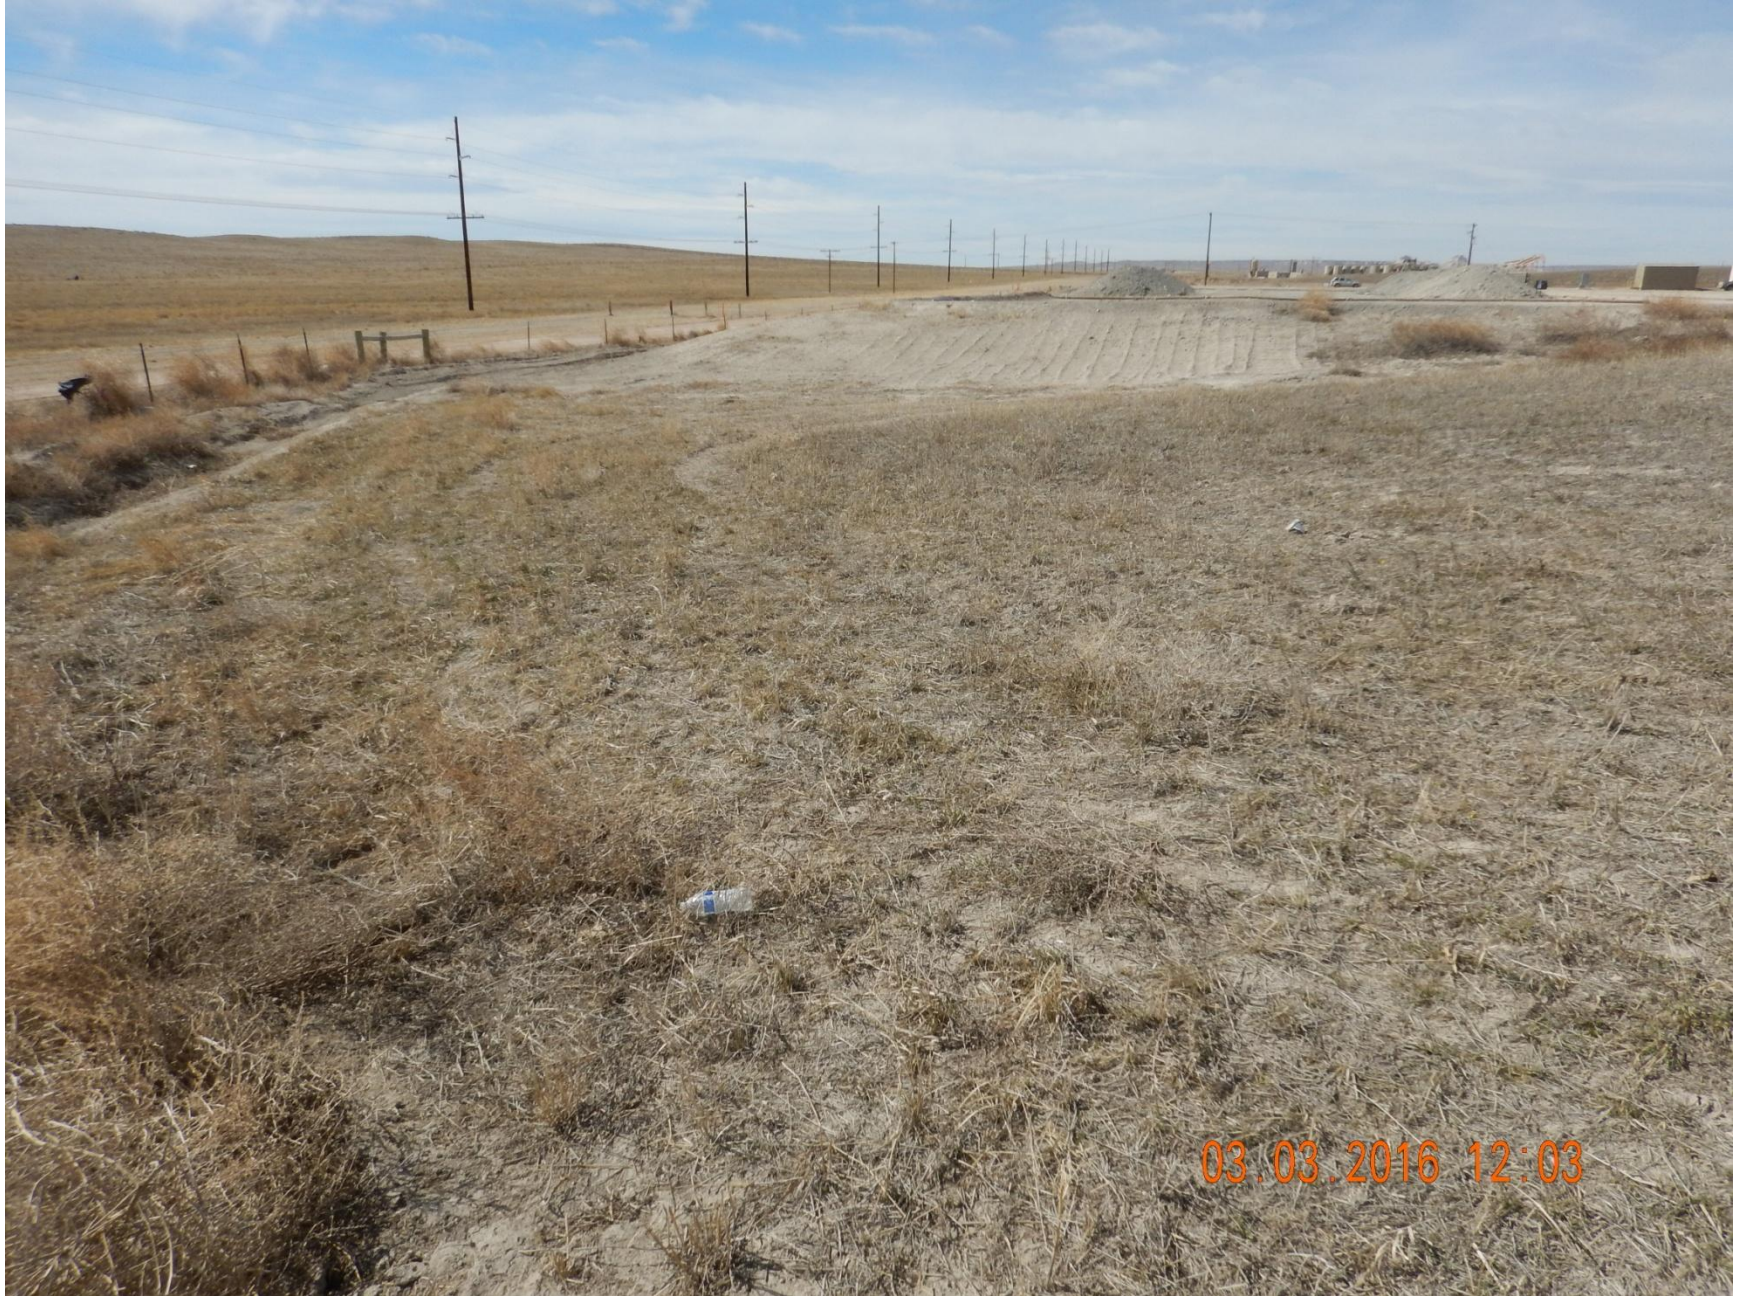
**Figure 30:** Photo taken from the southeast end of the interim area, facing west, towards project area. Photo shows vegetation on interim area.

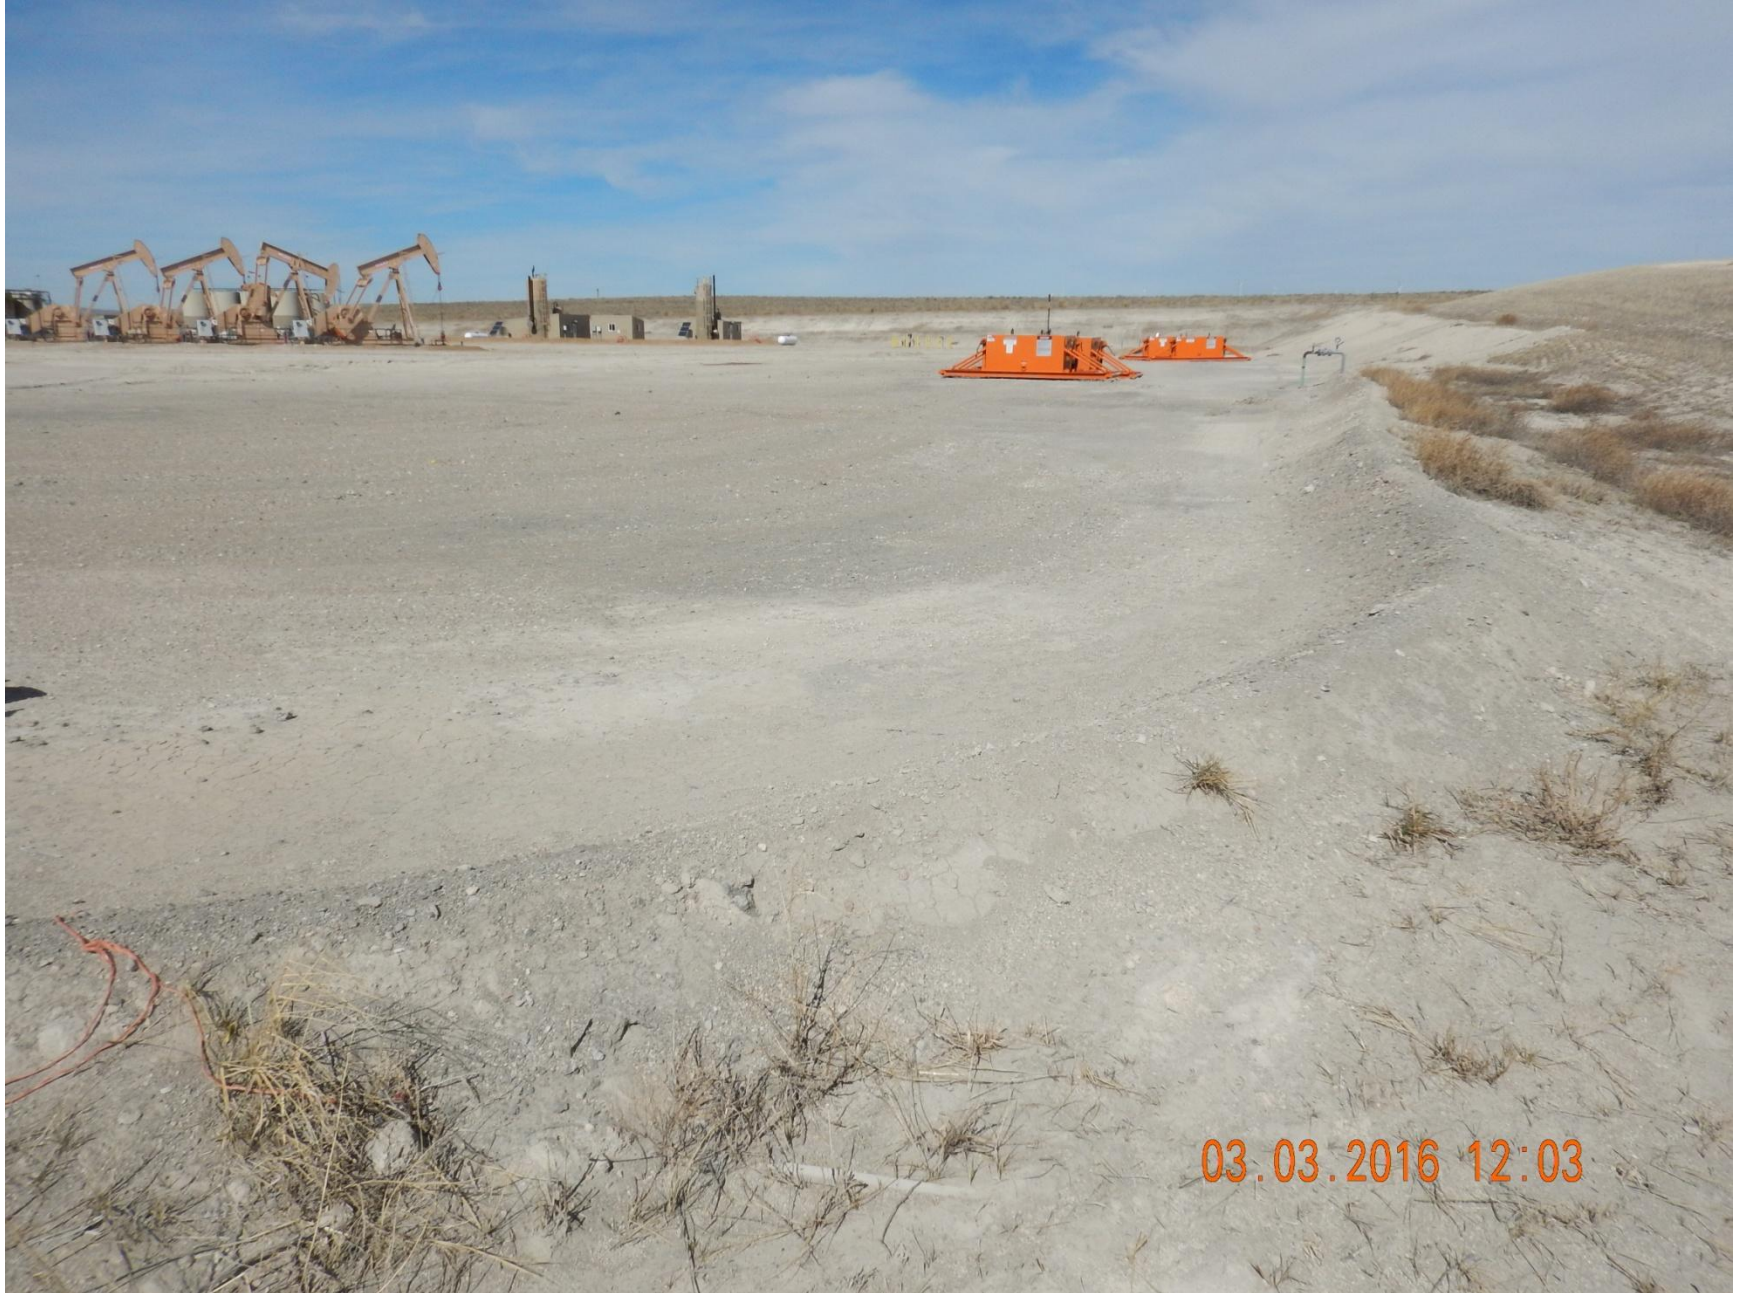
**Figure 31:** Photo taken from the southeast end of the project area, facing north. Photo shows project and interim areas.

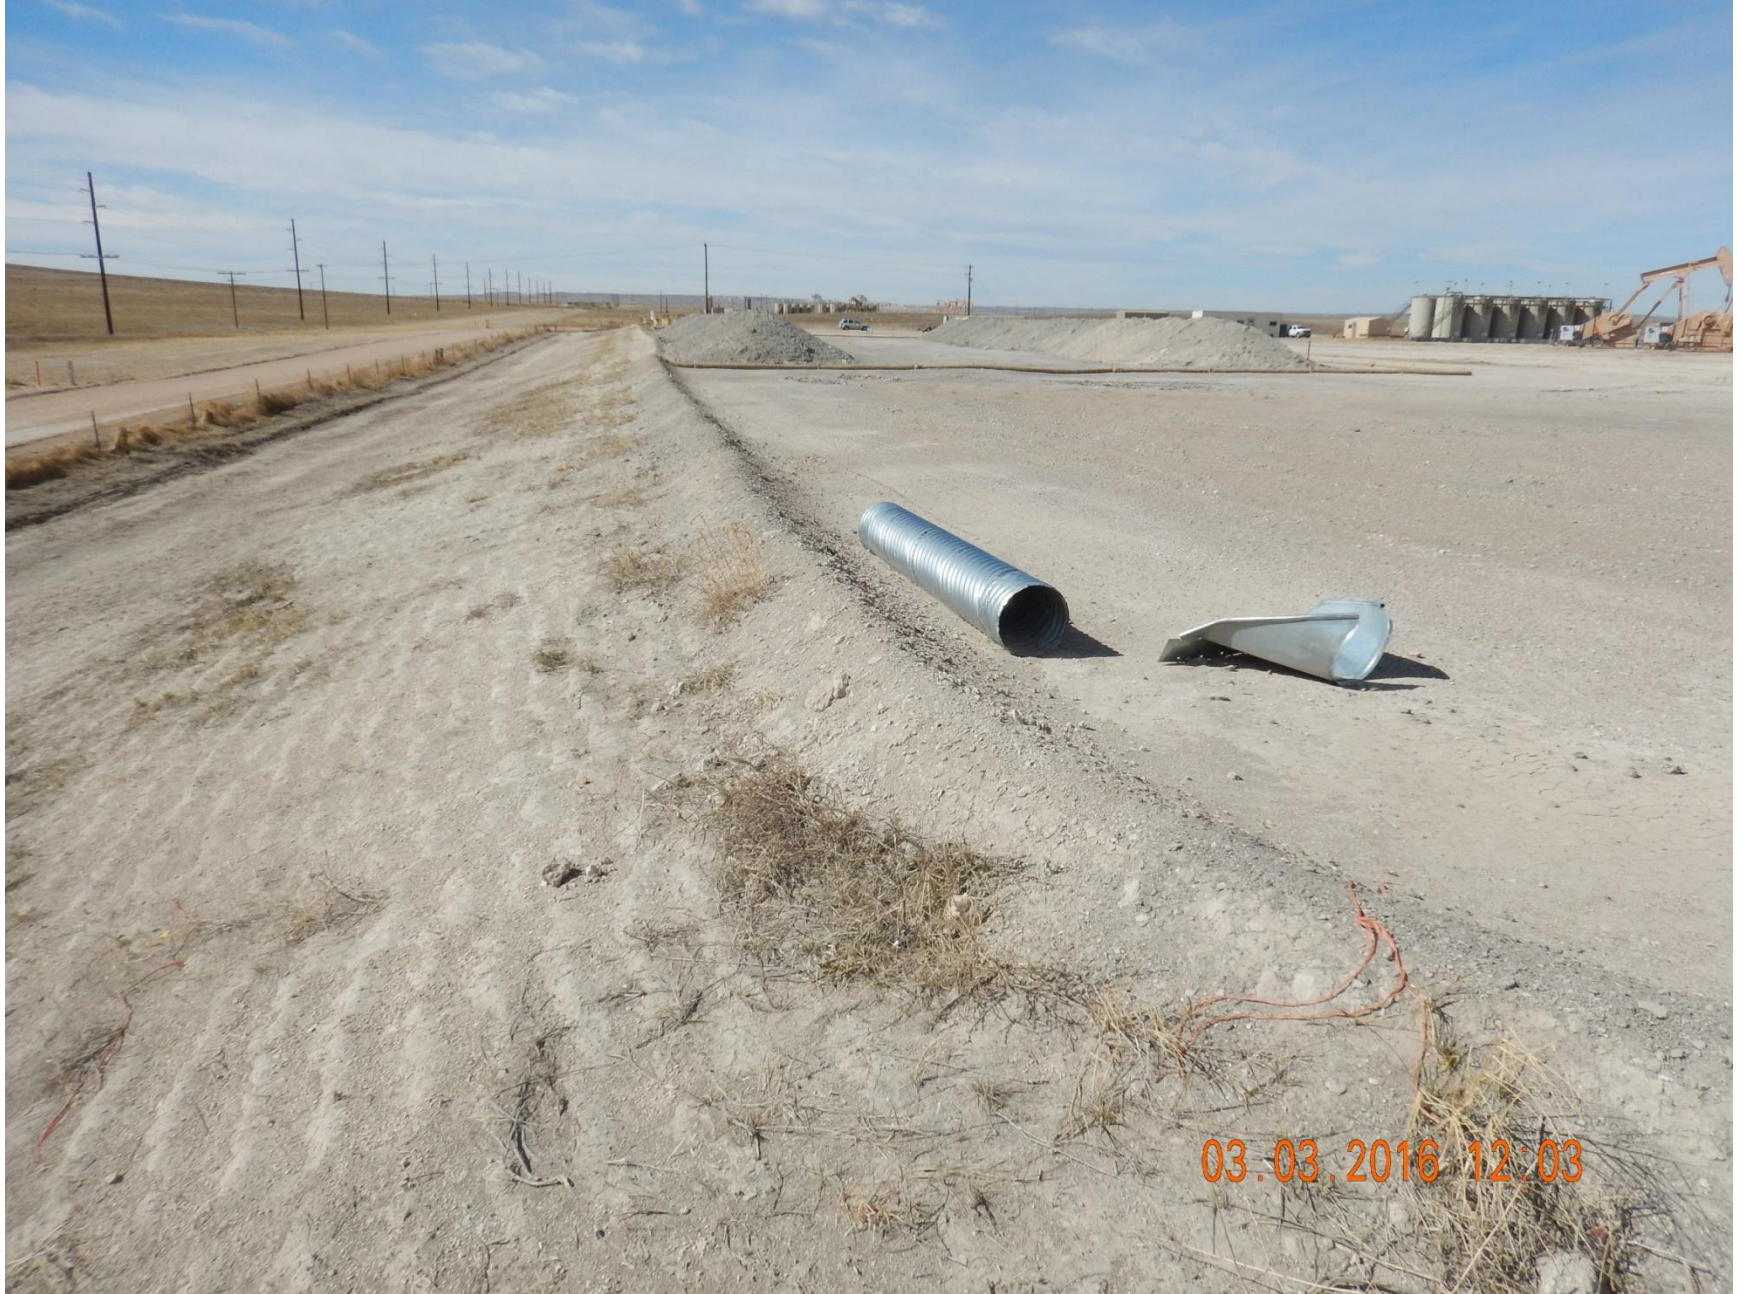
**Figure 32:** Photo taken from the southeast end of the project area, facing west. Photo shows project and interim areas. Note culvert pipe being stored on location.

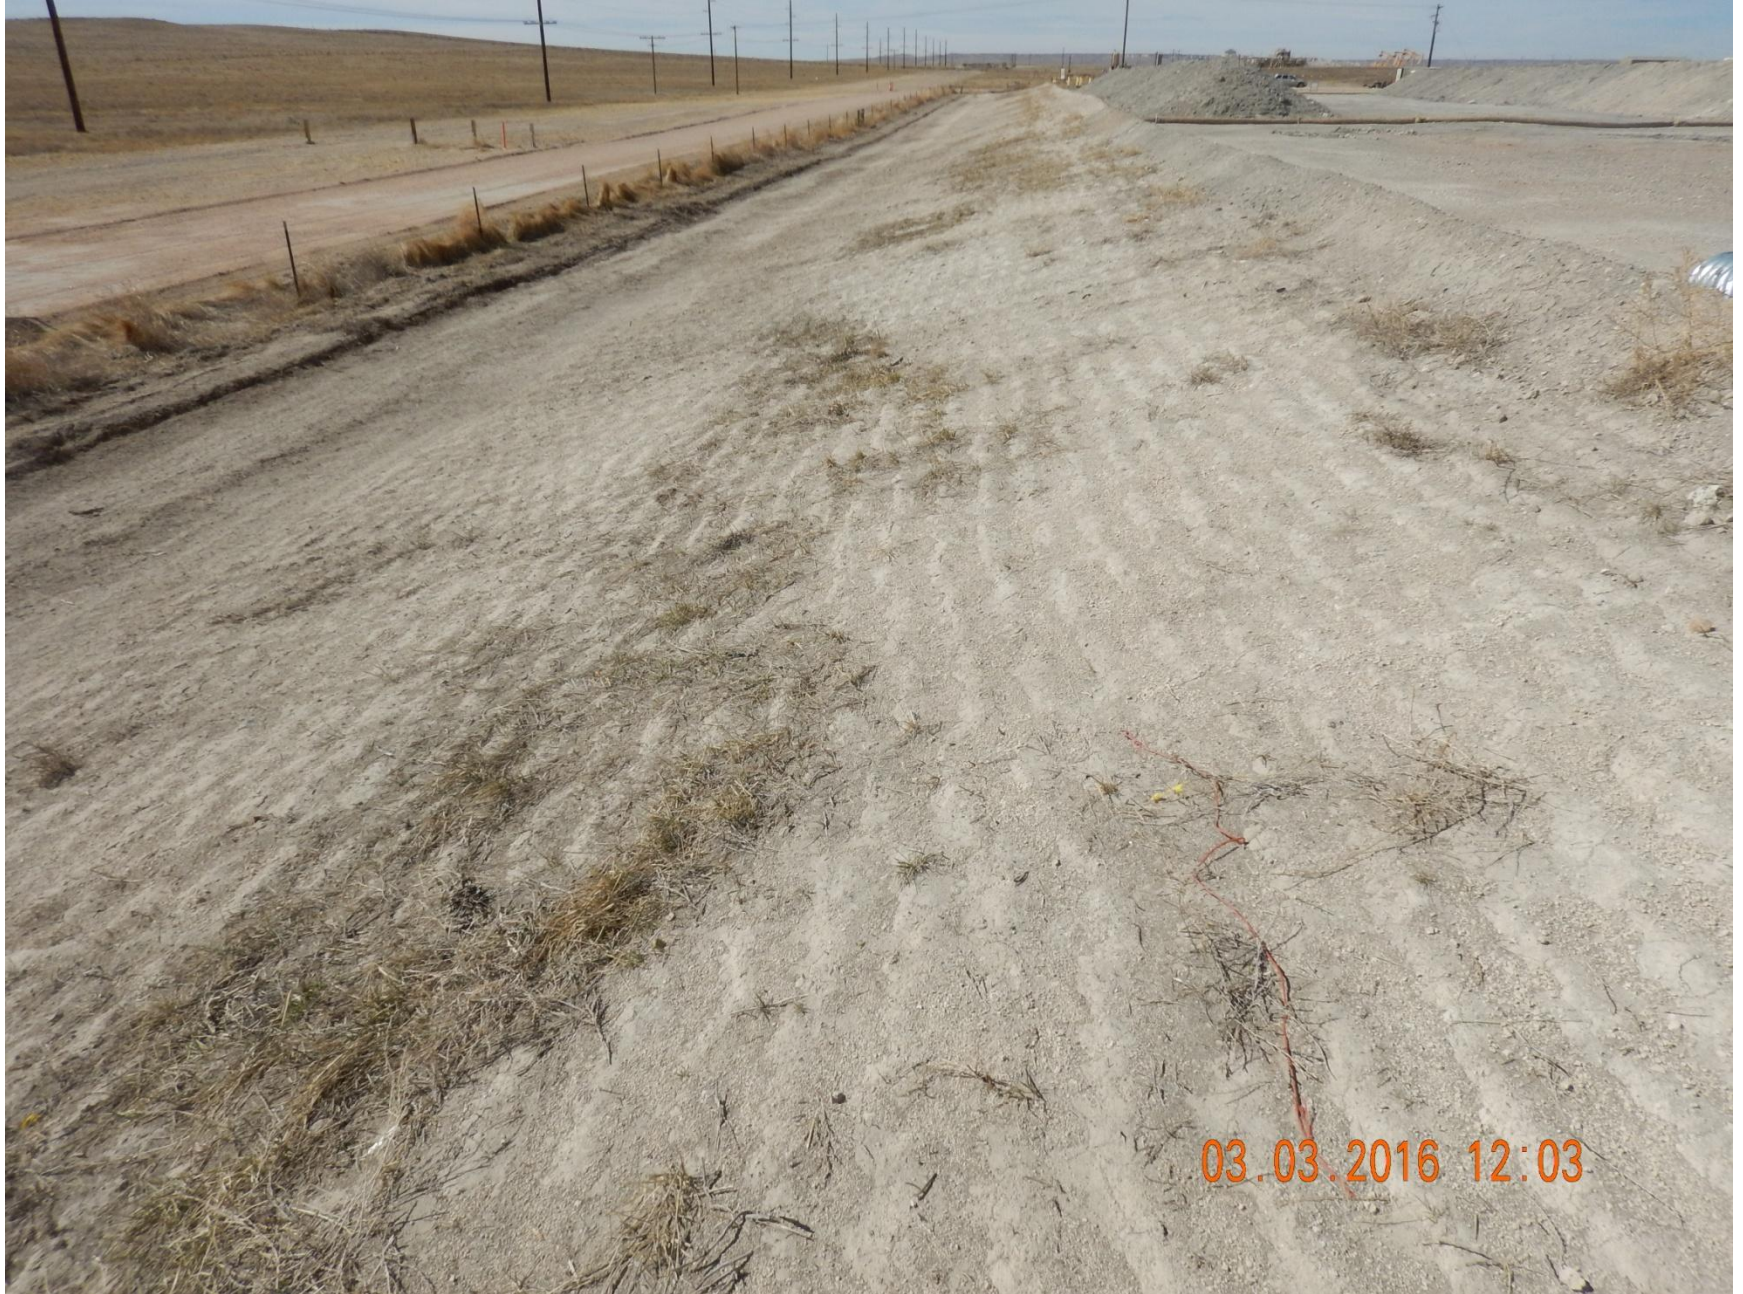
**Figure 33:** Photo taken from the southeast end of the project area, facing west. Photo shows vehicle tracking on interim area.

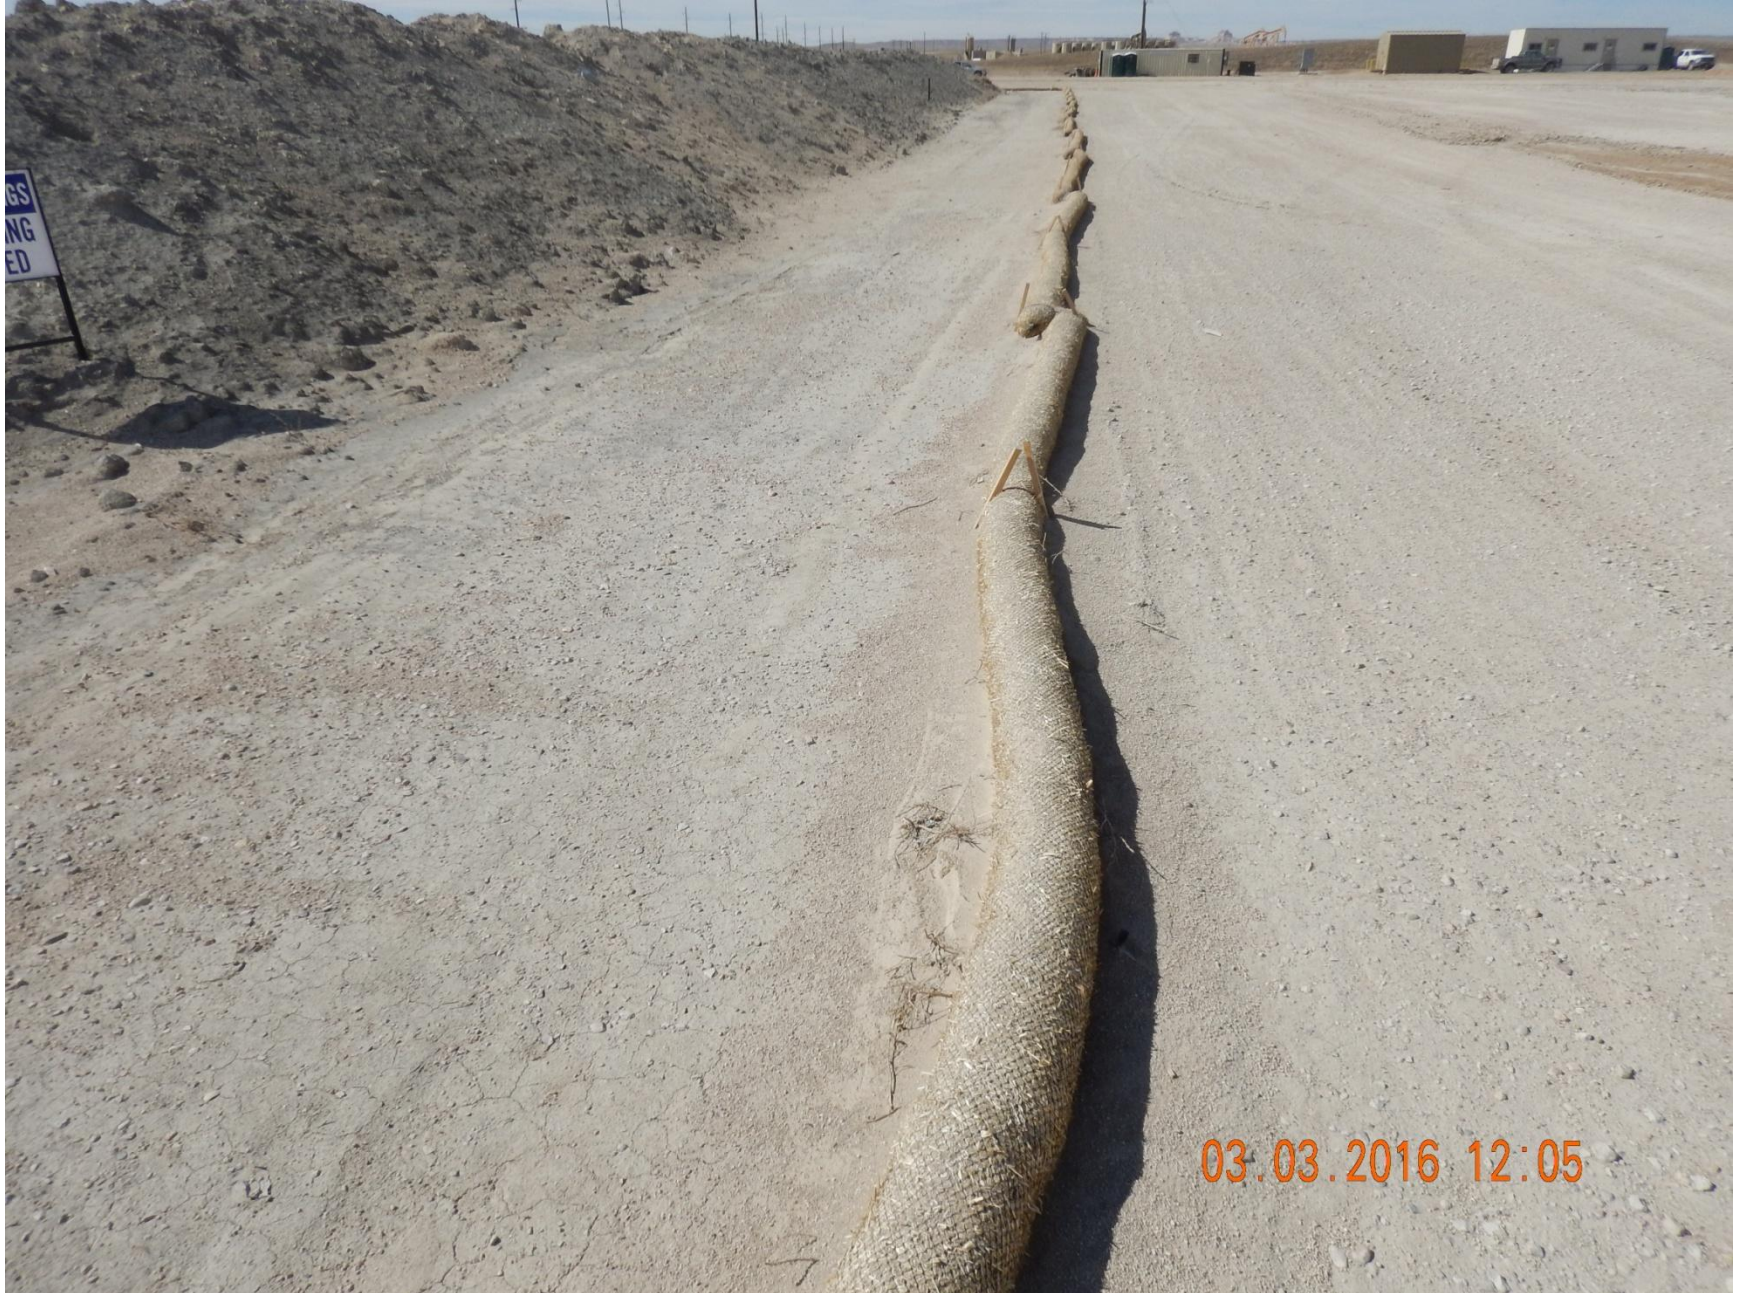
**Figure 39:** Photo taken from the southeast end of location, facing west. Photo of straw wattles used as a stormwater and sediment control BMP around drill cuttings

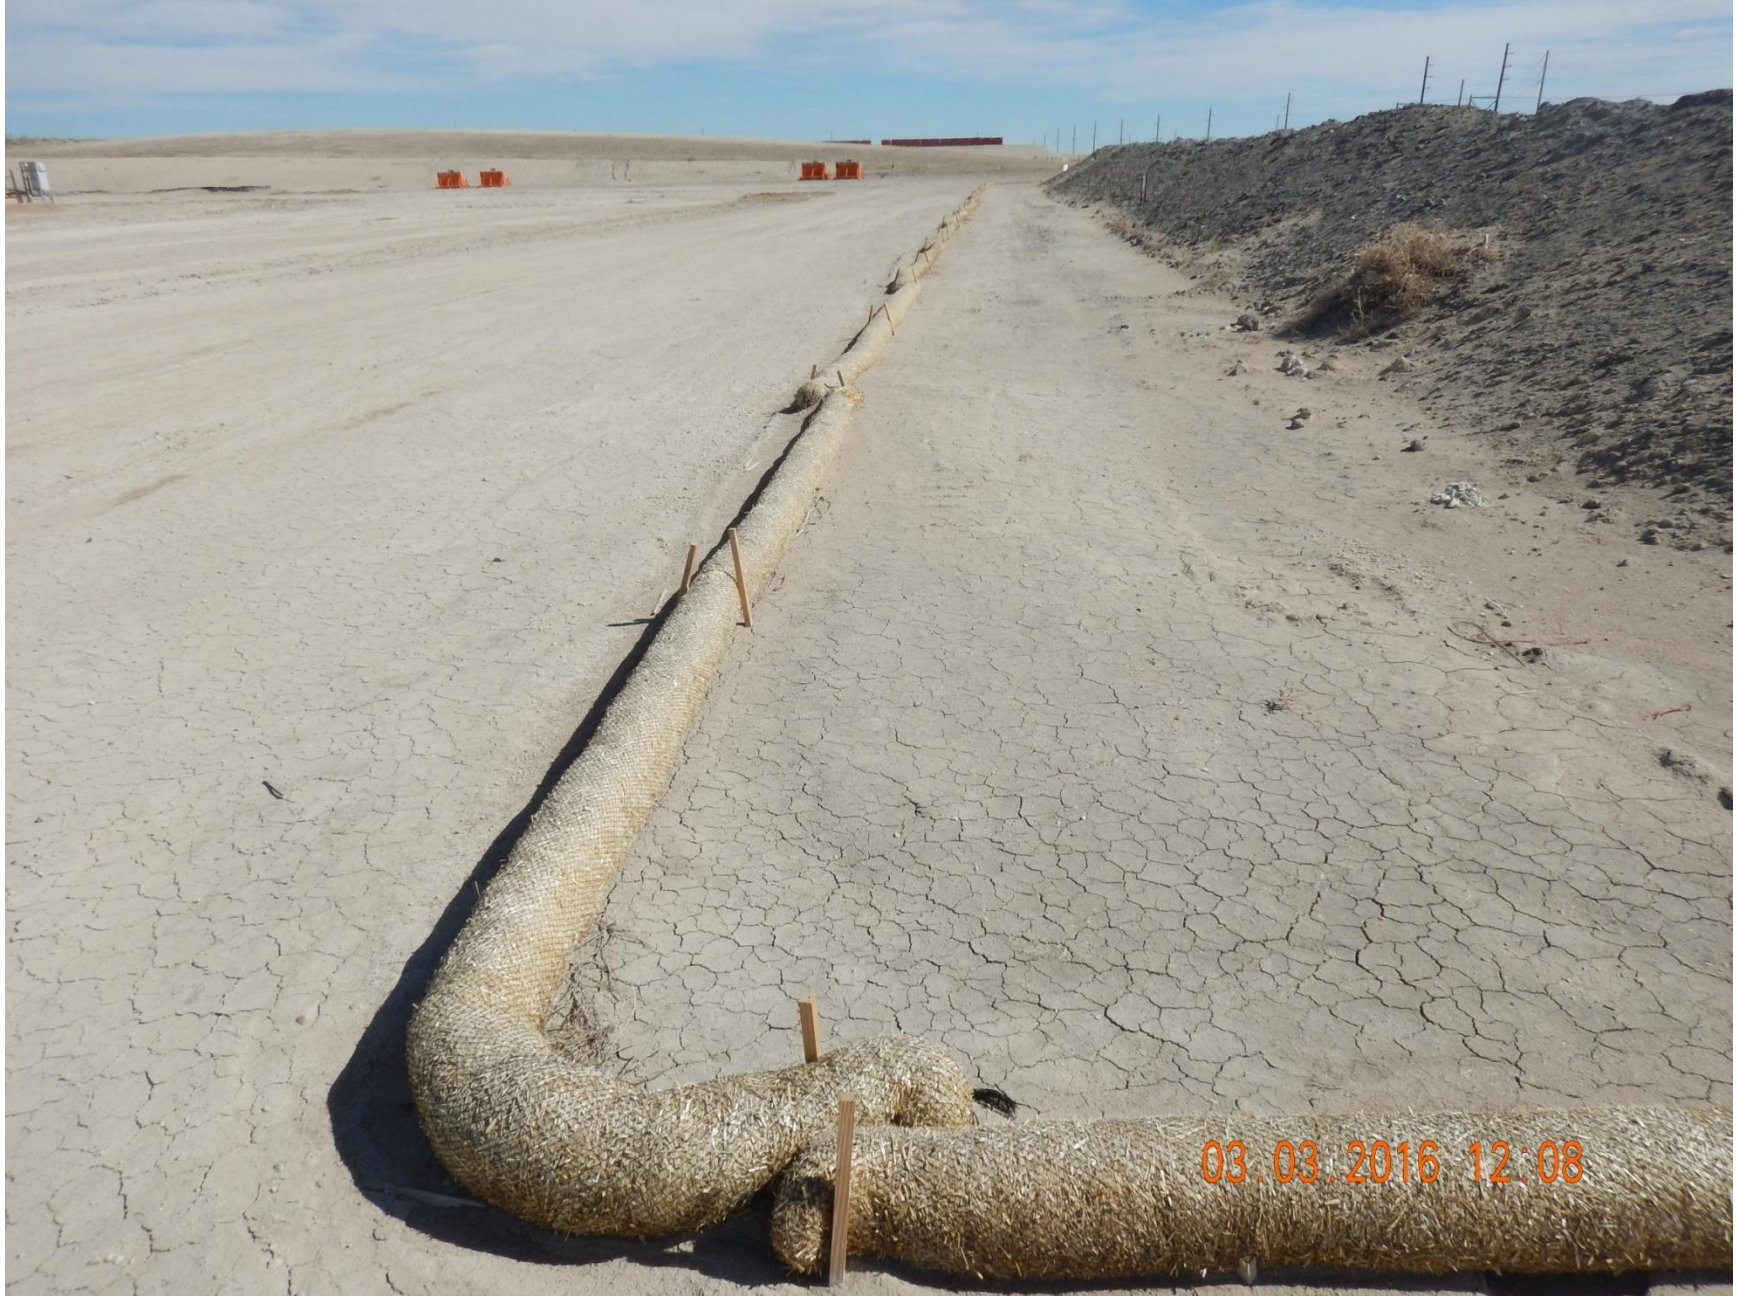
**Figure 40:** Photo taken from the southwestern end of location, facing east. Photo of straw wattles used as a stormwater and sediment control BMP around drill cuttings.
