ALL PHOTOS TAKEN 3/23/2016

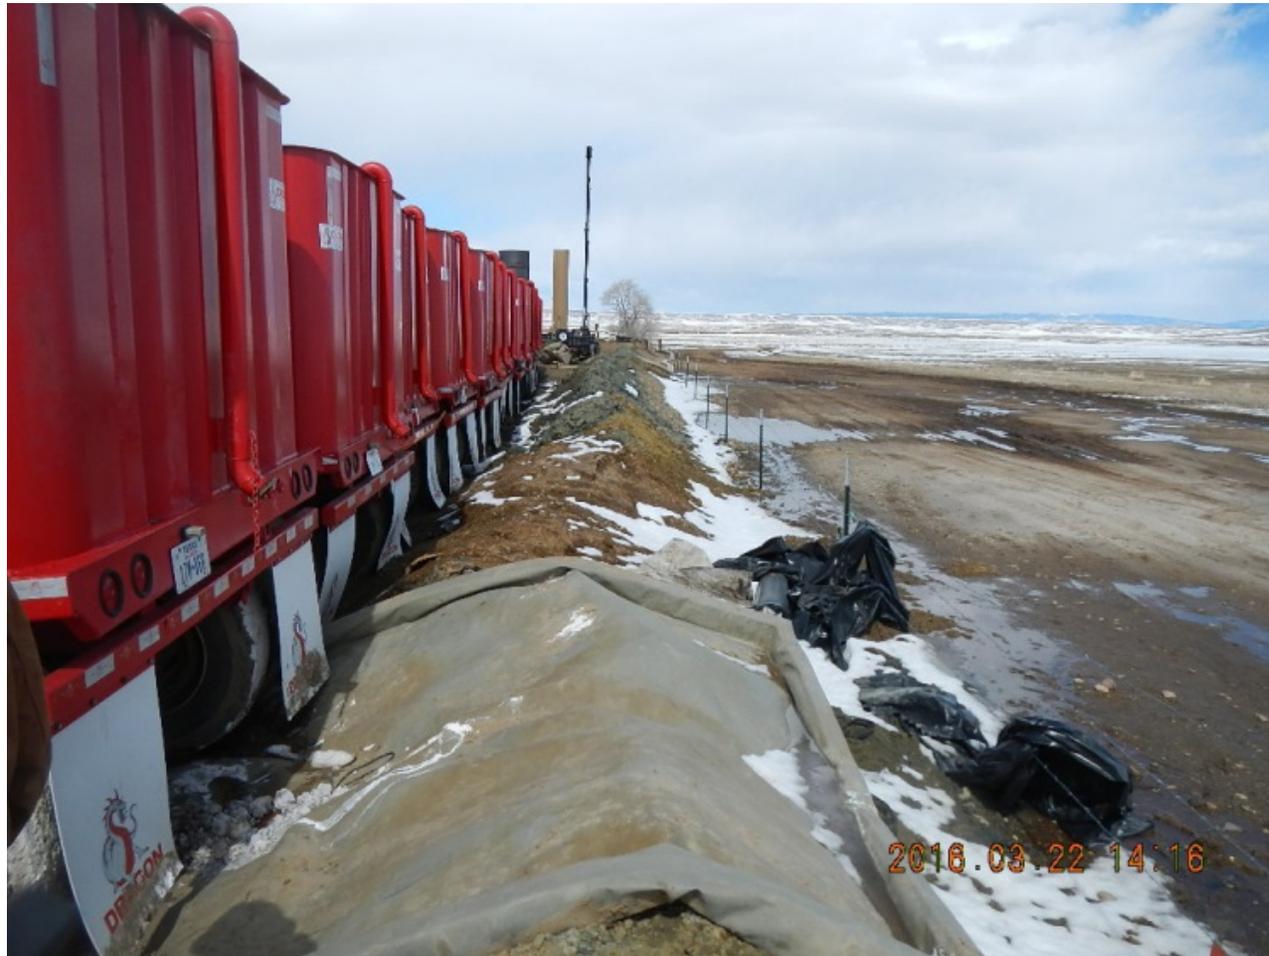
Area behind frac tanks, soil appears that it could be drill cuttings. Operator should investigate the soil and determine proper disposition of soil.

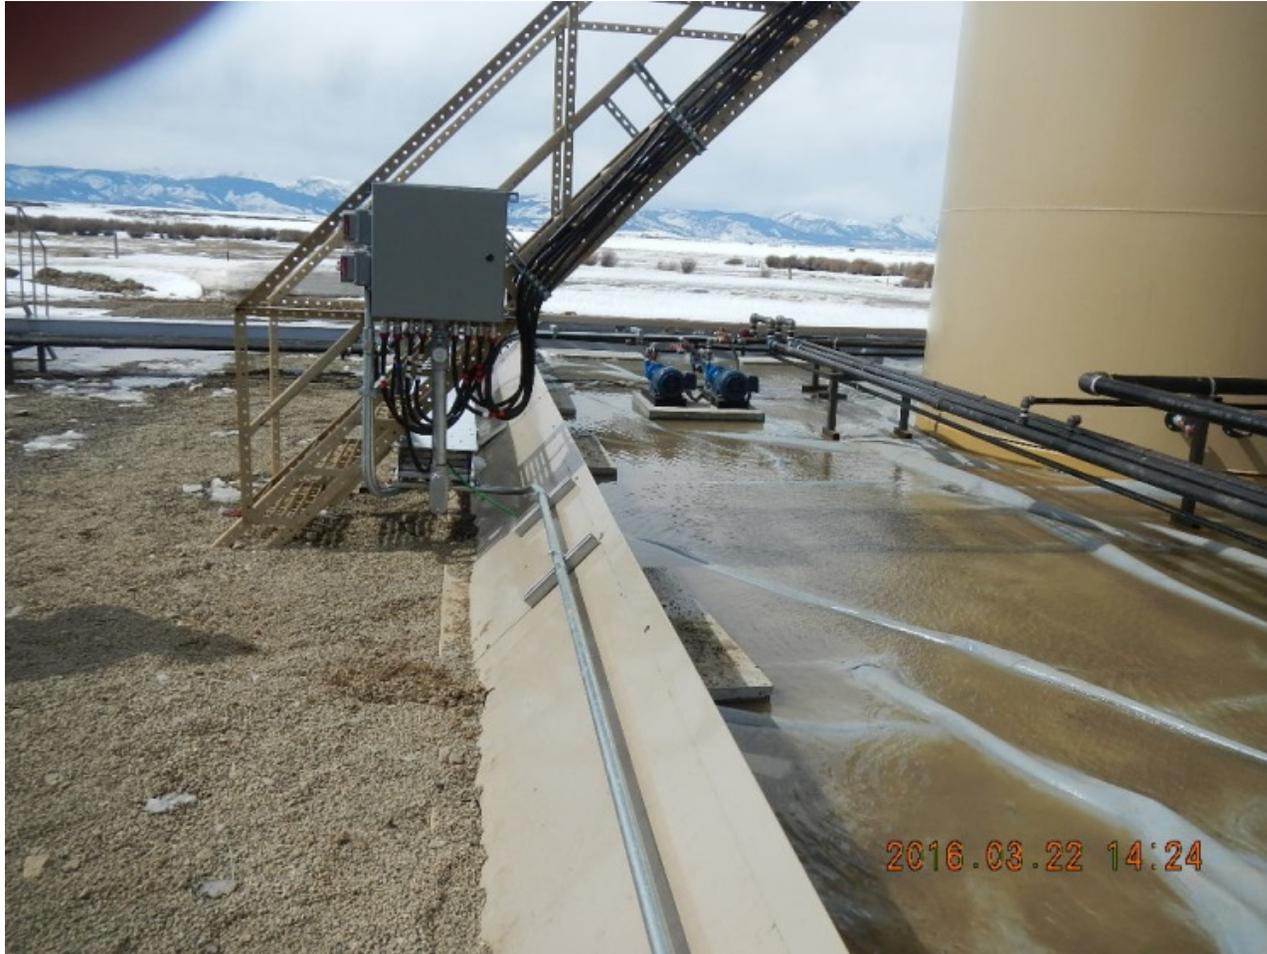
Tank battery, under construction
