Foundation Overview- Diffuse knapweed (*Centarea diffusa*)

3 Locations Inspected:

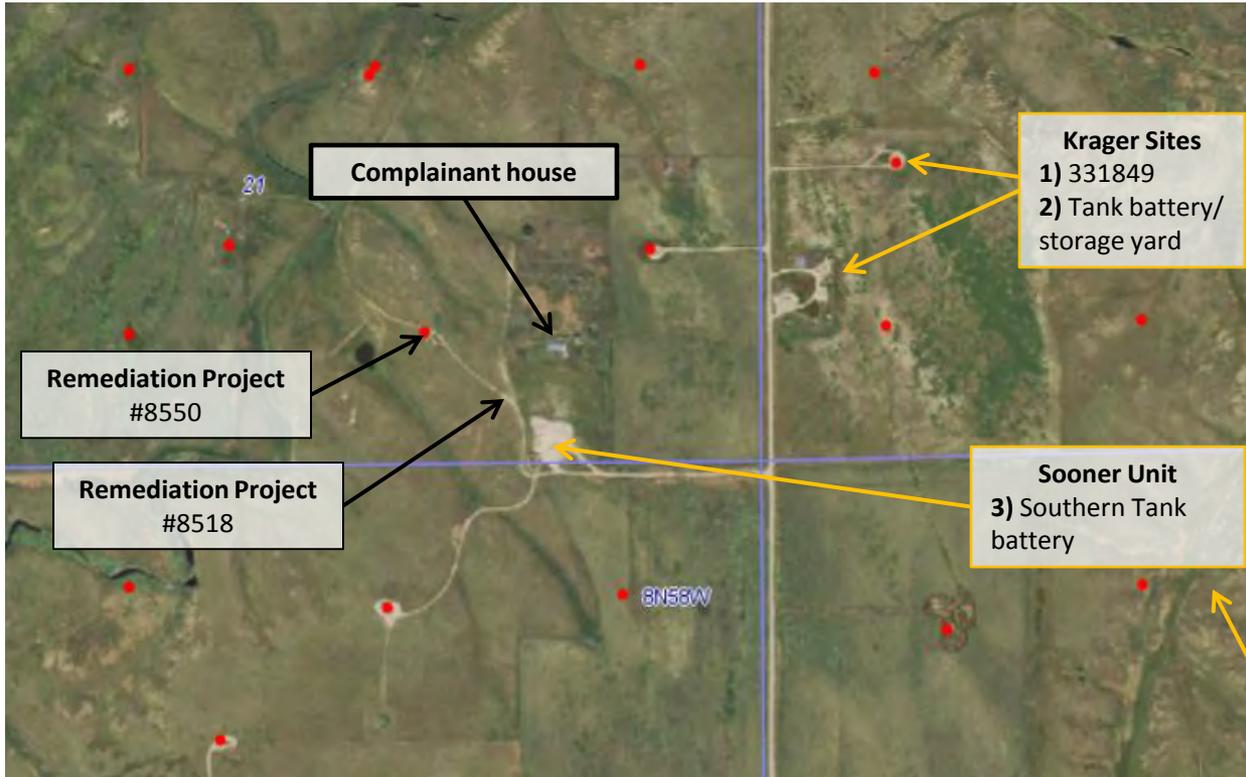
- 1) Location 331849- Portions mowed and knapweed was observed in the cuttings and a handful of individual Diffuse knapweeds left behind. Foundation instructed on 8/25/16 to pull and bag remaining plants. Foundation instructed on 8/30/16 to collect, remove, and dispose weed debris and seed heads properly from areas that were mowed.
- 2) Tank battery/storage yard- Portions mowed and knapweed was observed in the cuttings and several patches, varying in size, of Diffuse knapweed left behind. Foundation instructed on 8/25/16 to pull and bag remaining plants. Foundation instructed on 8/30/16 to collect, remove, and dispose weed debris and seed heads properly from areas that were mowed.

- 3) Southern Tank battery was mowed. Knapweed was observed in the cuttings and only a handful of individual knapweeds left behind. Foundation instructed on 8/25/16 to pull and bag remaining plants. Foundation instructed on 8/30/16 to collect, remove, and dispose weed debris and seed heads properly from areas that were mowed.
