Location Multi Well Plan

Construction and Stormwater Inspection

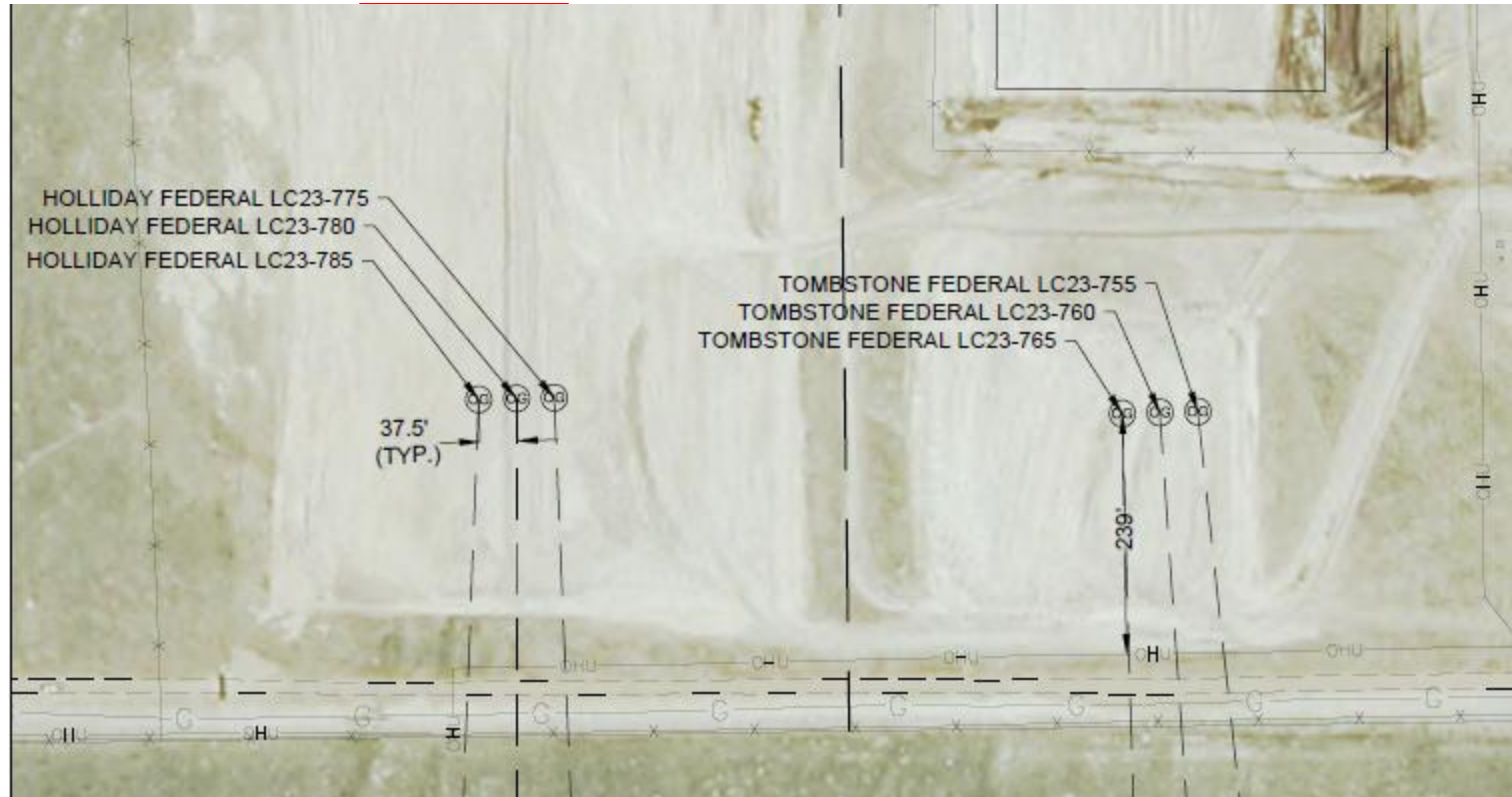
Photo taken from the Location file illustrating multi well plan design. The following photos will make reference as to which location the photo was taken from.
