Staff's Objection with Exhibits

BEFORE THE OIL AND GAS CONSERVATION COMMISSION
OF THE STATE OF COLORADO

IN THE MATTER OF THE APPLICATION OF RED)	CAUSE NO. 1
MESA HOLDINGS/O&G LLC. FOR AN INACTIVE)	
WELL FINANCIAL ASSURANCE VARIANCE, LA)	DOCKET NO. 150300176
PLATA COUNTY, COLORADO)	
)	TYPE: GENERAL
		ADMINISTRATIVE

STAFF OBJECTION

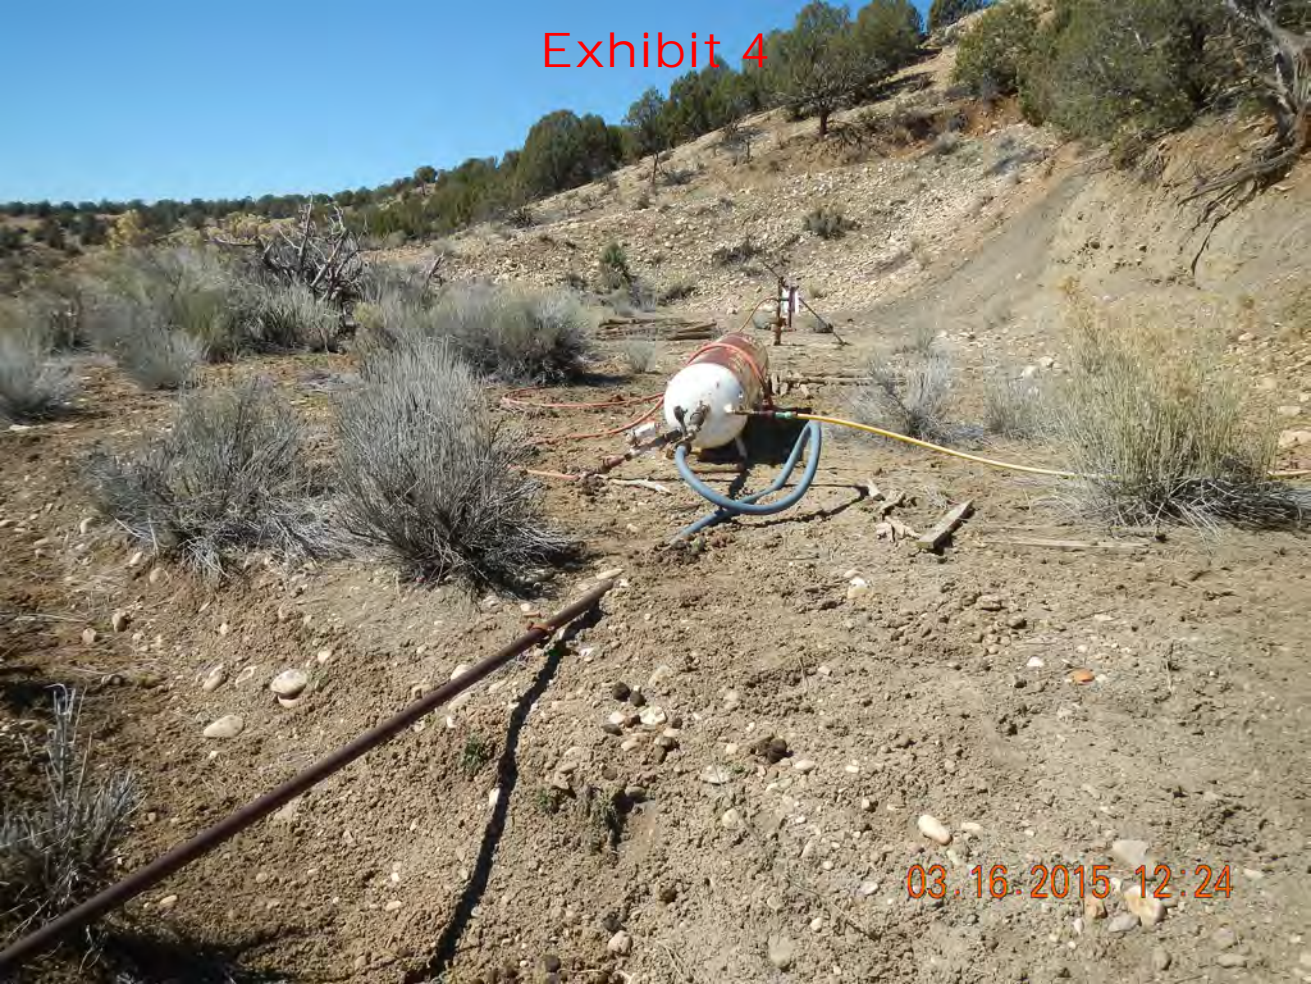
03.16.2015 12:24

Storm Water:						
Loc Erosion BMPs	BMP Maintenance	Lease Road Erosion BMPs	Lease BMP Maintenance	Chemical BMPs	Chemical BMP Maintenance	Comment
Wattles	Fail					Wattles are undercut on western edge of location.
Gravel	Pass	Gravel	Pass

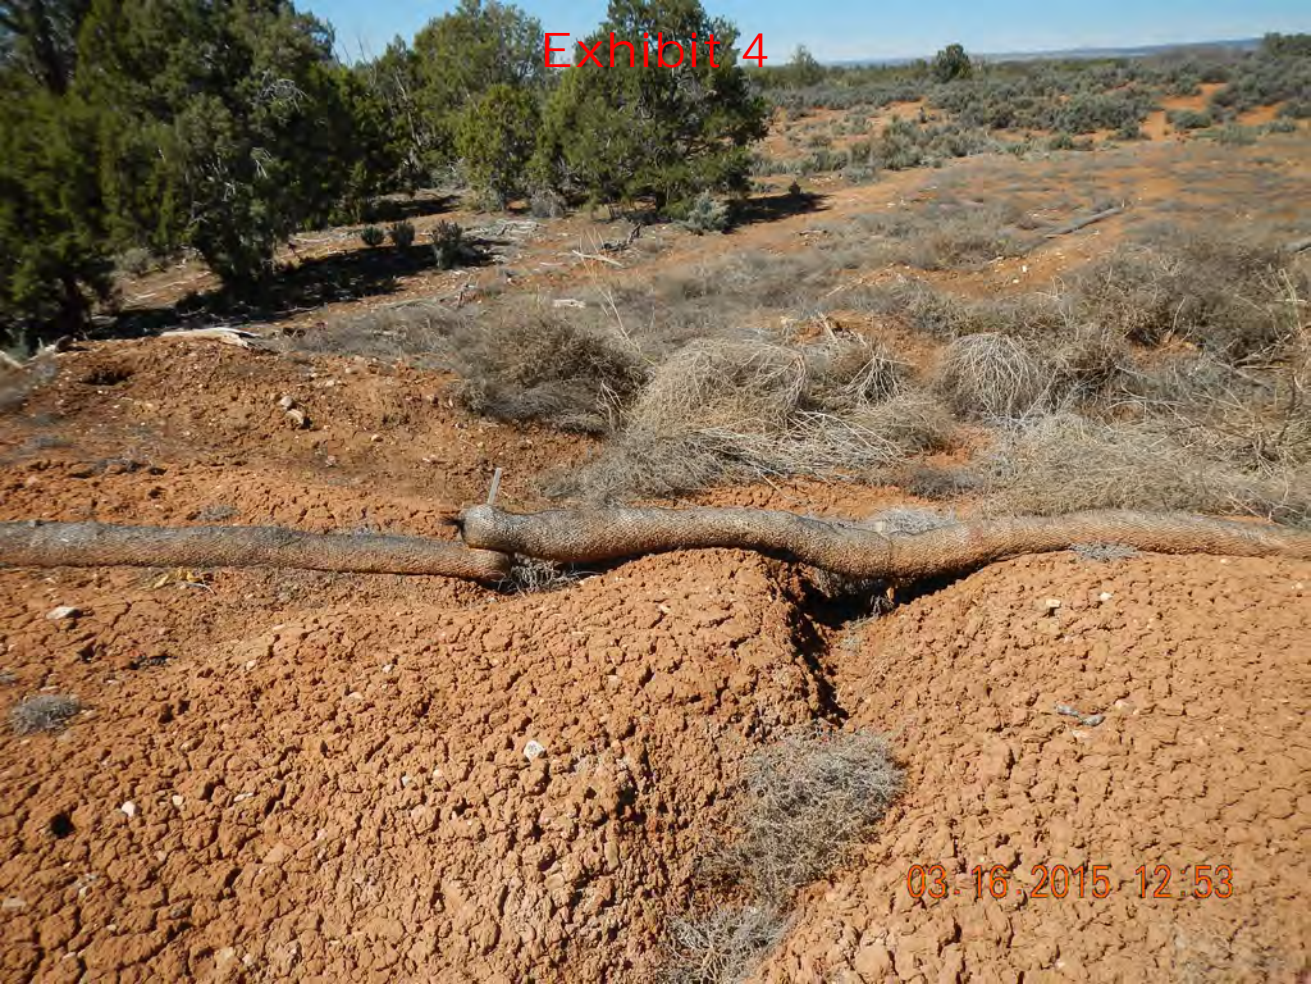
03-16-2015 12:53

Loc Erosion BMPs	BMP Maintenance	Lease Road Erosion BMPs	Lease BMP Maintenance	Chemical BMPs	Chemical BMP Maintenance	Comment
Gravel	Pass	Compaction	Pass	MHSP	Fail	Broken, unlabeled container near well head.
Compaction	Fail

S/A/V: **ACTION REQUIRED** Corrective Date: **04/17/2015**Comment: **Storm water run off on southern edge of location. Unlabeled 5 gal. container partially full of viscous brown liquid. Container has no lid and top is cracked and broken.**CA: **Install location BMPs to control storm water. Properly label and store 5 gal. container, or remove from location.**Pits: ☒ NO SURFACE INDICATION OF PIT**Attached Documents**

<u>Paint</u>				
Condition	Adequate			
Other (Content) _____				
Other (Capacity) _____				
Other (Type) _____				
<u>Berms</u>				
Type	Capacity	Permeability (Wall)	Permeability (Base)	Maintenance
Other	Inadequate	Walls Insufficient	Base Insufficient	
Corrective Action		Install secondary containment per COAs and Rule 605.a.4.		Corrective Date 04/17/2015
