# Construction and Stormwater Inspection

September 19, 2017

Operator: GREAT WESTERN OPERATING COMPANY LLC- #10110

Location ID: 451100

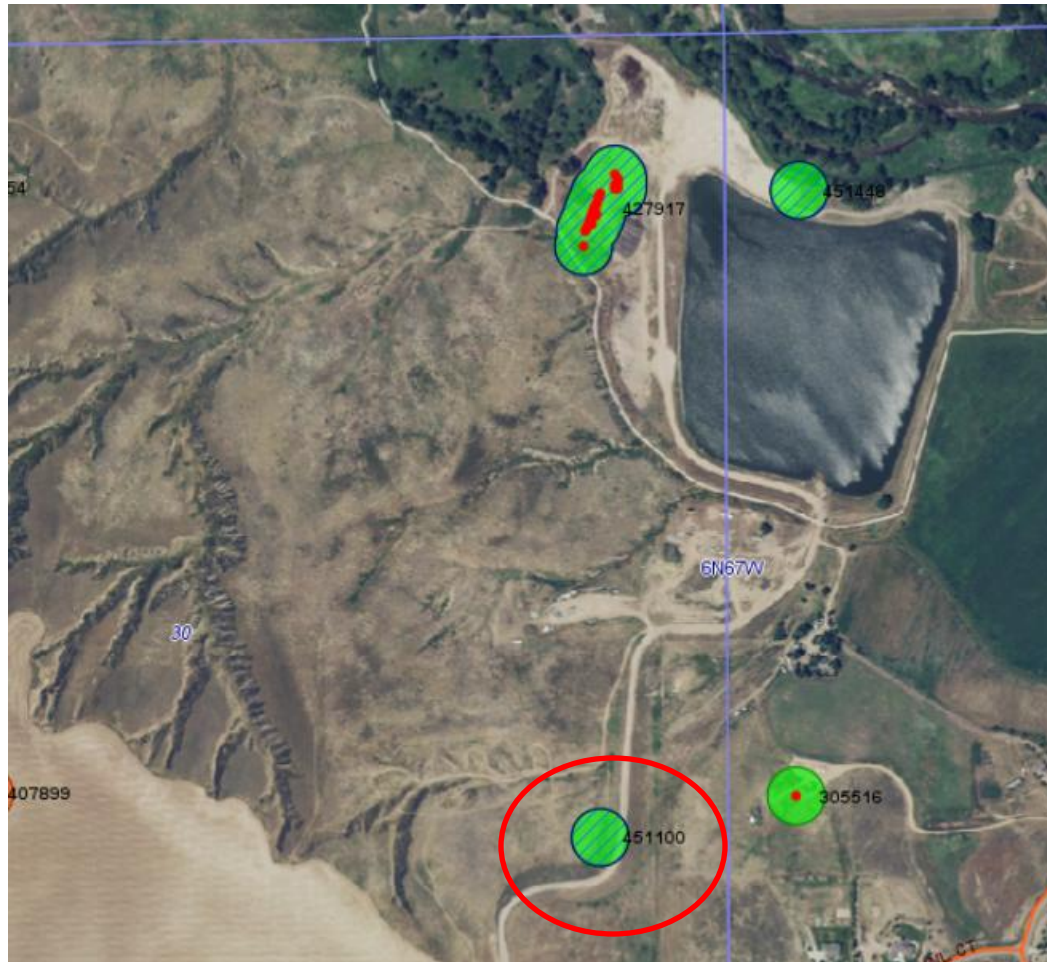
COGCC GISOnline aerial imagery illustrating the Raindance FD Off-site tank battery location (Location ID 451100 highlighted in the red circle) and the Raindance Drilling pad to the north (Location ID 427917).

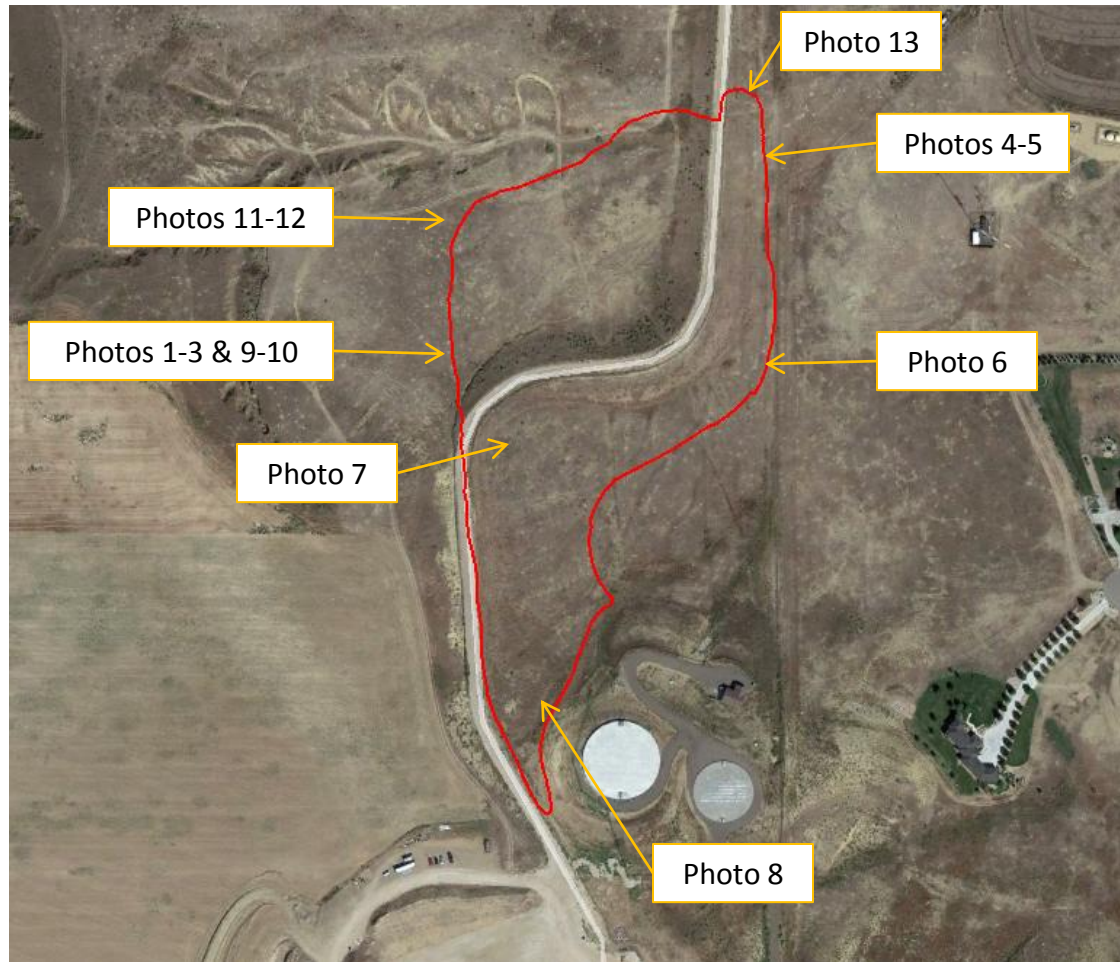
Photo reference points taken on September 19, 2017 to help illustrate approximate locations of the subject photo.

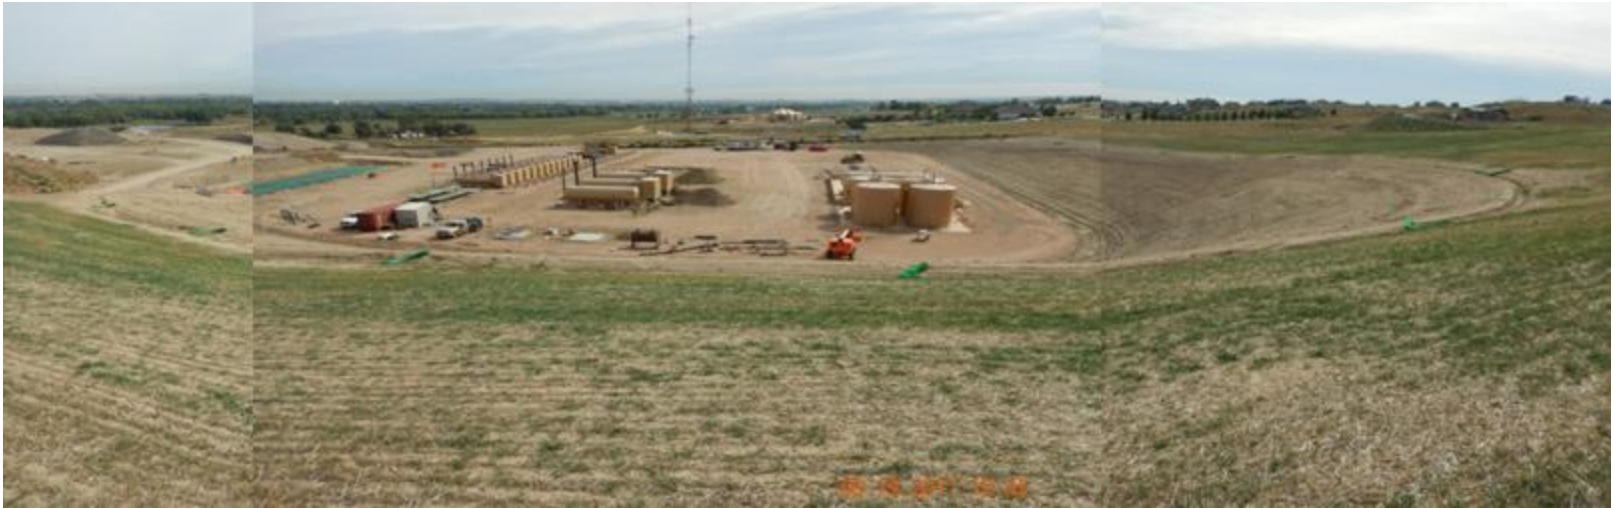
**Photo 1.** Photo taken from the western location, facing East. The above image is a combination of three photos put together to illustrate the Off-site Tank Pad.

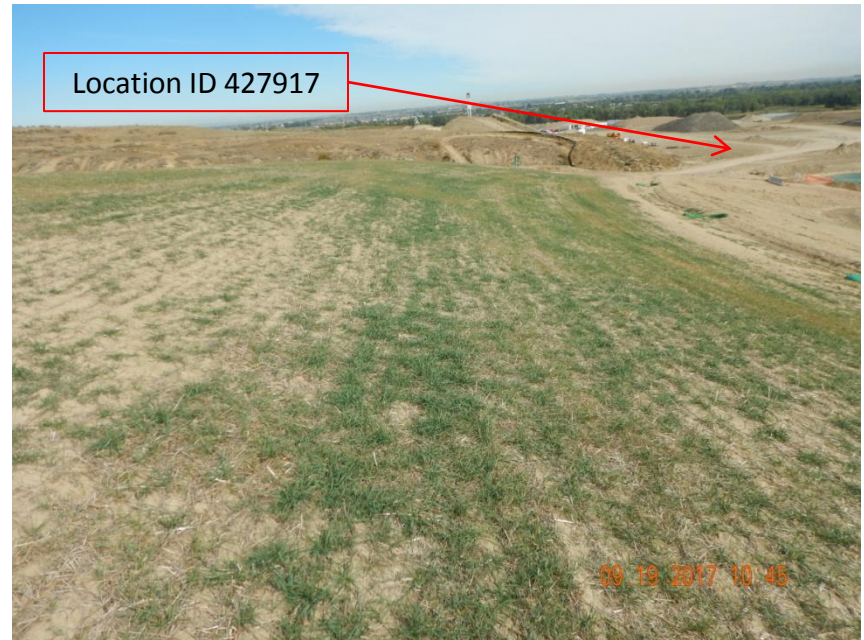
**Photo 3.** Photo taken from the western location, facing North. A portion of the southern well pad (Location ID 427917) can be seen in the above photo.
