# Final Reclamation Inspection

October 5, 2017

Operator: CHESAPEAKE OPERATING LLC- 16660

Inspection Photos  
Location Name: HEIBY 18-8-66 #1H  
API: 05-123-34627

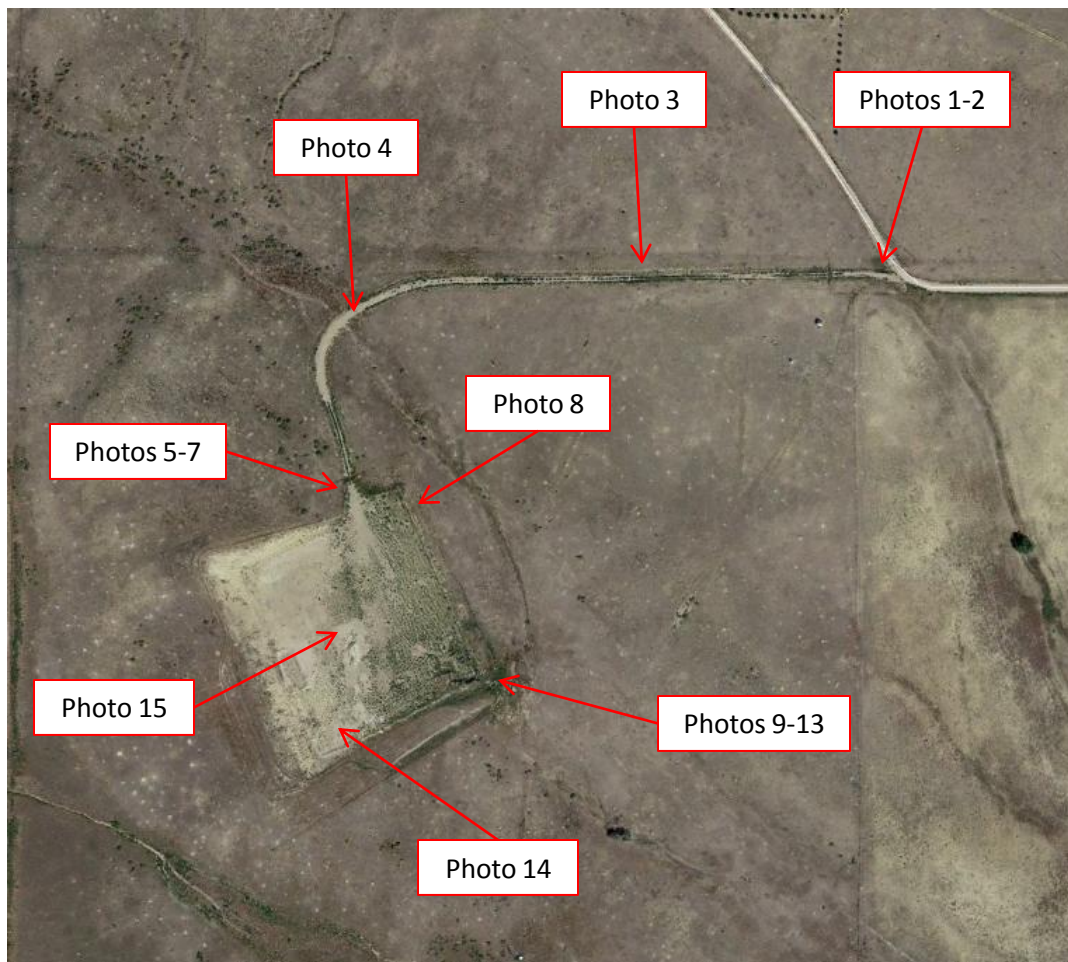
Photo reference points taken during the site inspection on October 5, 2017.

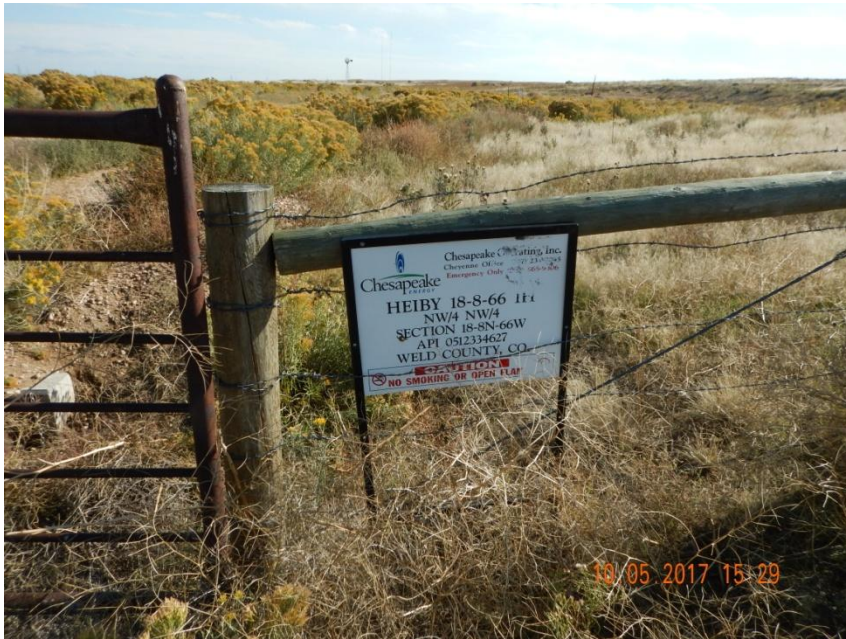
**Photo 5.** Photo taken from the entrance of the location, facing South. Operator sign at well entrance confirms location.
