Final Reclamation Inspection

Operator: CHESAPEAKE OPERATING LLC- 16660

API: 05-123-34670

Inspection Photos
Location Name: BRENT 20-8-66 #1H
API: 05-123-34670

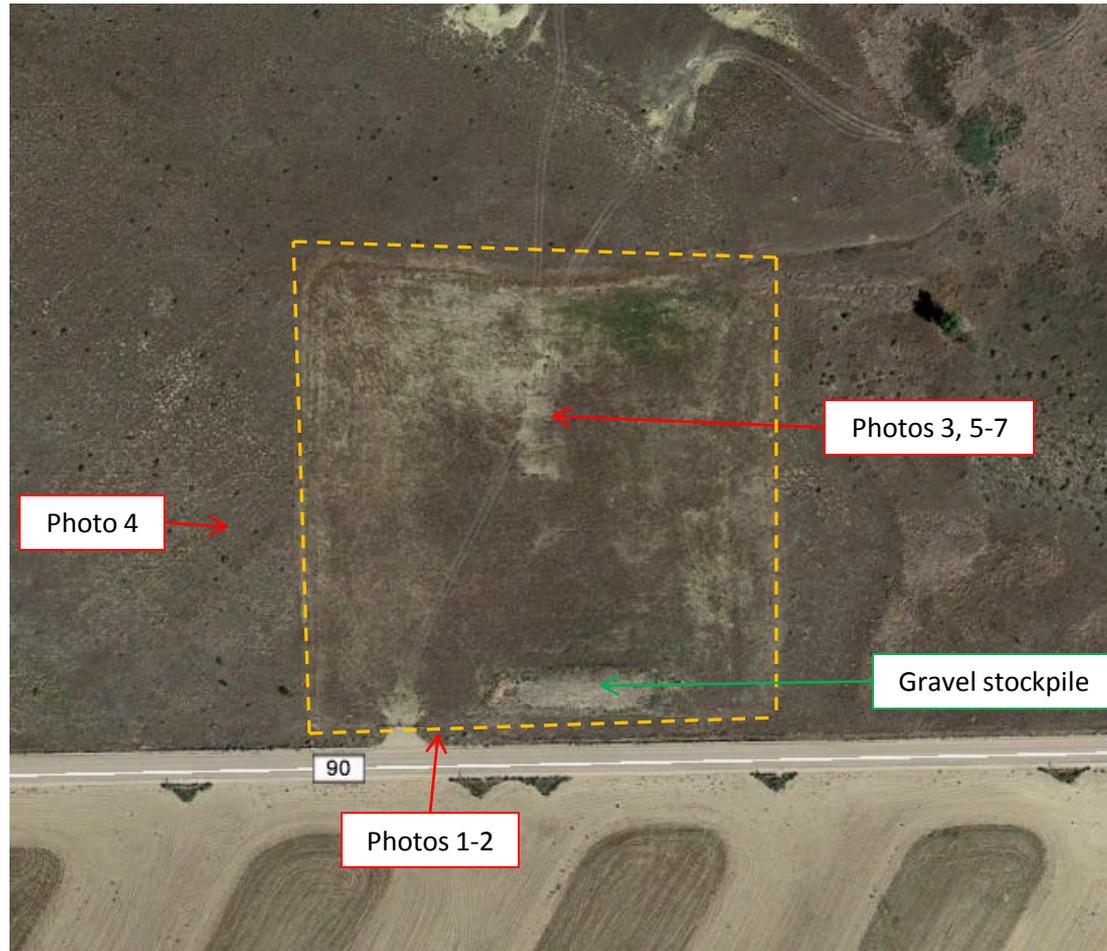
Google Earth imagery taken September 7, 2016. Photo reference points taken during the site inspection on October 5, 2017. Orange-dashed line is the approximate perimeter of the disturbance area (~5.2 acres in size).
