COLORADO
Oil & Gas Conservation
Commission
Department of Natural Resources

Inspection Photos: Laramie Gunderson Loc#452797

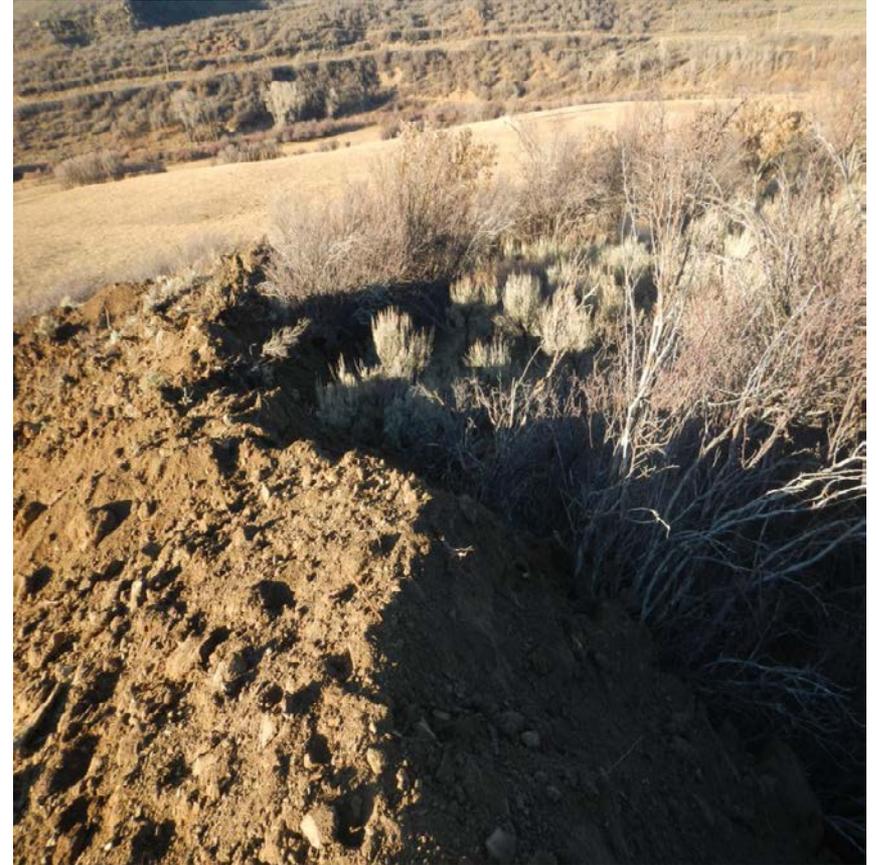
Photo#7:

Steep Cut bank side of Access road is awaiting installation of Pipeline. Operator will self inspect; if any Sediment migration is noted BMPs will be installed.
