Hoffman Inspection

12.6.17

Inspection Photos
Location Name: Hoffman #34-10
API: 05-123-20097
Inspection Date: November 28, 2017

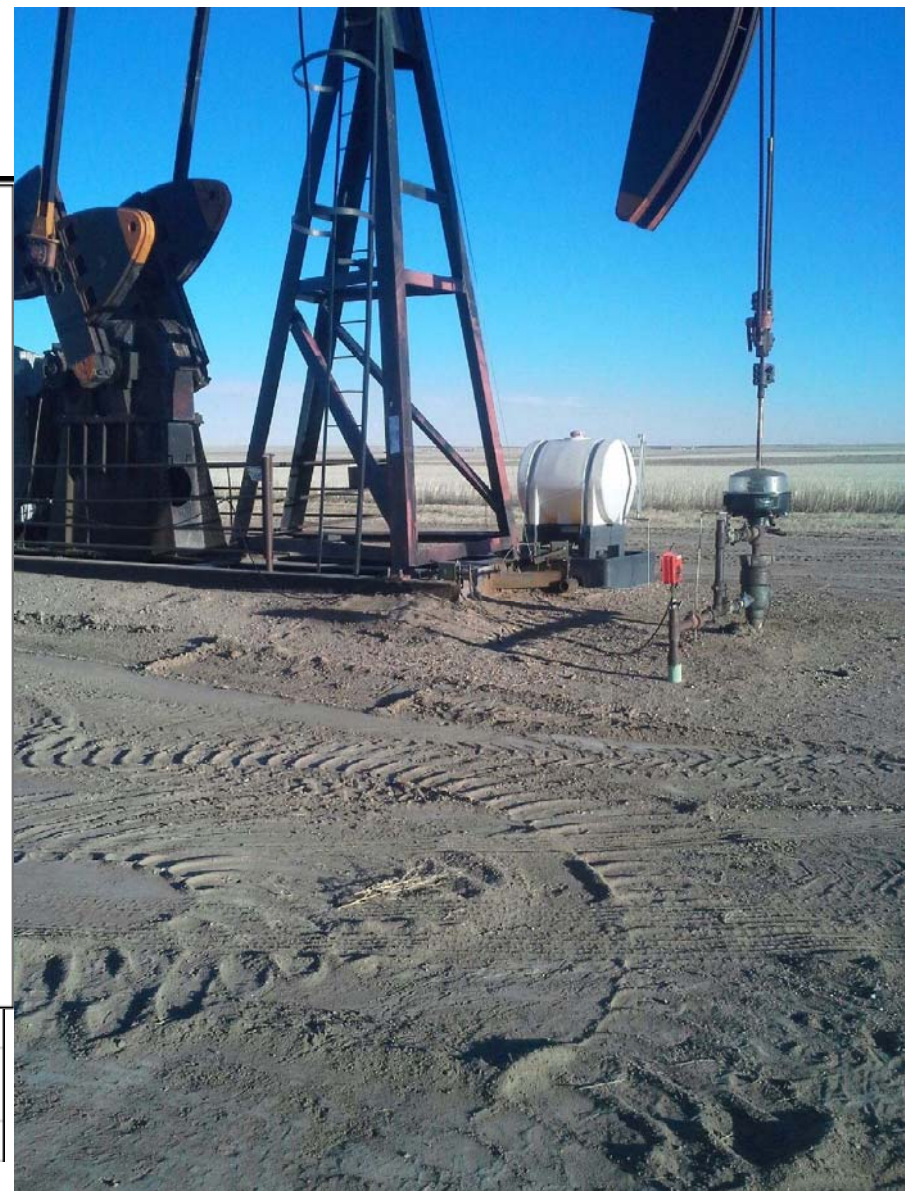
Type	WEEDS		
Comment:	Accumulation of wind-blown weeds at pump jack and wellhead. Uncontrolled weeds growing inside/along both produced water pits, as indicated in previous Field Inspection Reports. See photos.		
Corrective Action:	Comply with Rule 603.f.	Date:	10/08/2017

Wind blow weeds and tank without containment removed from location per COGCC write-up.

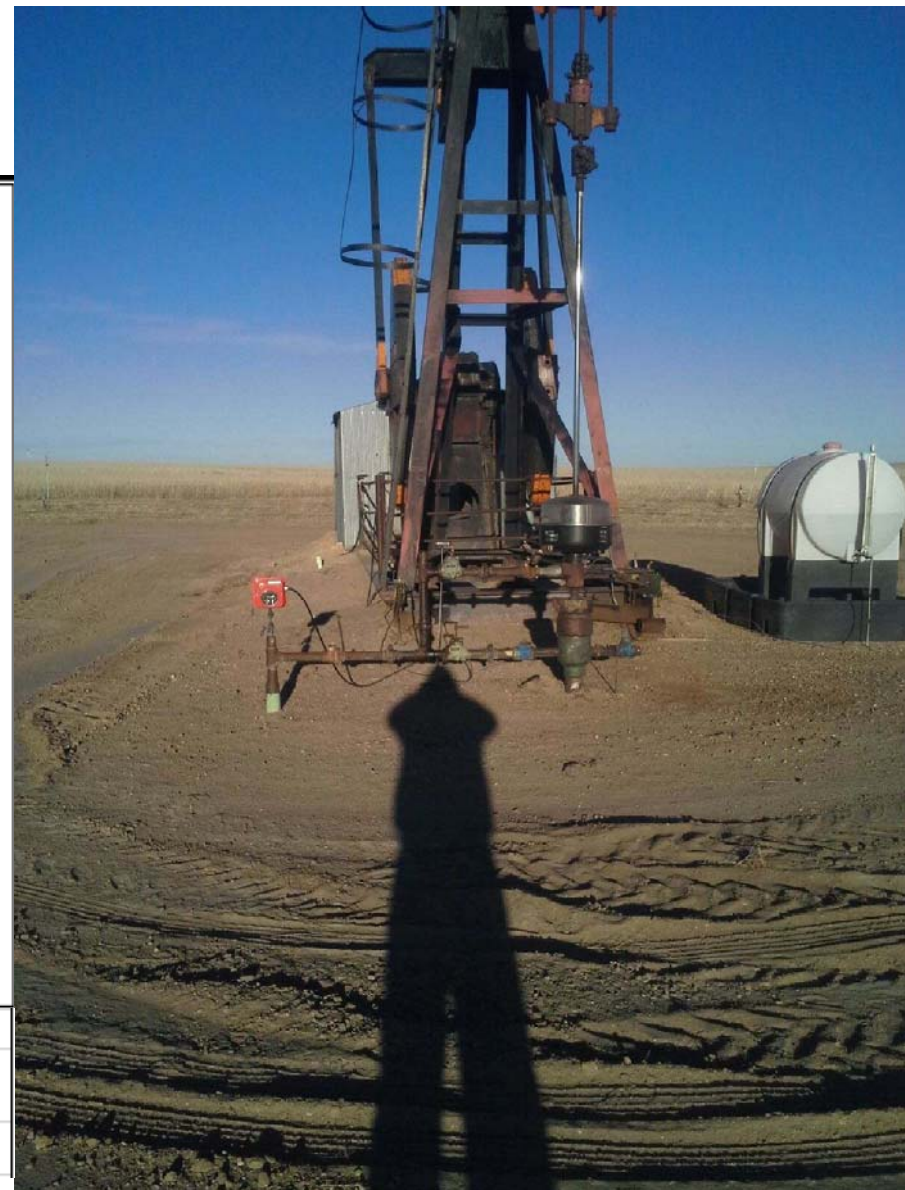
Type: Ancillary equipment	# 2		
Comment:	Two day tanks located at SW and SE corners of pump jack. 55-gallon drum used as day tank at SW corner of pump jack lacks secondary containment. See photos. This corrective action remains unresolved from previous FIR.		
Corrective Action:	Repair or install berms or other secondary containment devices per Rule 908.d.(1). (day tanks)		Date: 11/24/2017

Added new H2S warning sign at tank battery. 2 following photos show that ruts have been removed.

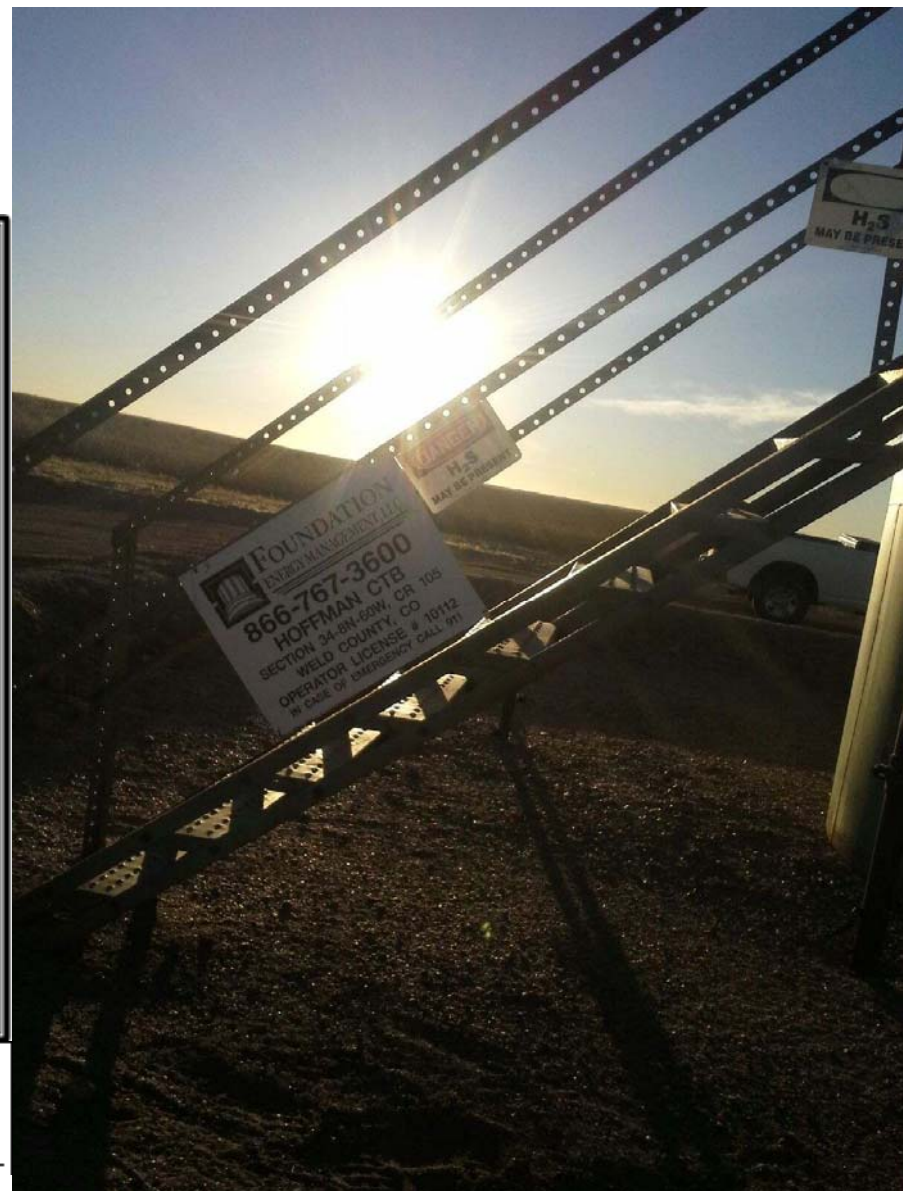
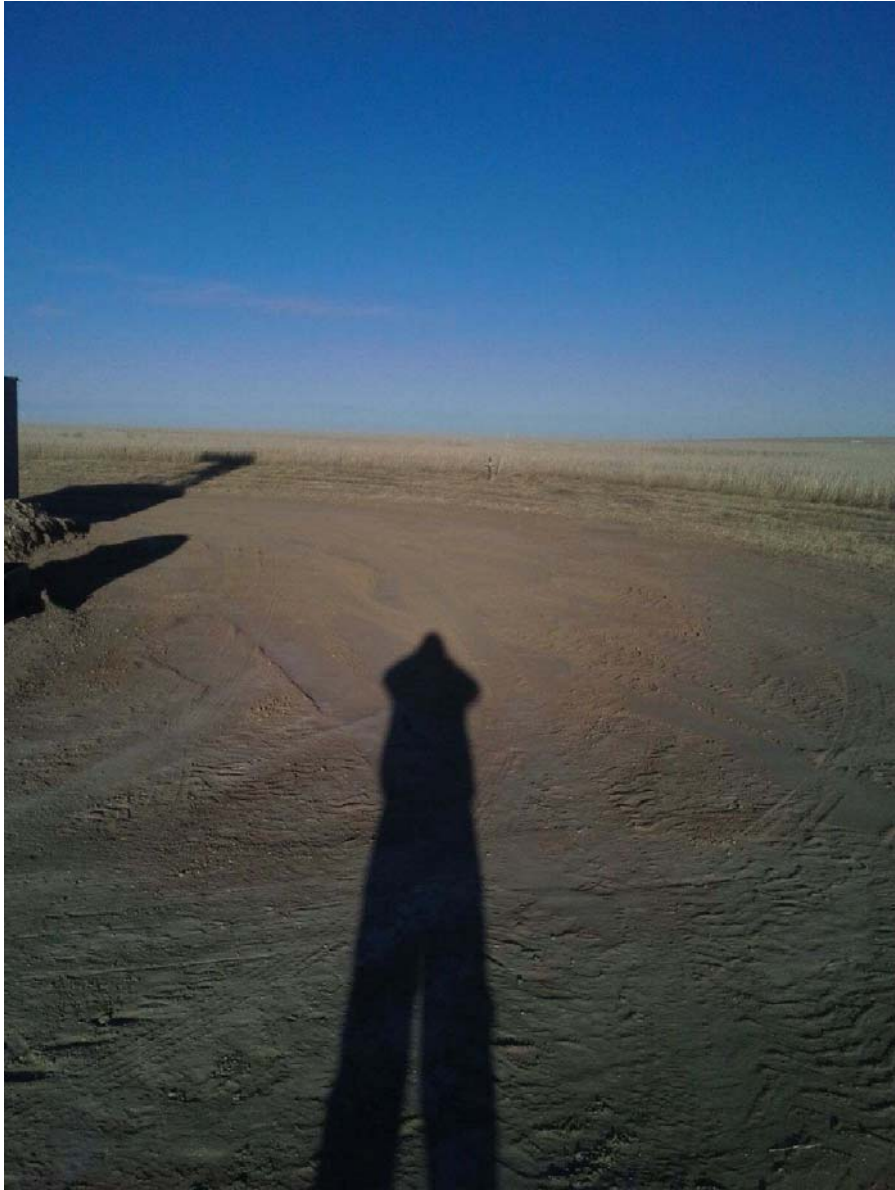
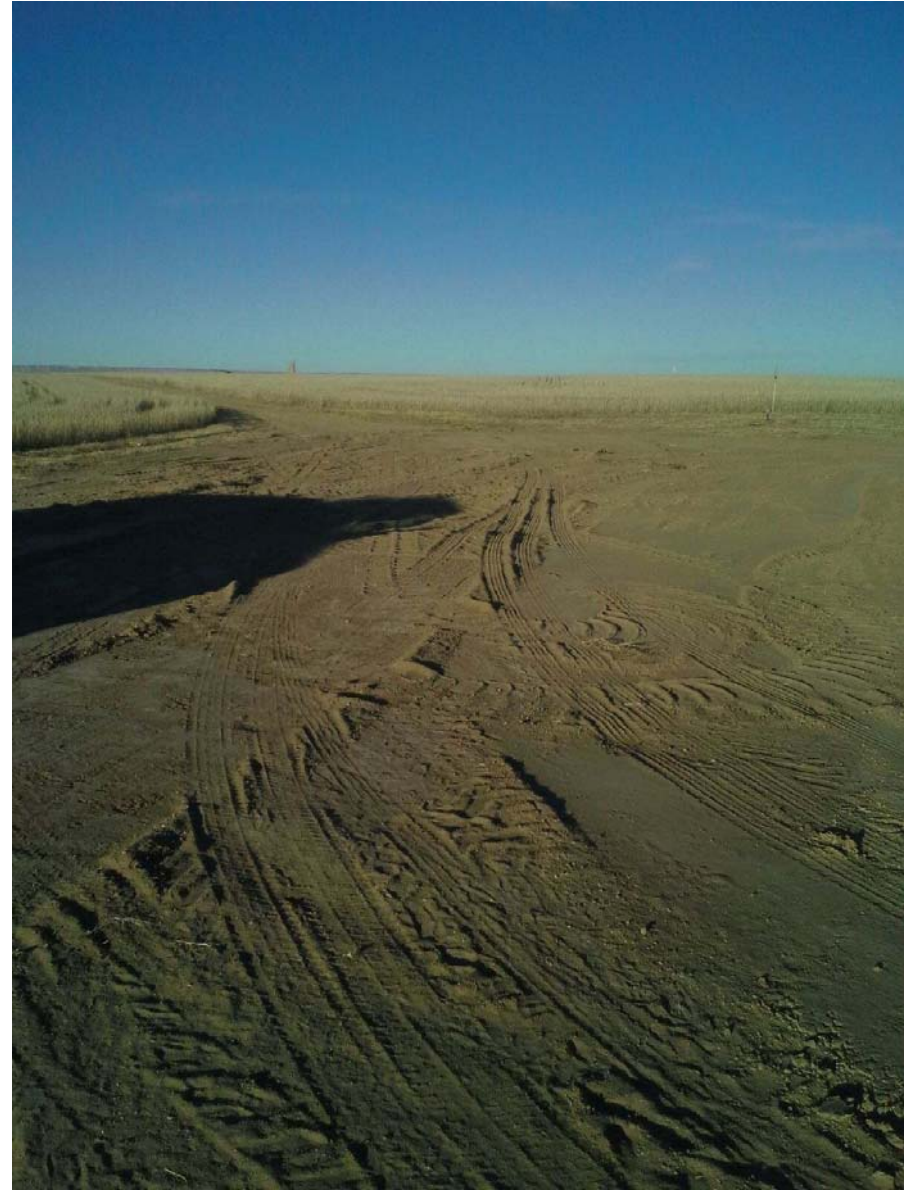
Comment: Deep ruts at NW, SW, and SE sides of pump jack have allowed precipitation to pool on-site during previous inspections. While no precipitation was observed on date of this report, the ruts and depressions remained at the well pad.

Corrective Action: Install or repair required BMPs per Rule 1002.f.

H2S sign at tank battery replaced on the right. Signs have also been installed at water tank and on the pumping unit shown in subsequent photos.
