# Final Reclamation and Stormwater Inspection

April 20, 2018

Operator: PETROSHARE CORPORATION- 10454

API: 05-039-06428

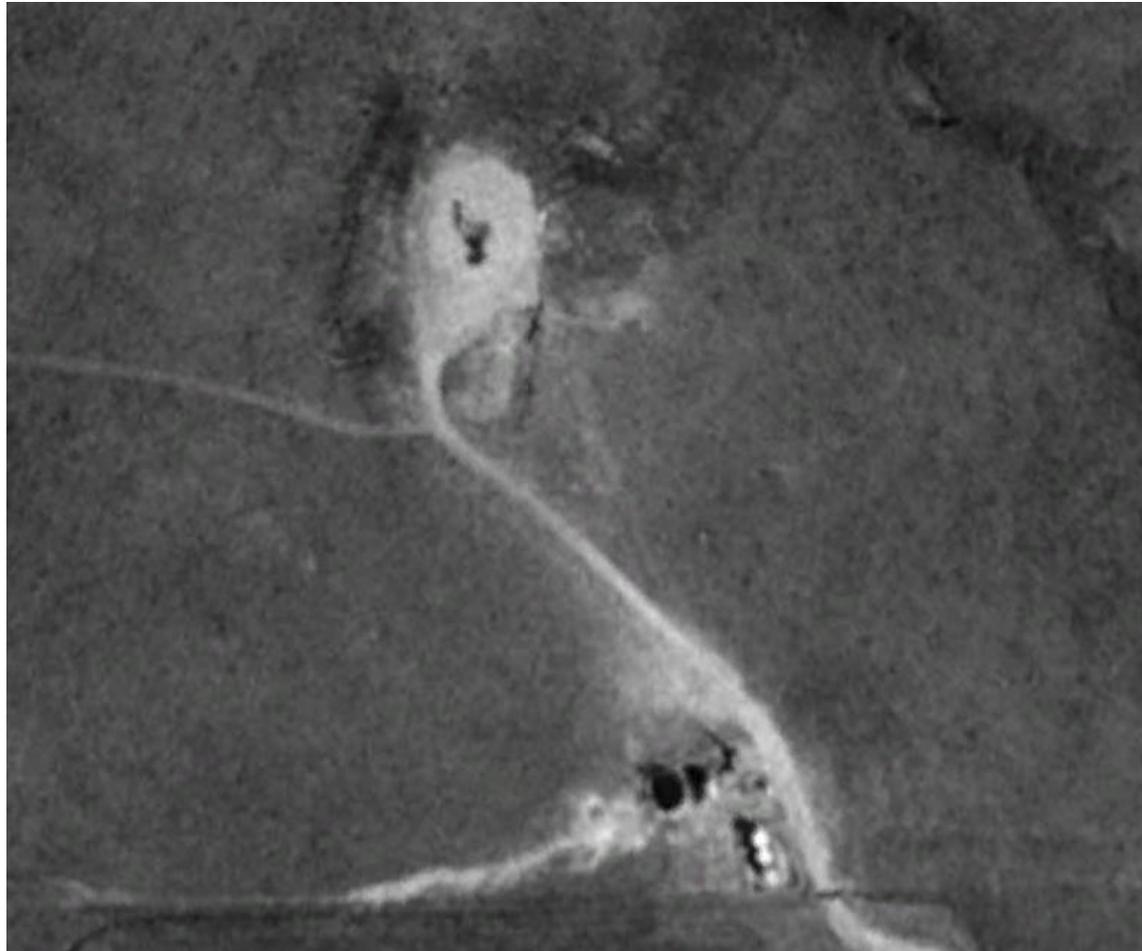
Google Earth aerial imagery taken 9/29/1999 illustrating well and battery location during operations.

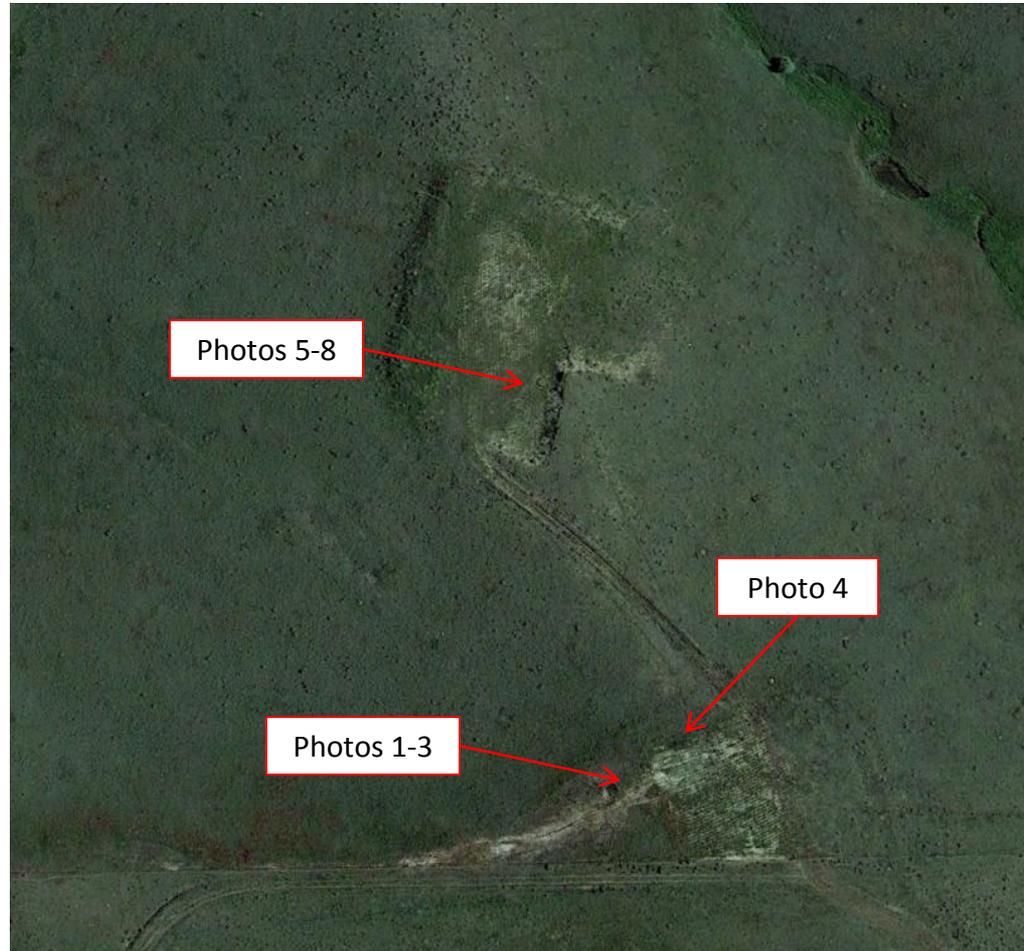
Photo reference points to help illustrate approximate locations of the subject photo during the April 20, 2018 inspection.
