# Final Reclamation Inspection

Operator: HOMESTEAD OIL INC - #41050

API: 05-123-10108

Inspection Photos  
Location Name: STATLER #1  
API: 05-123-10108

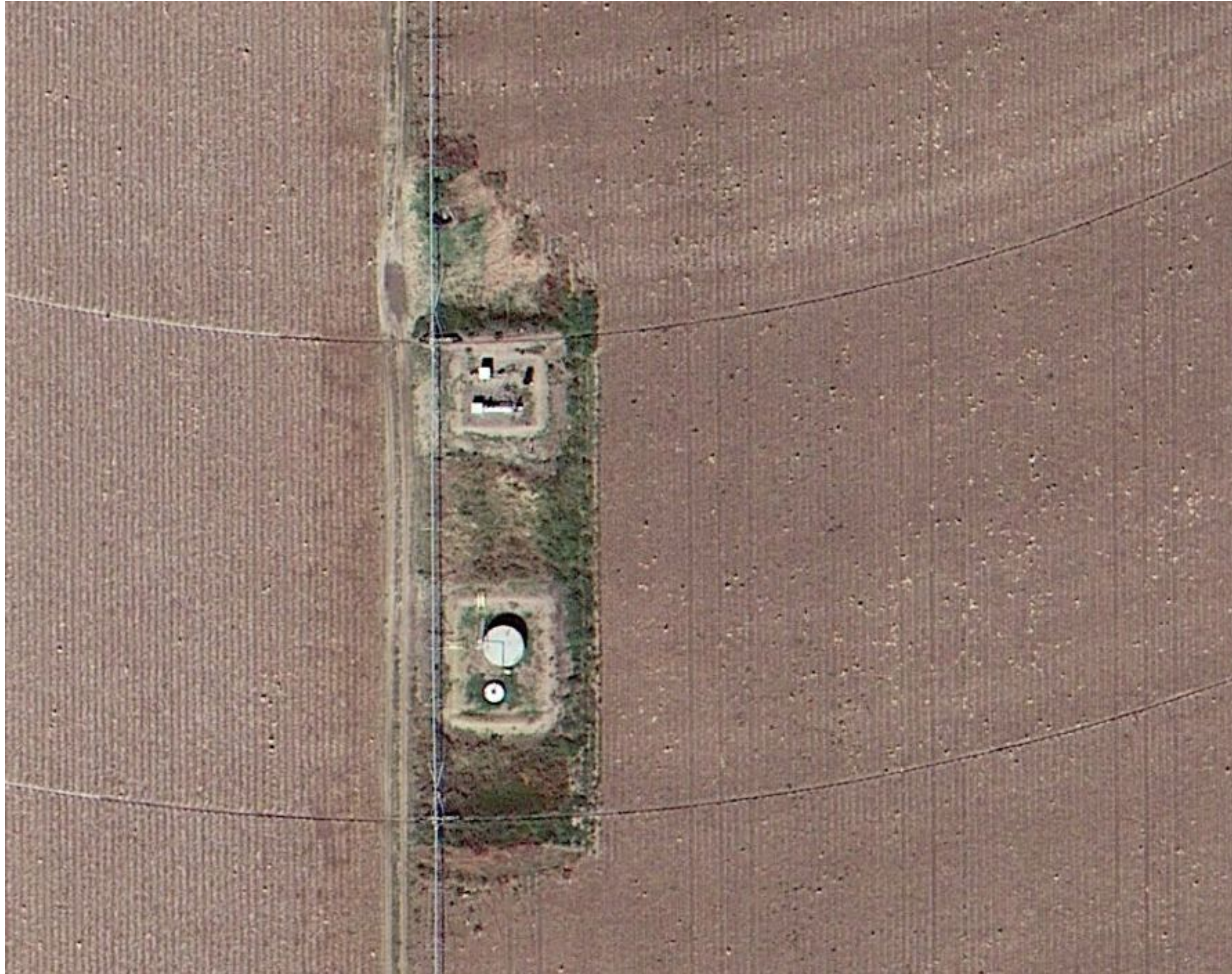
Google Earth aerial imagery taken August 18, 2012 of the battery location used for the three nearby Homestead wells during active operations.
