# **INCIDENT INVESTIGATION REPORT**

## **Gregory Pad Fire**

### **Castle 7 Pump House**

**SANDRIDGE ENERGY**

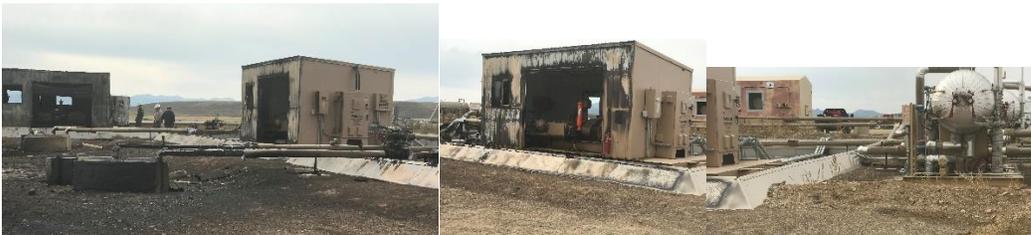
Photo 3: Left to right, Pump House Skids C7, C6, C5 and first Allocation Tank west of C5 skid

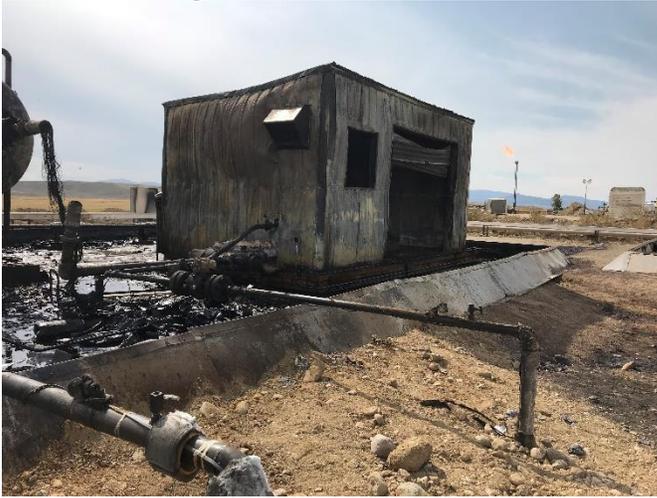
Photo of C7 Pump House walls facing to the north and west

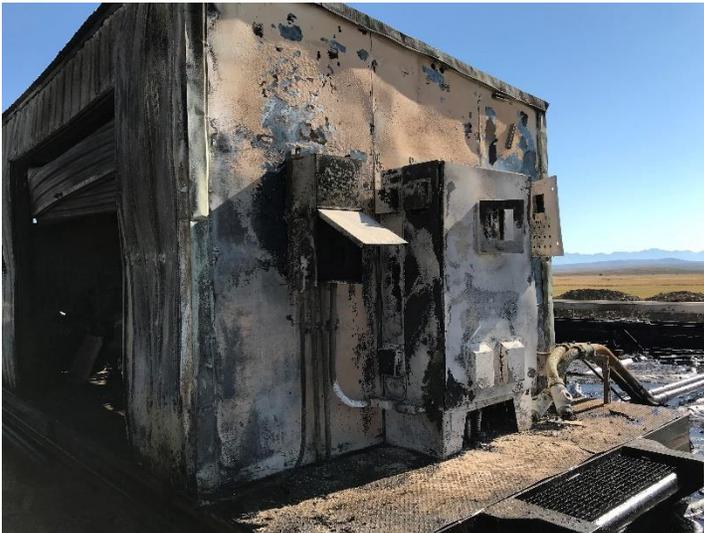
Photo of C7 Pump House south wall with Power Panel Box in center, low voltage breaker box to left and PLC box to right. Power lines enter the Power Panel Box from the cable tray to the far right.

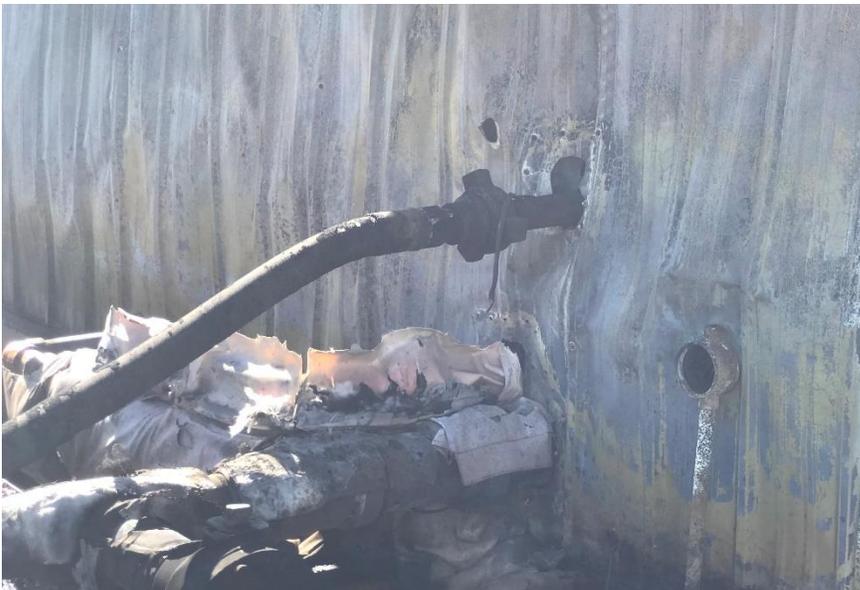
- The higher pressure (5,000 psig) rated discharge flex hose was not damaged to the extent of the suction hose off the Power Fluid Vessel separator. The lower pressure (500 psig) metal flex hose on this suction line for water to the Triplex pump was destroyed with just strands of metal remaining.

Photo of C7 Skid flex discharge line exiting north wall above the suction line

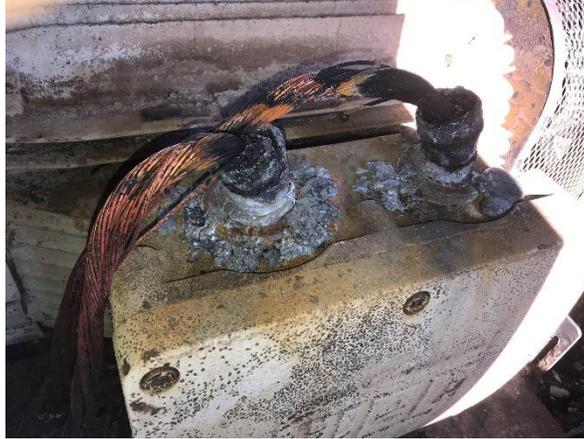
Power In to C7 Triplex 200hp Motor Connection

The two power lines passing through the skid deck to the motor were arched and unsupported, suspended only by the wire cable strength and its connections. The power lines rose from the skid deck opening and arched towards the motor connection. Wiring approached from the left at about 45 degrees from vertical into the motor connection. The photo below shows the weight of the wiring resulting in the connections melting further on the left side. Metal slag is present adjacent to the melted connectors confirming that this was very hot. This is a possible location of a the initial short.

- c. Power lines into the motor had significant damage that melted connections between the motor and power lines. These lines pass under the pump skid from the Power Panel Box through roughly cut holes for access to the motor. These two lines then rise over the height of the motor and bend down at an approach angle of about 45 degrees from vertical. See comparison photos between C5’s wiring on a newer looking skid and the C7 motor power photos.

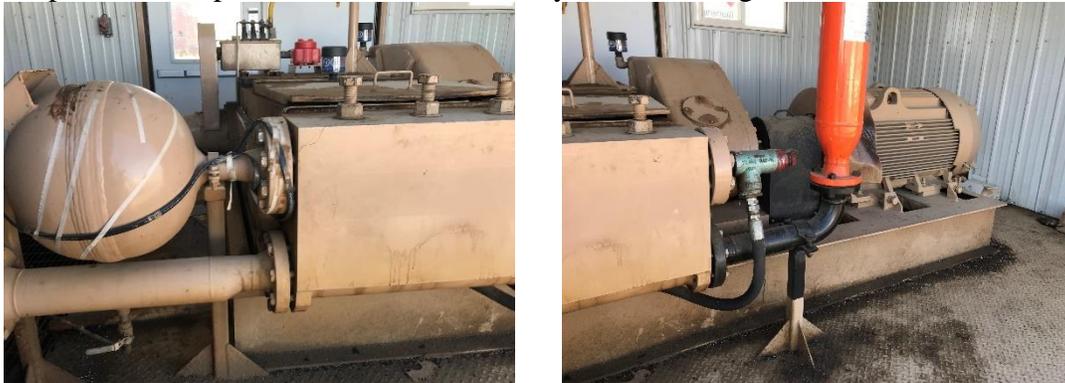
### C5 Triplex Jet Pump Photos – similar to C7 layout and wiring to motor

C5 Discharge Line above Suction Line out/in of C5 Pump  
Triplex Pump Top Inspection Cover and handle is visible in background

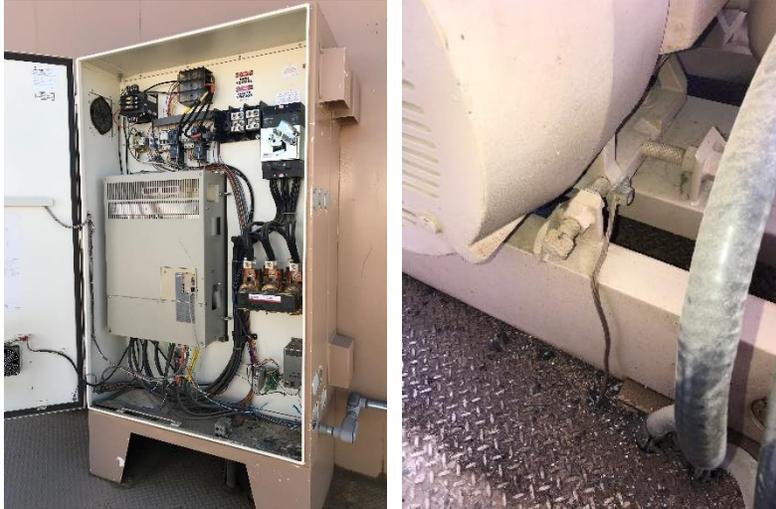
### C5 Power Panel Box and Motor Skid Pass Through Photos

C5 appears to be newer than C6 and C7. The Power Panel is configured similar to C7 and can be used to identify Phase B and C conductor locations in orange and yellow colors. There appears to be more spacing between the motor ground wire and the first conductor power line passing through the skid deck in C5. The C5 ground wire is closer to the front of the motor, shorter length and a single strand wire as compared to the C7 motor wiring.

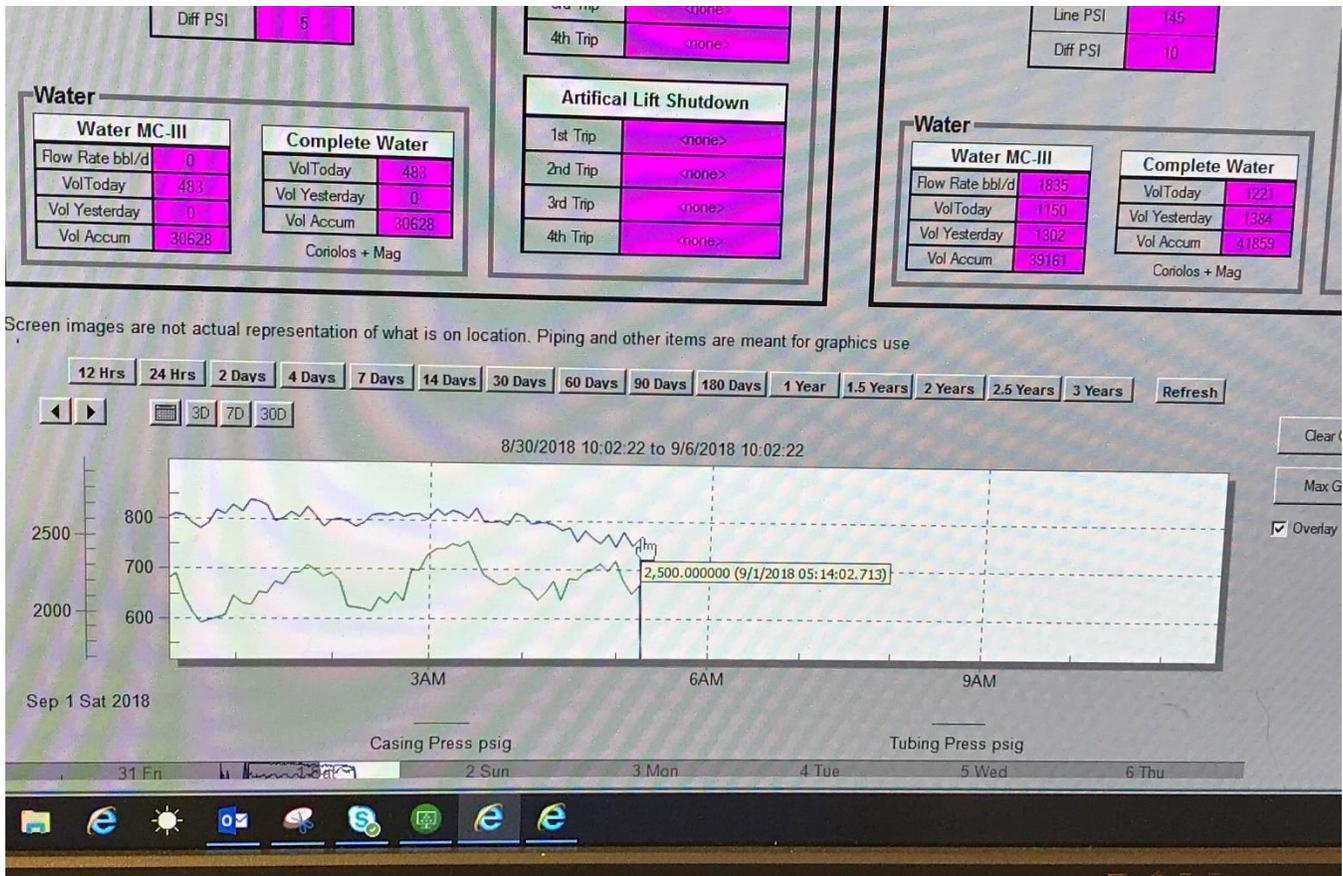
Trend data shows loss of pressure power loss to the wellpad at 5:20am Central Time or 4:20am Mountain Time. This confirms wellhead was shut in and wellpad operations were shut in.

DCS data kept in Oklahoma City time zone. Time of 05:14.02 was actually 4:14:02 Mountain Time in Colorado.

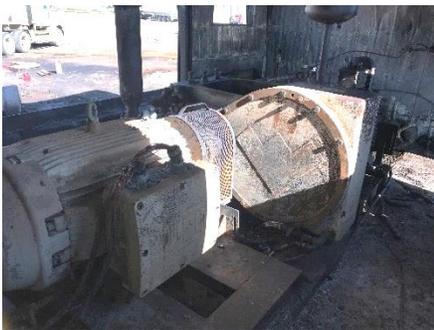
Power lines into the C7 motor.

Large rough-cut openings for wire pass through with the power cable insulation providing the only protection from damage to the wiring insulation. Appears to have a clamp above the skid to secure the insulated line in place. Lines are subject to vibration that can cause additional rubbing and scraping. The potential for grounding the power lines exists at the skid pass through opening and the connectors.

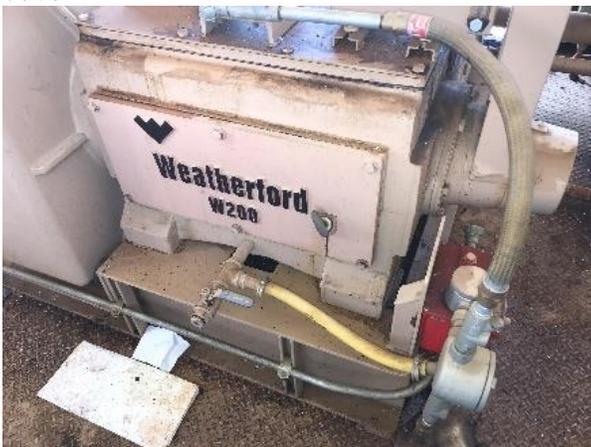
C5 rear inspection cover for comparison to the damaged C7 pump rear inspection cover

Rear Triplex inspection cover allows access to the connecting rods of the pump, mechanical section. Melted metal slag was found inside the cover location on the right end where the melt of the cover occurred. Melting of metal can occur with Arc Flash incidents, temperatures from 5,000 to 30,000 degrees F are possible.

Additional evidence of Arc Flash damage that can have temperatures to melt steel. Possible cause of the initial small fire igniting insulation or wiring from the Triplex pump extreme temperatures.

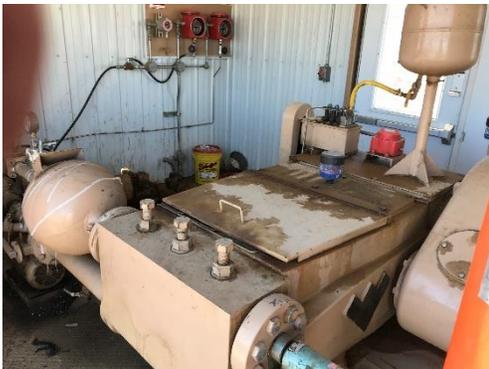
C5 photo below of the Top Inspection Cover with lift handle for C7 melted cover comparison:  
 Note also close cover location to discharge and suction lines passing through the pump reciprocation plungers in the rectangular box adjacent to this cover

Top inspection cover was lighter weight and is not as securely sealed to air exposure than the rear inspection cover. The Top Inspection cover is within 2 feet of the suction and discharge lines into the Triplex pump and within 8 feet of the wall location where these lines are insulated outside the walls of the Pump House.. If one of these lines got sufficiently hot like the similar lines at C6 and C5 from the Triplex pump, they could have caused the initial small fire.

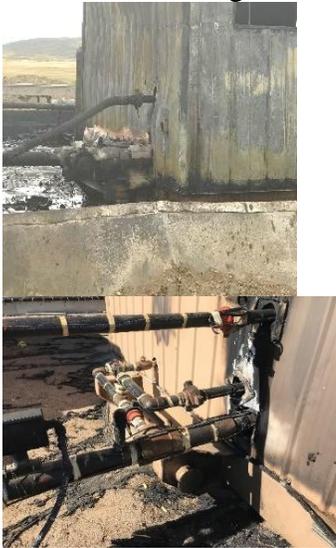
Outside C7 wall photo below does not show soot markings.

The melted top cover was within two feet of the suction and discharge lines just off picture to the right of the discharge pulsation sphere. It may be possible for sufficient heat transfer to the inside piping from the Triplex pump to cause the external piping insulation to catch fire. Outside insulation at C5, C6 and C8 caught fire from the heat of the large flame.

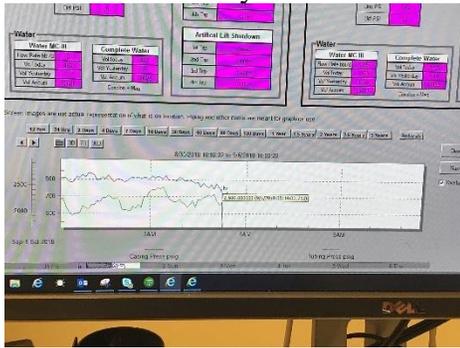
### Trend line data shows power and pressure loss simultaneously

Power supply trend lines also showed stable conditions until loss of power to the motor.

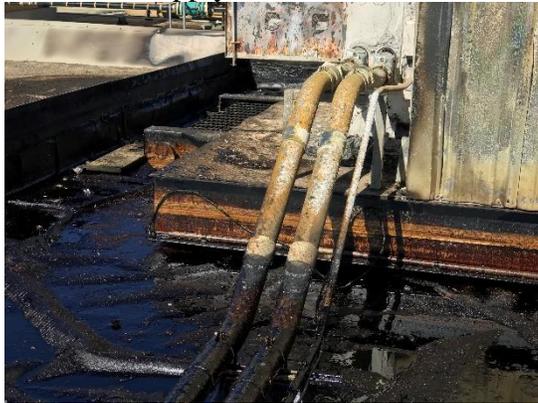
### C7 Power Supply Lines

No visual damage to power lines into the C7 Power Panel Box.
