Caerus

Corrosion Review

28-7 E280U Flowline Failure Analysis

February 12, 2019

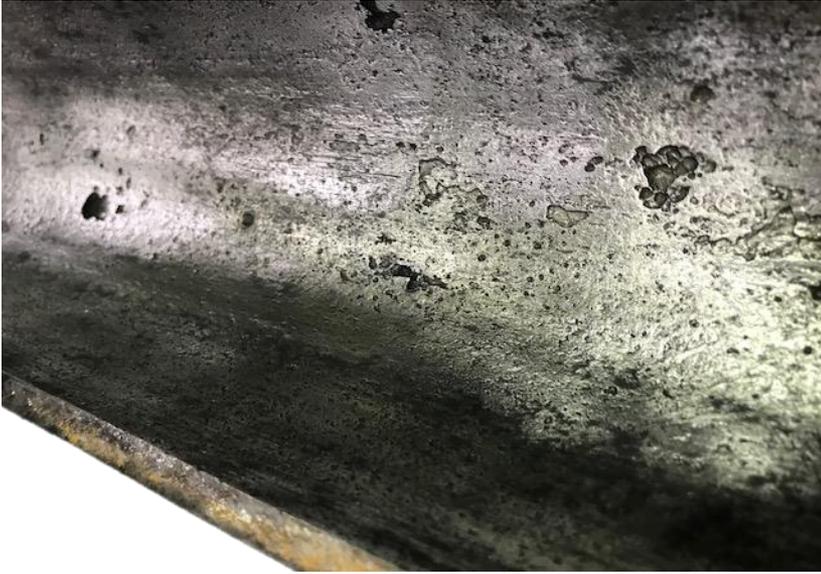
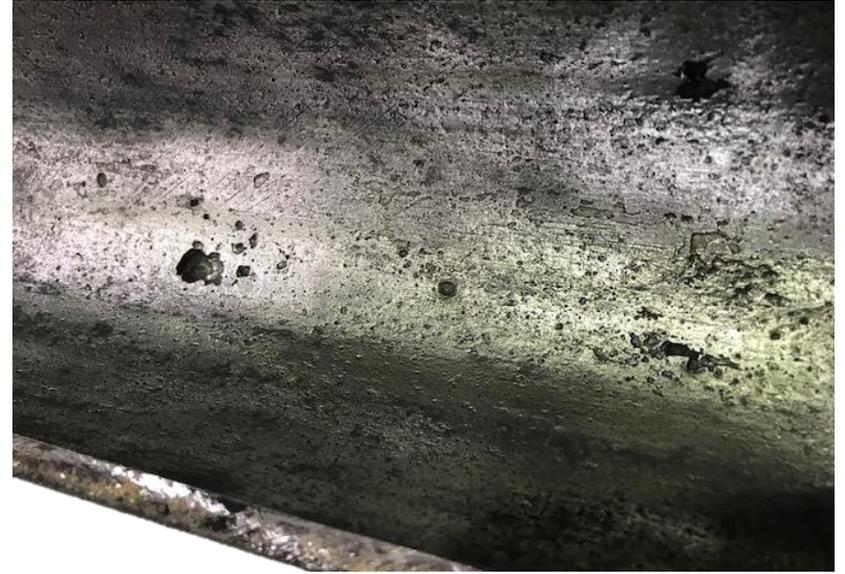
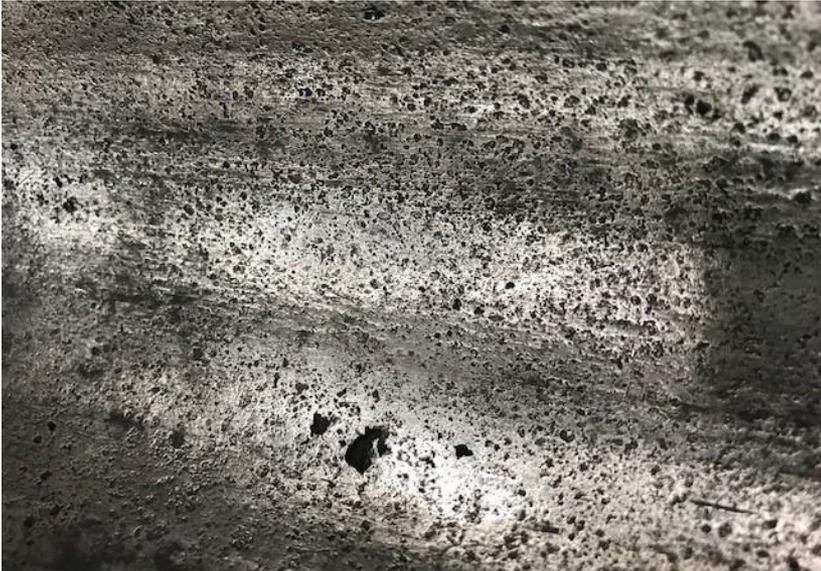
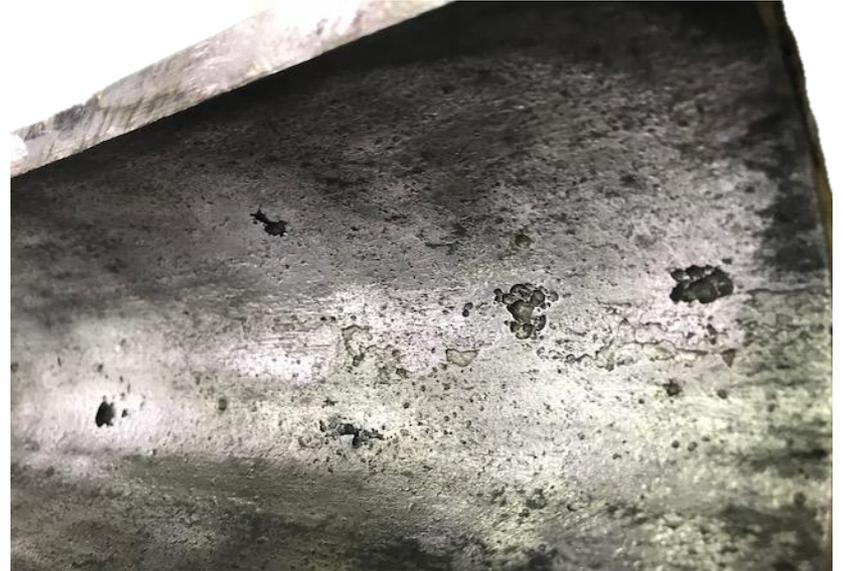
Pit Morphology - Additional Pictures

- Deep, isolated pits found among lighter pitting with through hole wall
- Pit similar to bottom of line with stair stepped pattern
- Black material tested positive for iron sulfide

- **Corrosion in flowline is exclusively internal corrosion**
- **Hole in tubing found in the top of the line.**
- **Less severe pitting found throughout the line.**
- **Severe, isolated pits found were on both sides of line.**
- **Pit morphology is stair stepped with pits within pits and iron sulfide at the base of the pits.**
- **Light pitting is highly characteristic of H₂S pitting.**
- **Severe pitting is highly characteristic of sulfate-reducing bacteria.**
- **Sulfate reducing bacteria secrete H₂S, which reacts with iron to form iron sulfide.**
- **Pitting failure likely due to Microbially Influenced Corrosion (MIC). H₂S pitting is likely a byproduct of SRB metabolism.**
