PIT STATUS EVALUATION FORM

Facility ID: 111797
 Pit Name: DUFFY 10-3

S.S. PAPADOPULOS & ASSOCIATES, INC.

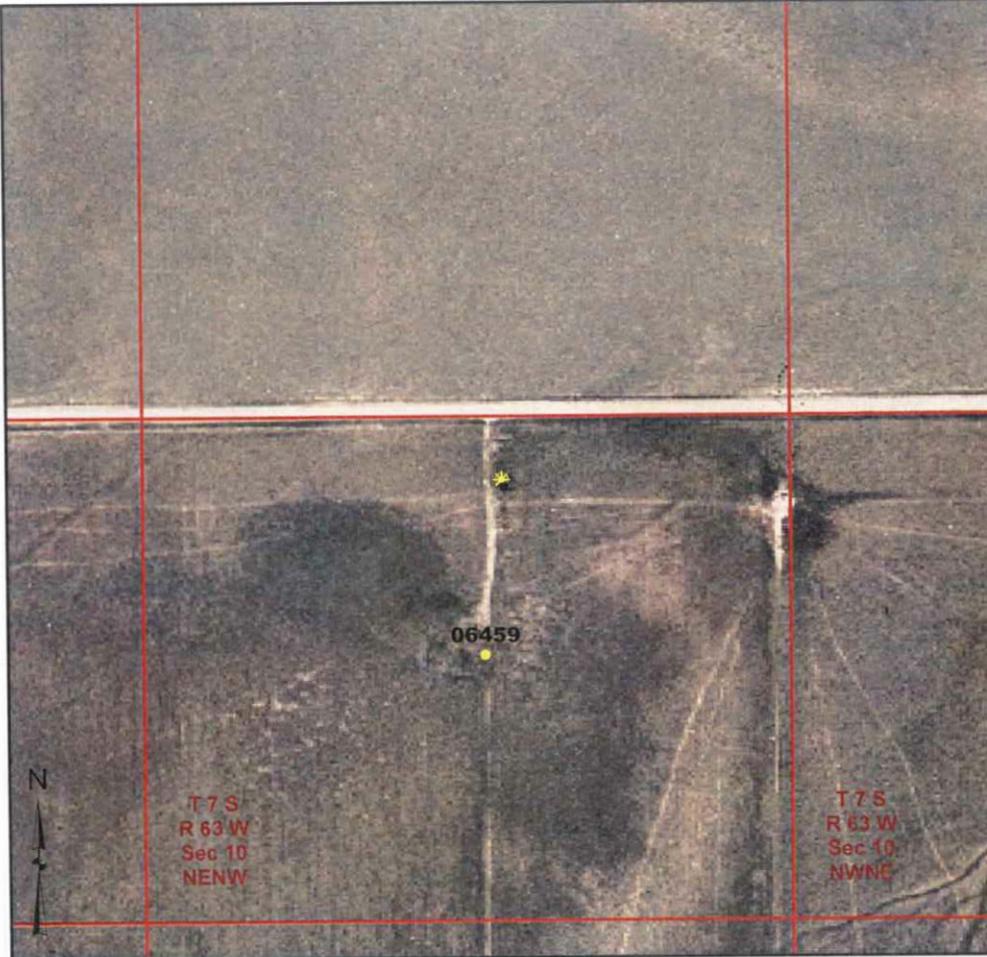
Notes: No lease inspections for Facility ID#111797. NOVA #119754 (2004) indicates well maintain TA status until 4-20-2010.
Field Visit 6-4-2008: Earthen Pit & Culvert found. Heavily oil saturated soils & pit cover / berm unsatisfactory.
