PIT STATUS EVALUATION FORM

Facility ID: 115084
 Pit Name: MILLER 6-11

S.S. PAPADOPOULOS & ASSOCIATES, INC.

Miller 6-11, 6-7, 6-13 & 6-15
Miller 6-11
Miller 6-7
Miller 6-13
Miller 6-15

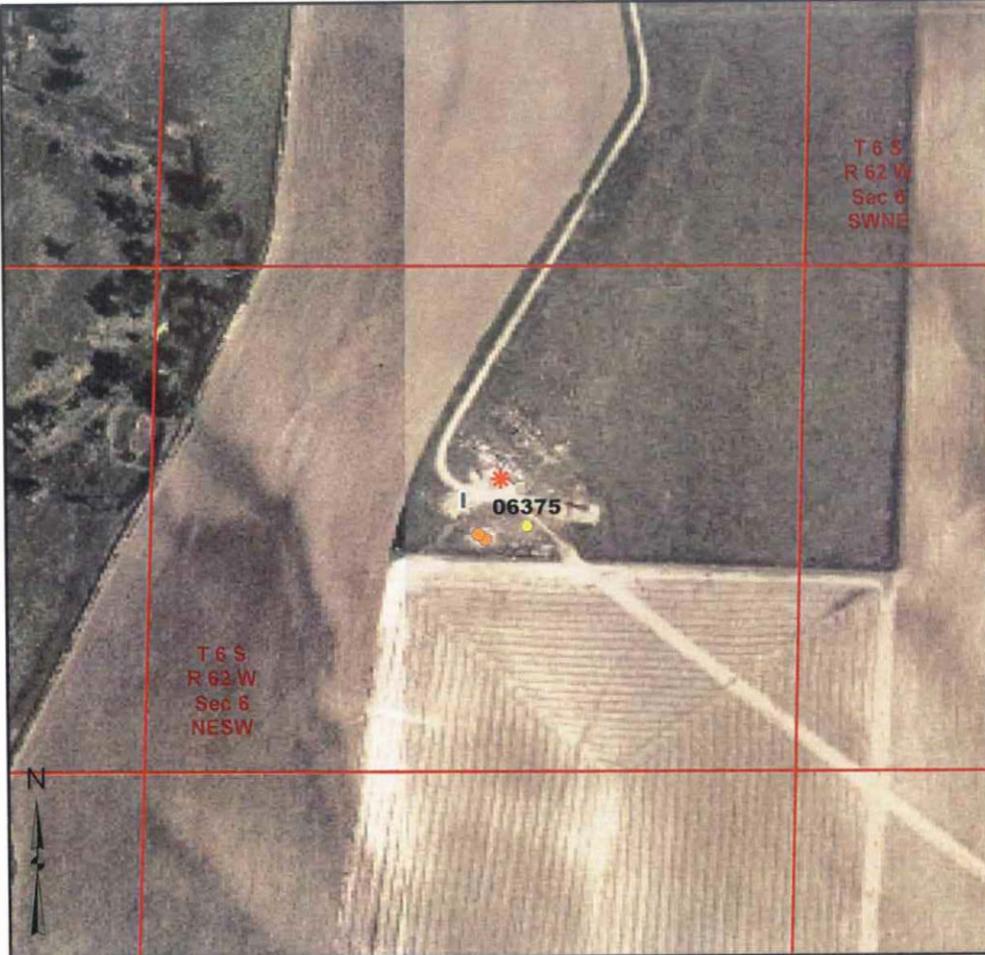
Covered steel tank

Common Use for Miller 6-11, 6-7, 6-13, 6-15

Notes: FIR(2008) indicates no closure documents for pit and excessive area disturbed. corrective action due 5-19-08.
FIELD VISIT 6-4-2008 : PIT BACKFILLED, SITE NOT CLEAN. Debris Found.

Recommend Remediation
