Inspection Photos
Operator: Kinder Morgan
Location #: 313490
Date: 2/20/2020

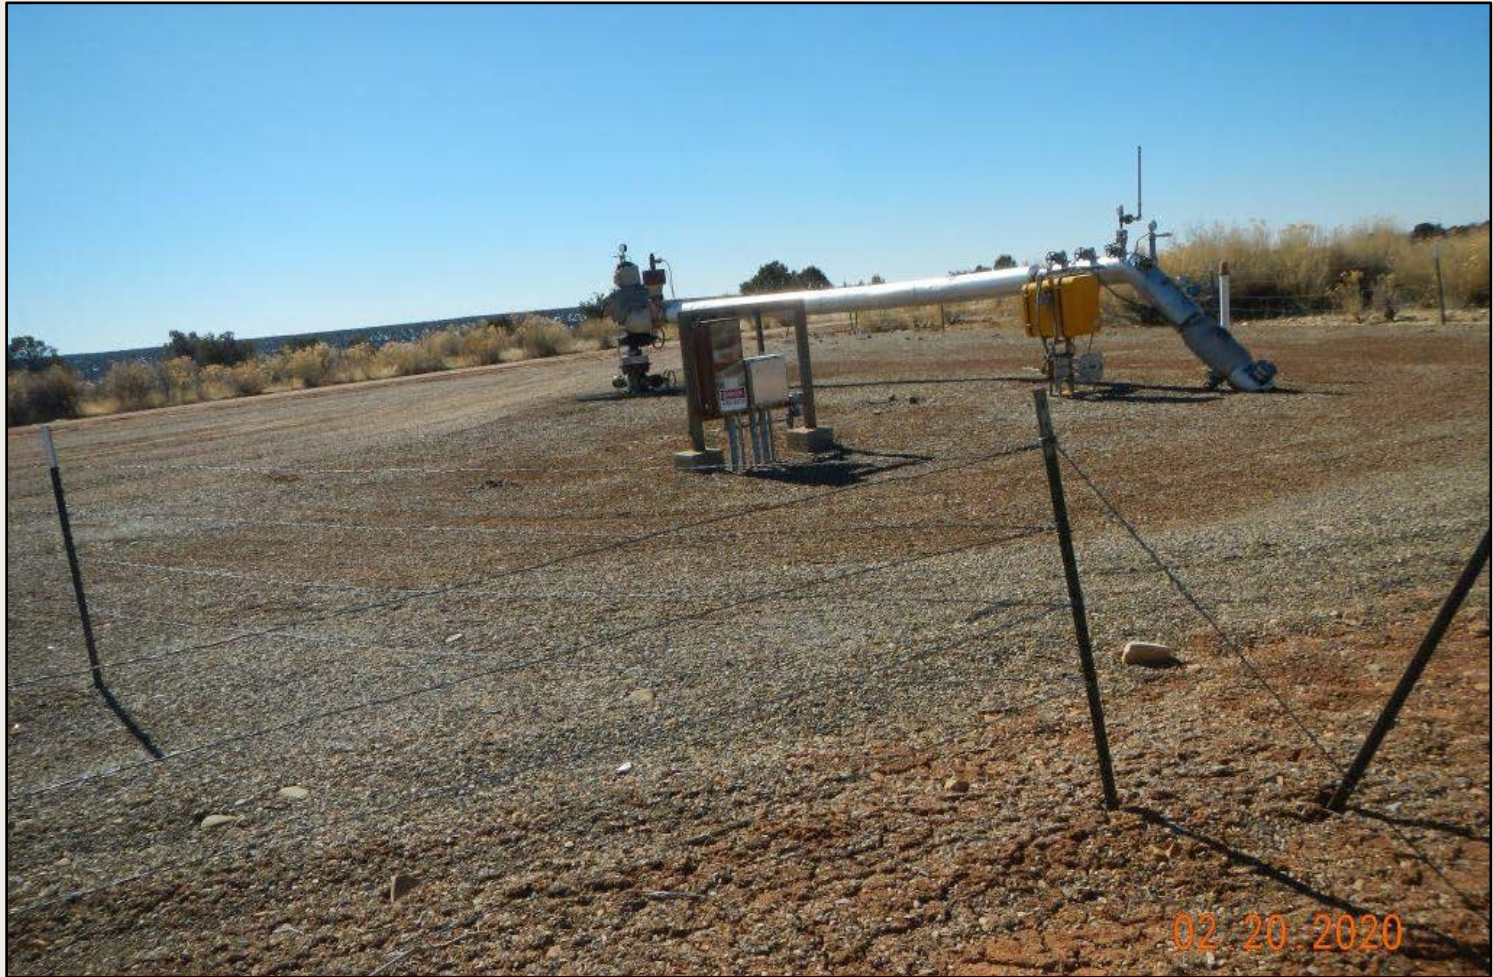
Photo 1. View of the project area from the northeastern edge of the working area facing center.

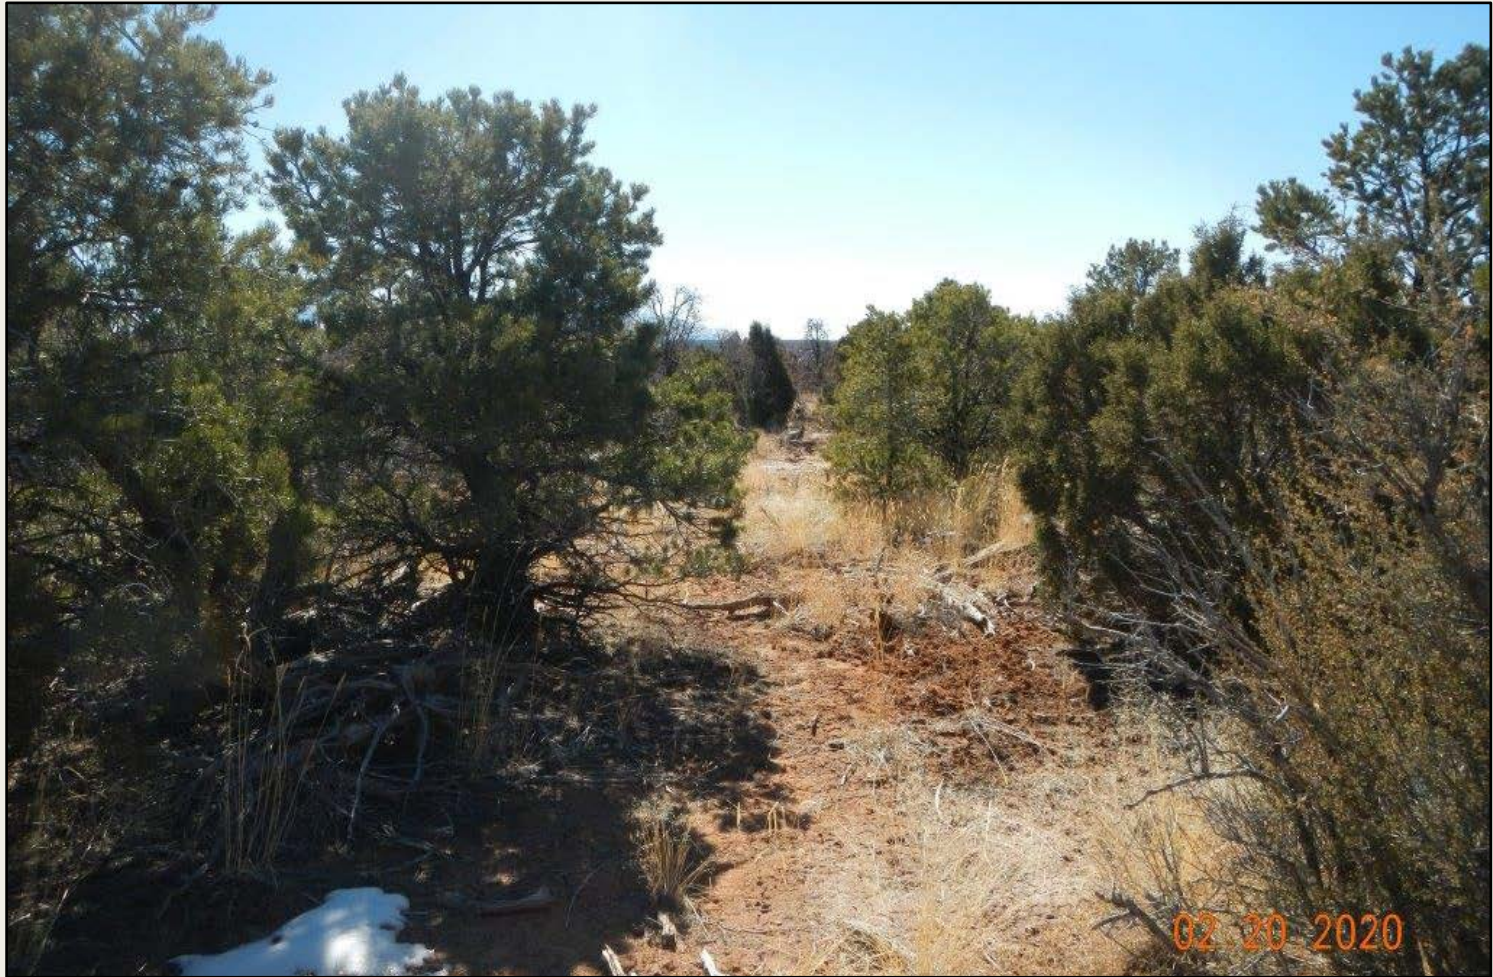
Photo 7. View of the reference area, comprised of pinyon juniper woodland, mixed cliffrose shrubland, and grasses such as Indian ricegrass and sand dropseed in the understory.
