Inspection Photos

Operator: Hilcorp Oil and Gas
API: 067-06442
Date: 7/28/2020

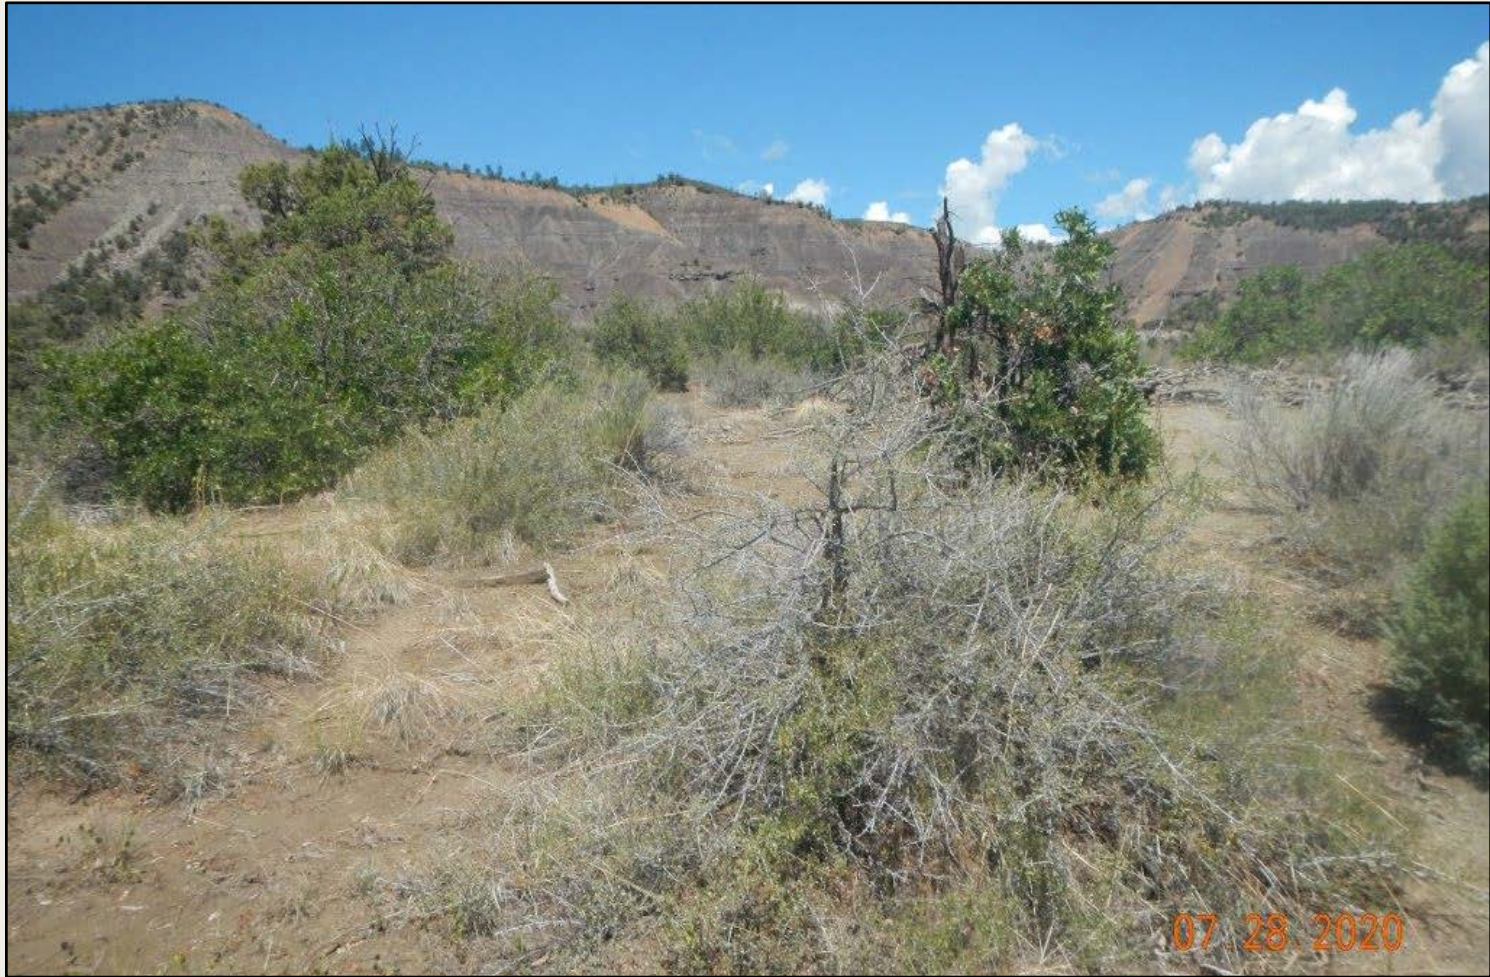
Photo 4. View of reference area vegetation comprised of gambel oak and antelope bitterbrush-dominated shrubland with grasses such as western wheatgrass and blue grama common in the understory.
