## Issue Report

# Pelton Twin #1-SWD, 017-06482, Mull Drilling

Report created on August 14, 2020

Captured: August 7, 2020

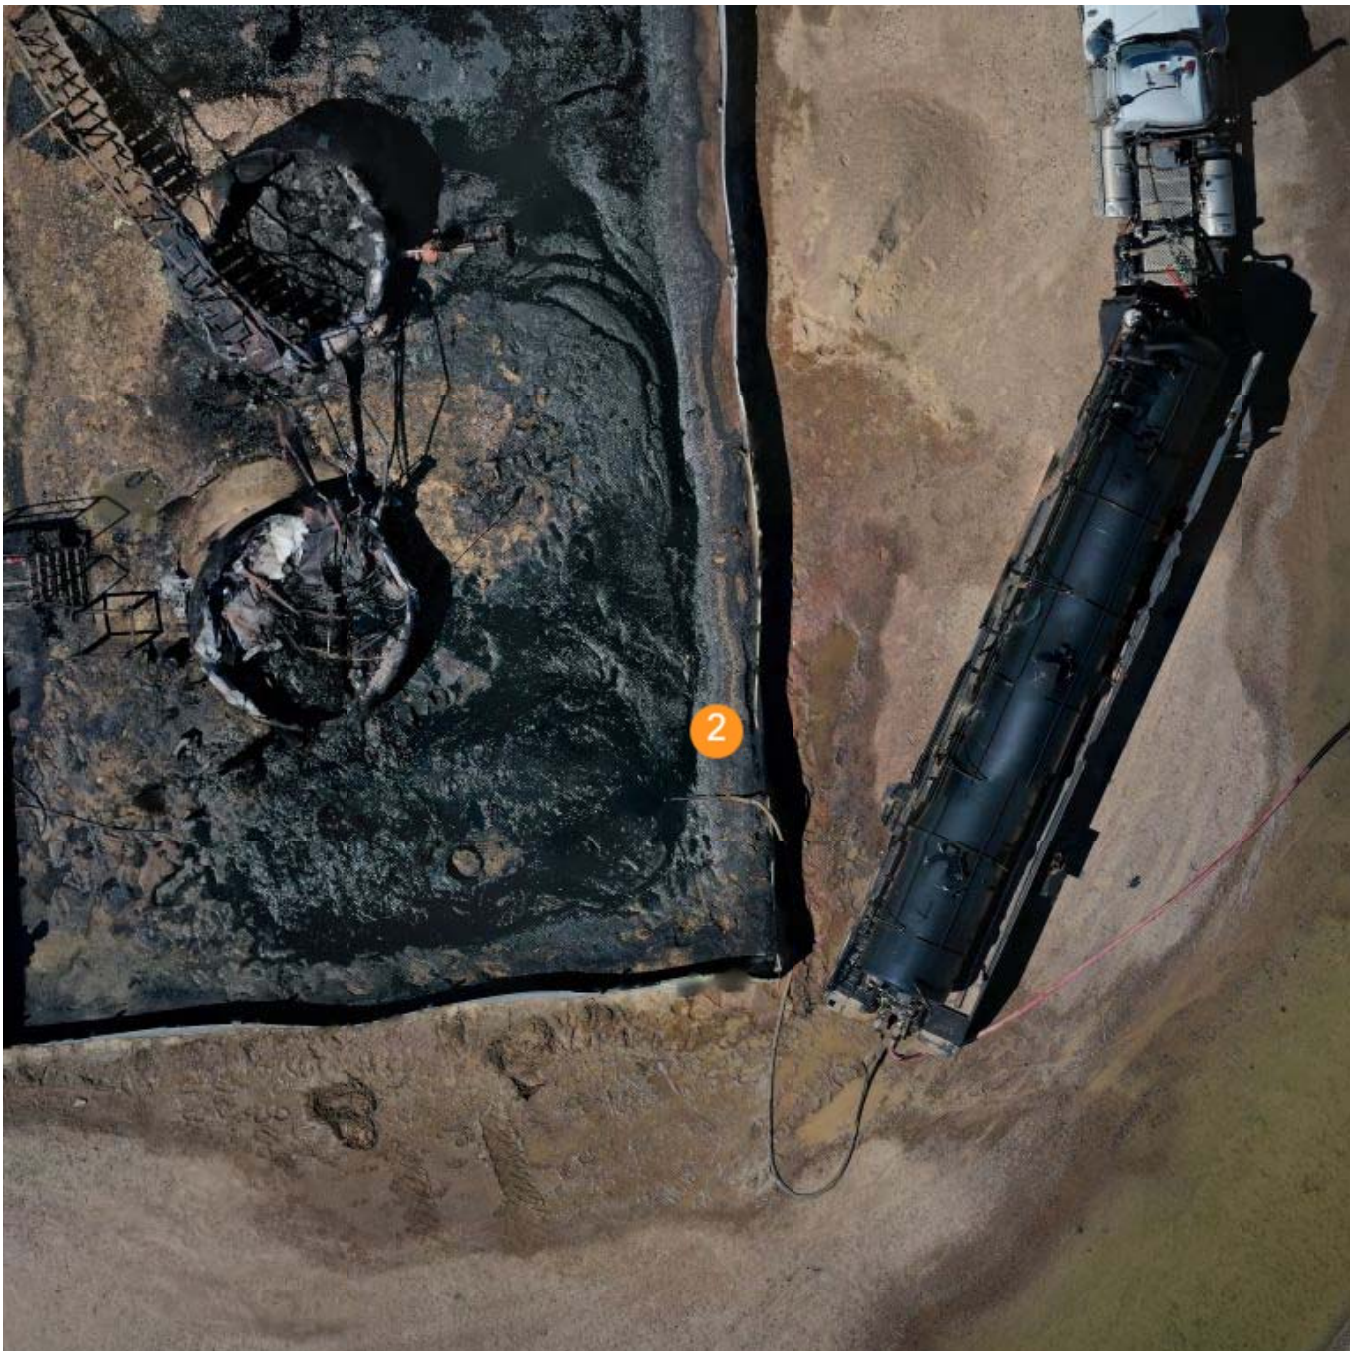
**No. 2 OPEN****Captured: Aug 7, 2020 at 2:53pm**

No.	Summary	Created	Status
2	Oil contained inside metal berm.	Aug 14, 2020 at 2:51 PM	Open

**Type**  
Leak**Lat/Long**  
38.87929, -102.33303**Summary**  
Oil contained inside metal berm.**Created**  
Aug 14, 2020 at 2:51pm by Craig Quint

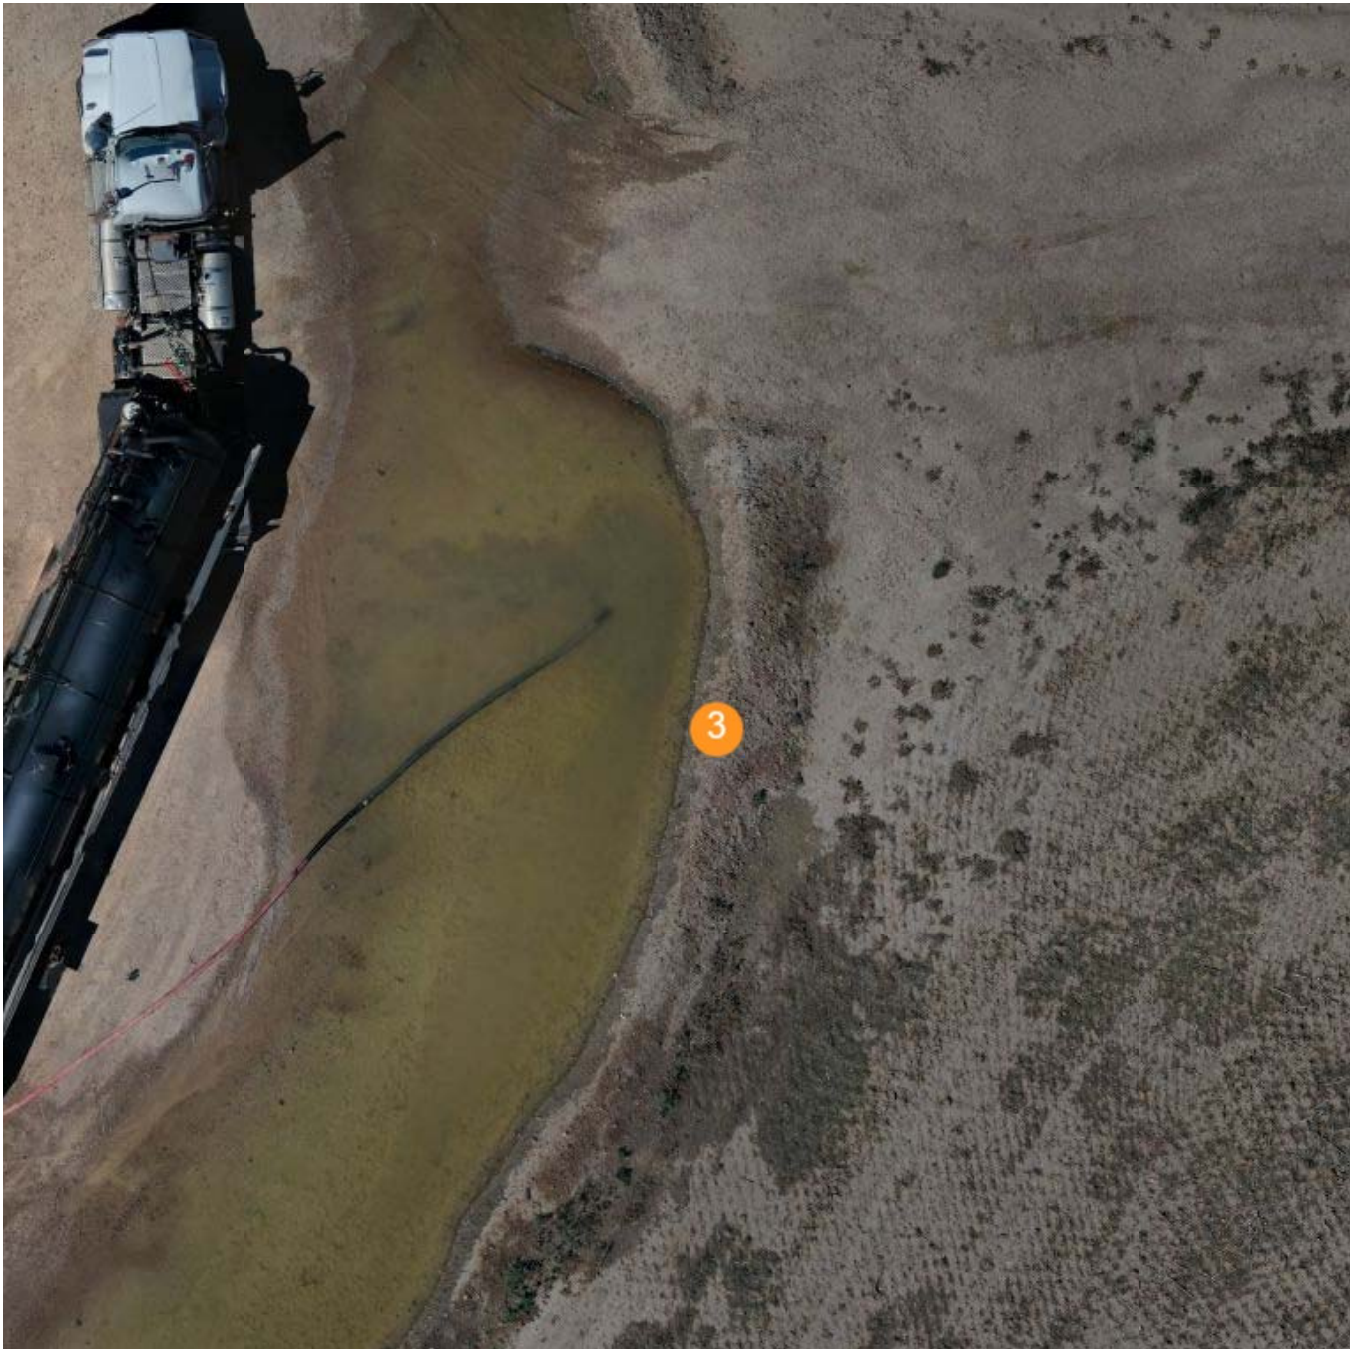
No. 3 OPEN

No.	Summary	Created	Status
3	Earthen berms on east side of battery filled with rain water.	Aug 14, 2020 at 2:59 PM	Open

Summary  
Earthen berms on east side of battery filled with rain water.

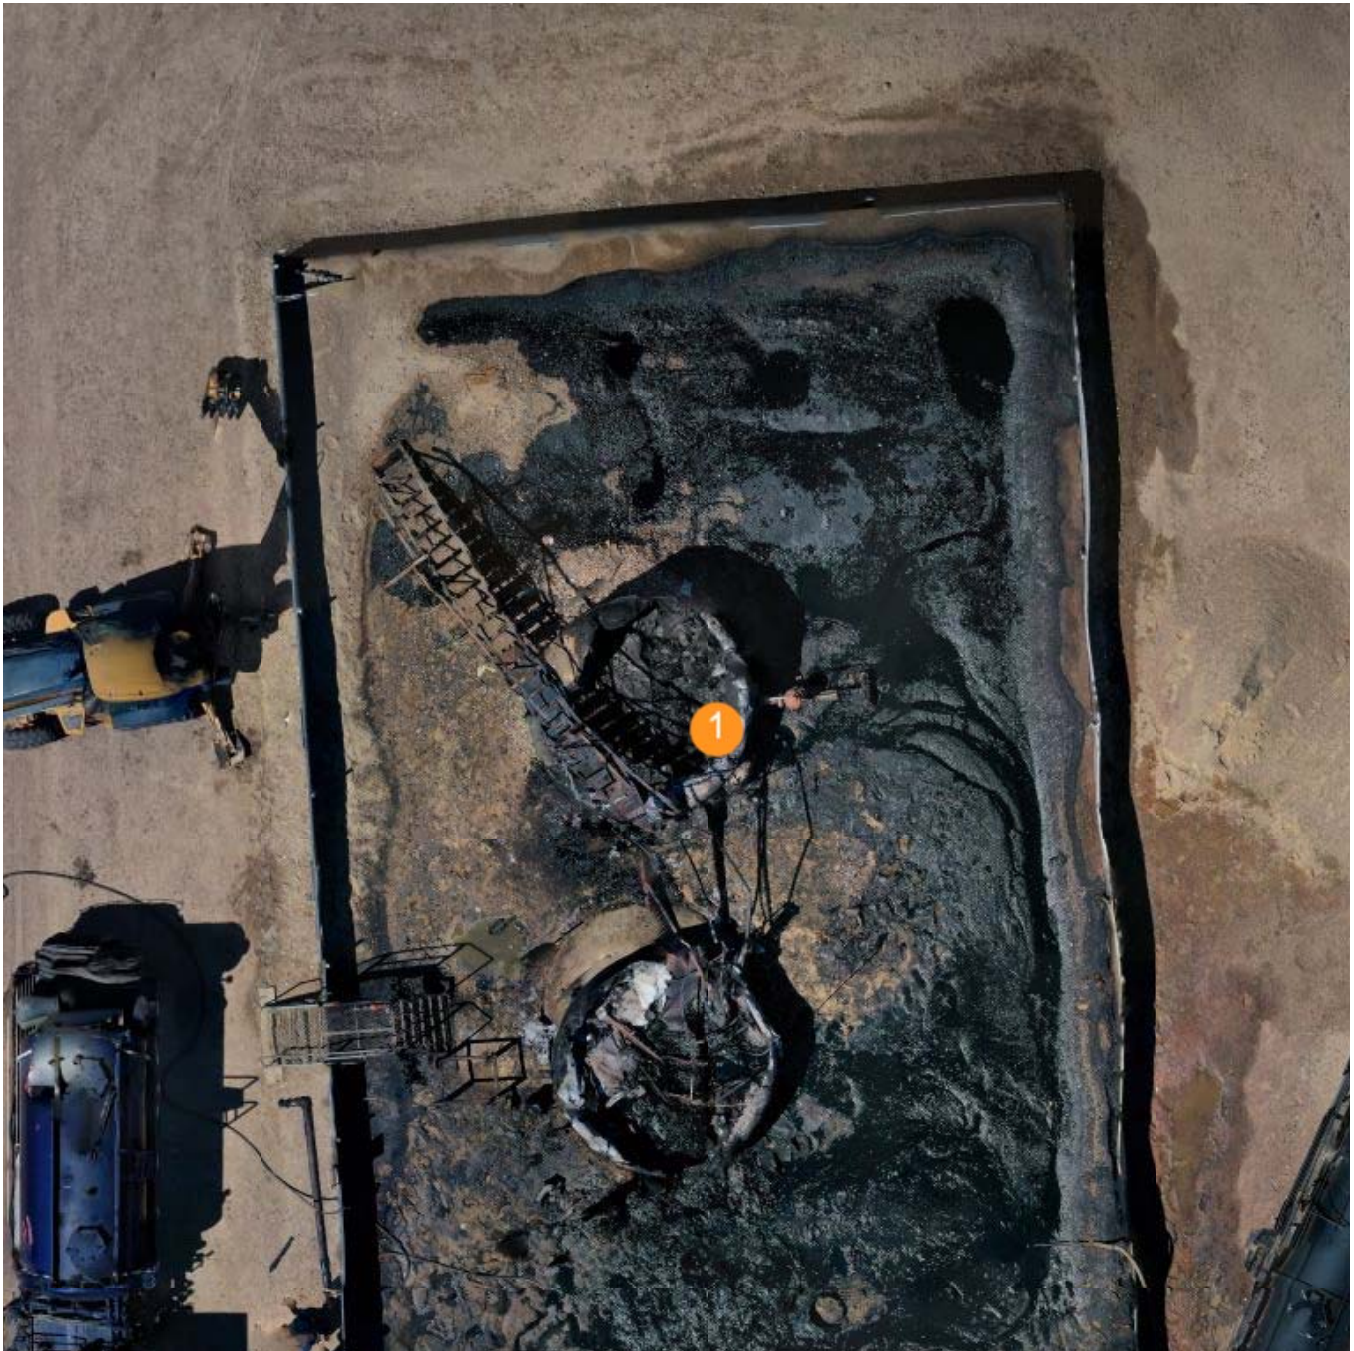
No. 1 OPEN

No.	Summary	Created	Status
1	Lightning Strike, Remains of tanks	Aug 14, 2020 at 2:49 PM	Open
