Inspection Photos

Operator: BP America
API: 067-07114
Date: 9/1/2020

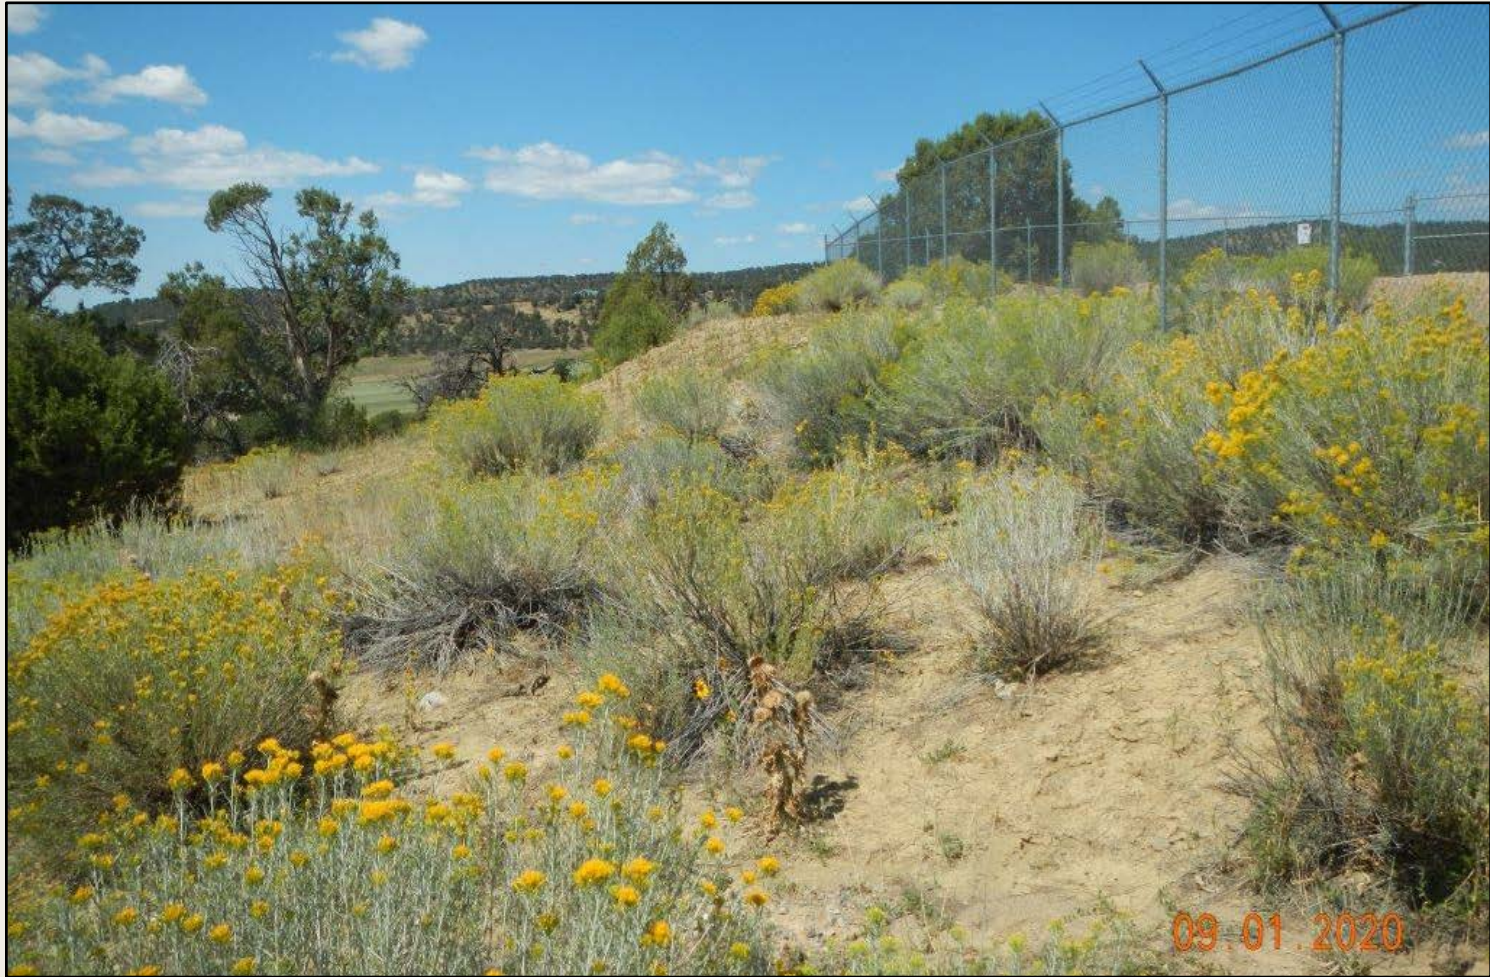
Photo 3. View of the southern project area from the southwestern corner facing eastward.

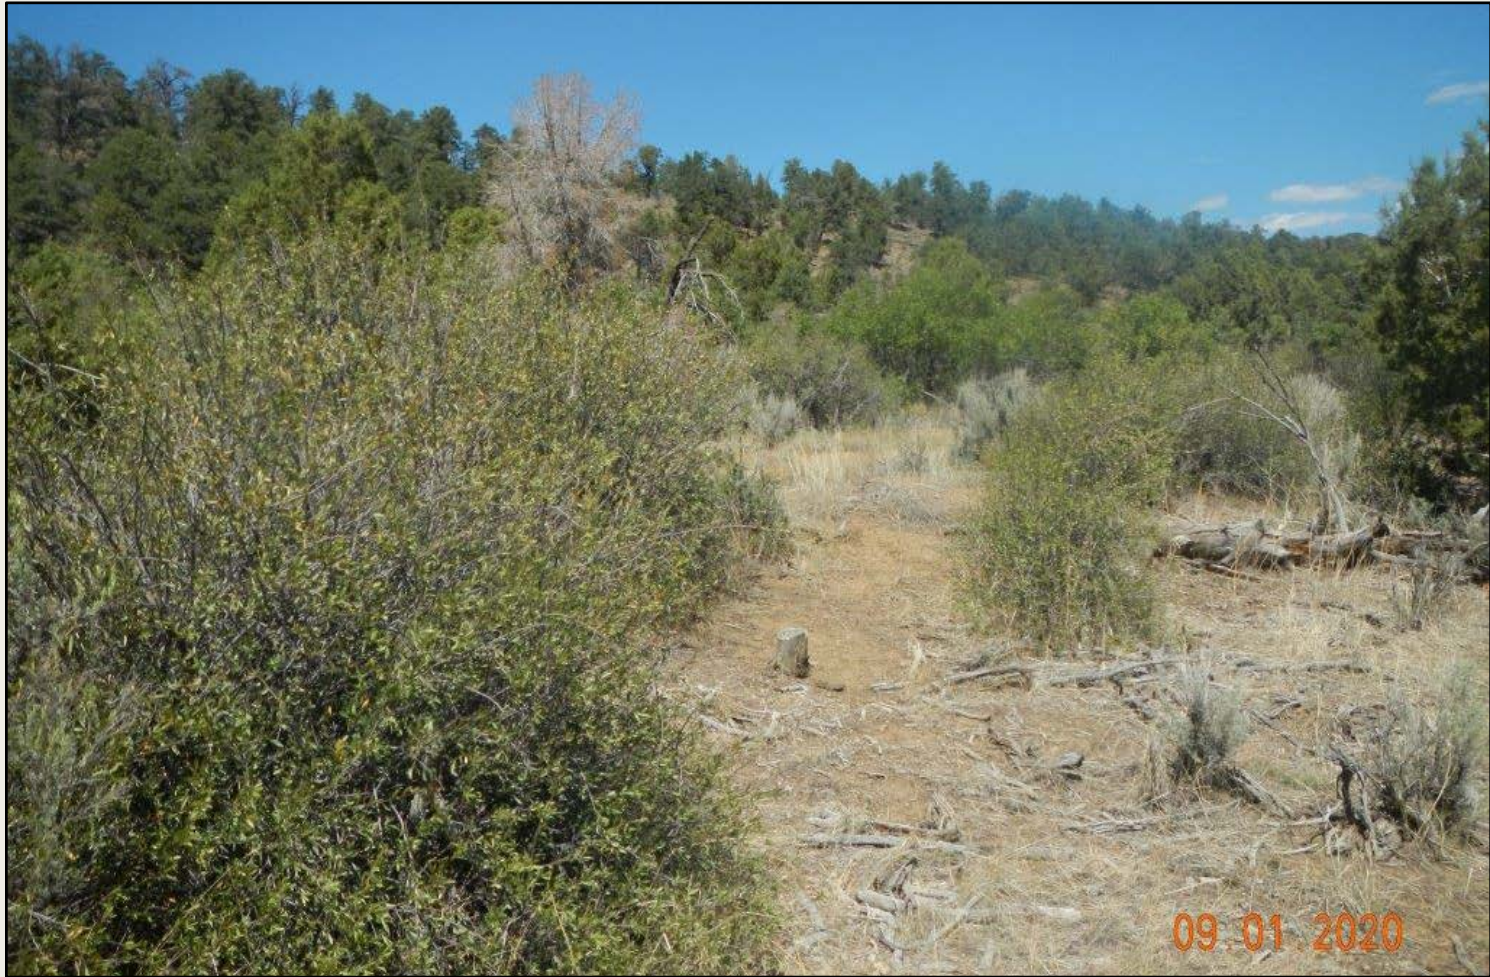
Photo 6. View of reference area vegetation comprised of mixed gambel oak and ponderosa pine woodland, with pinyon and juniper trees, shrubs such as mountain mahogany and antelope bitterbrush, as well as grasses and forbs such as Indian ricegrass, James galleta, and bricklebrush.
