Inspection Photos

API: 061-06590

Operator: OXY USA INC

Inspection Date: 6/9/2021

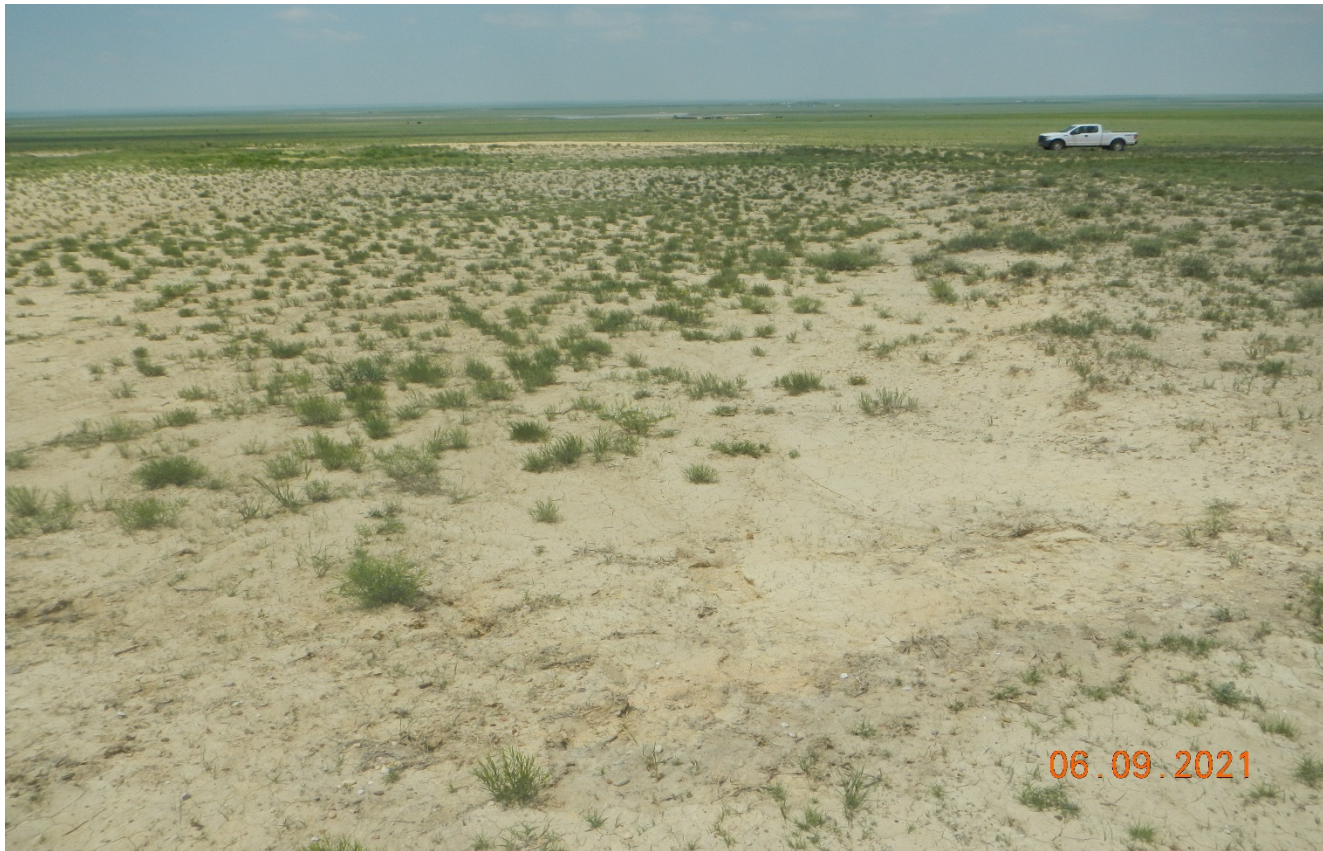
Photo 9. Facing northwest at the at the eastern corner of the location.

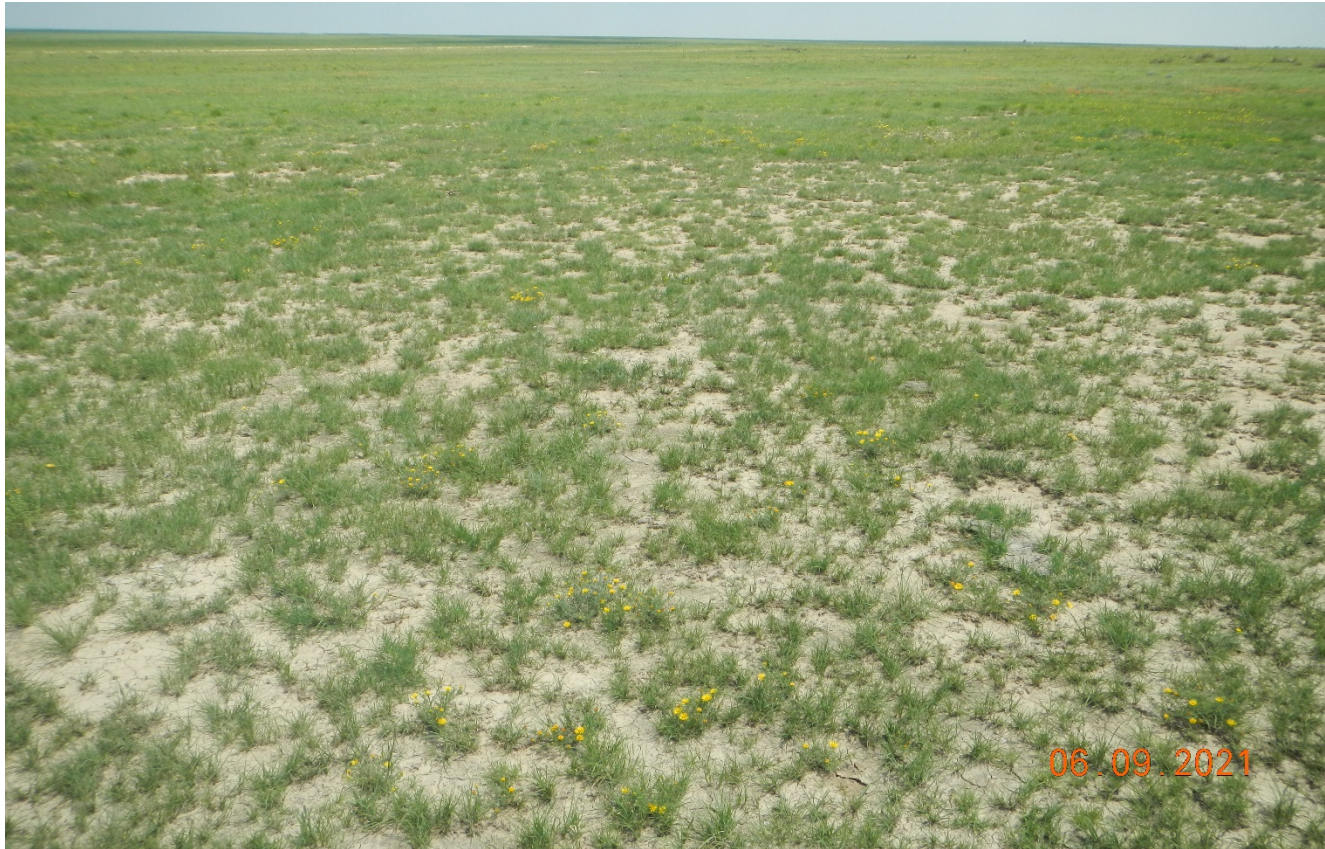
Photo 10. Facing east toward the surrounding undisturbed rangeland consisting of Blue grama, Sand dropseed among other native species.
