Inspection Photos  
Operator: Petrox  
Facility: 007-06235  
Date: 9/13/2021

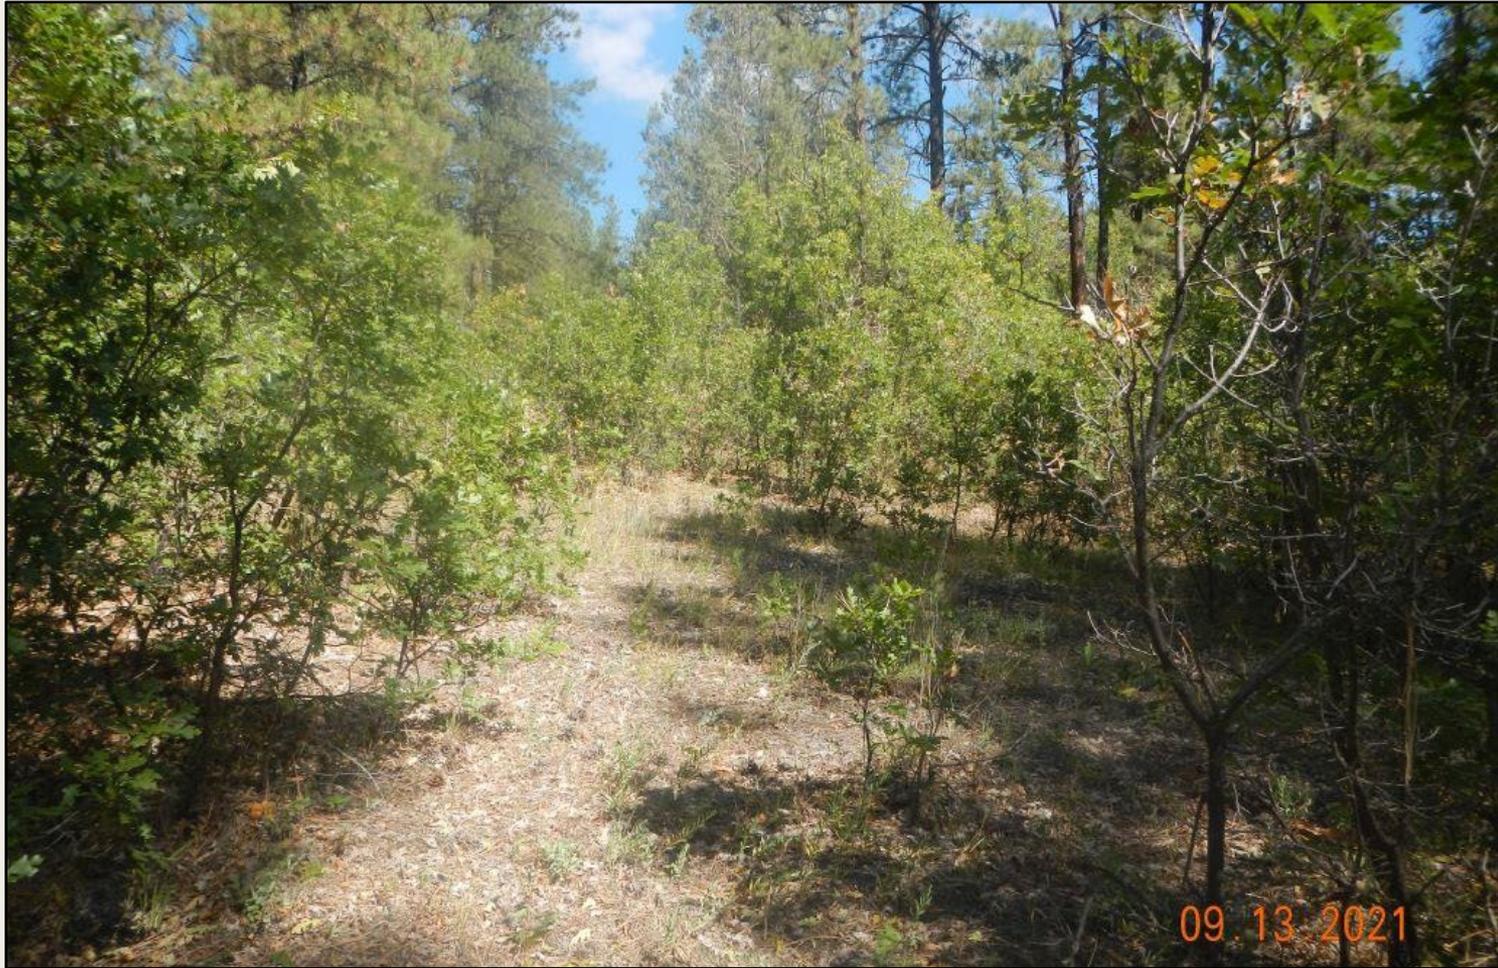
Photo 7. View of the reference area comprised of mixed grass field, with ponderosa pine forest, and western wheatgrass, smooth brome, serviceberry, and gambel oak in the understory.
