Inspection Photos
Operator: Simcoe
API: 067-07858
Date: 10/27/2021

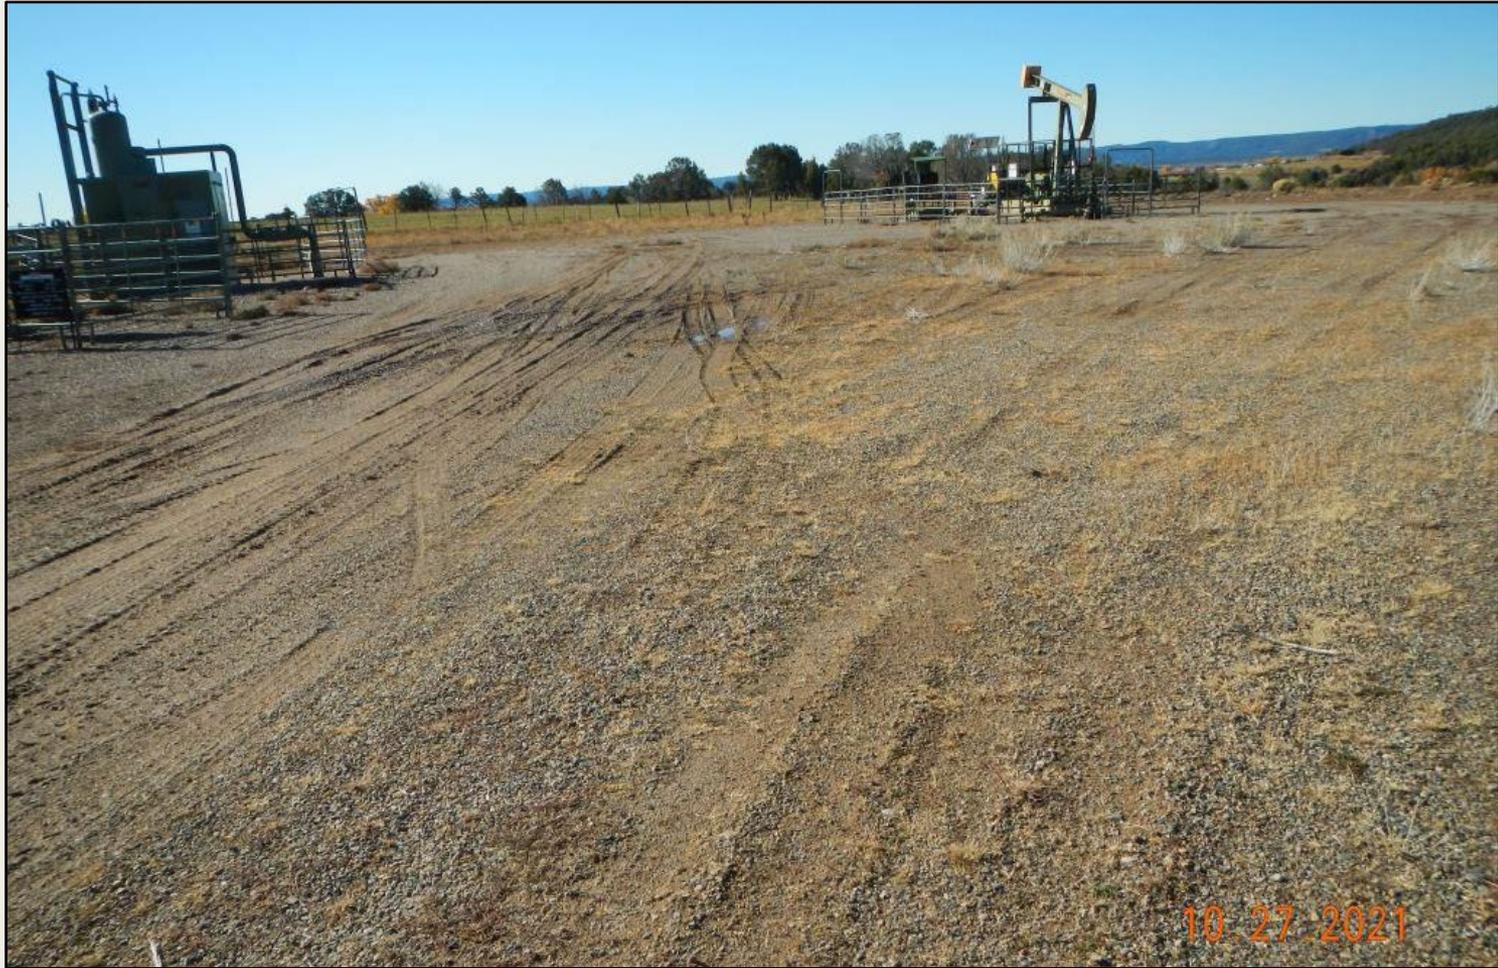
Photo 1. View of the project area from the well pad entrance facing center.

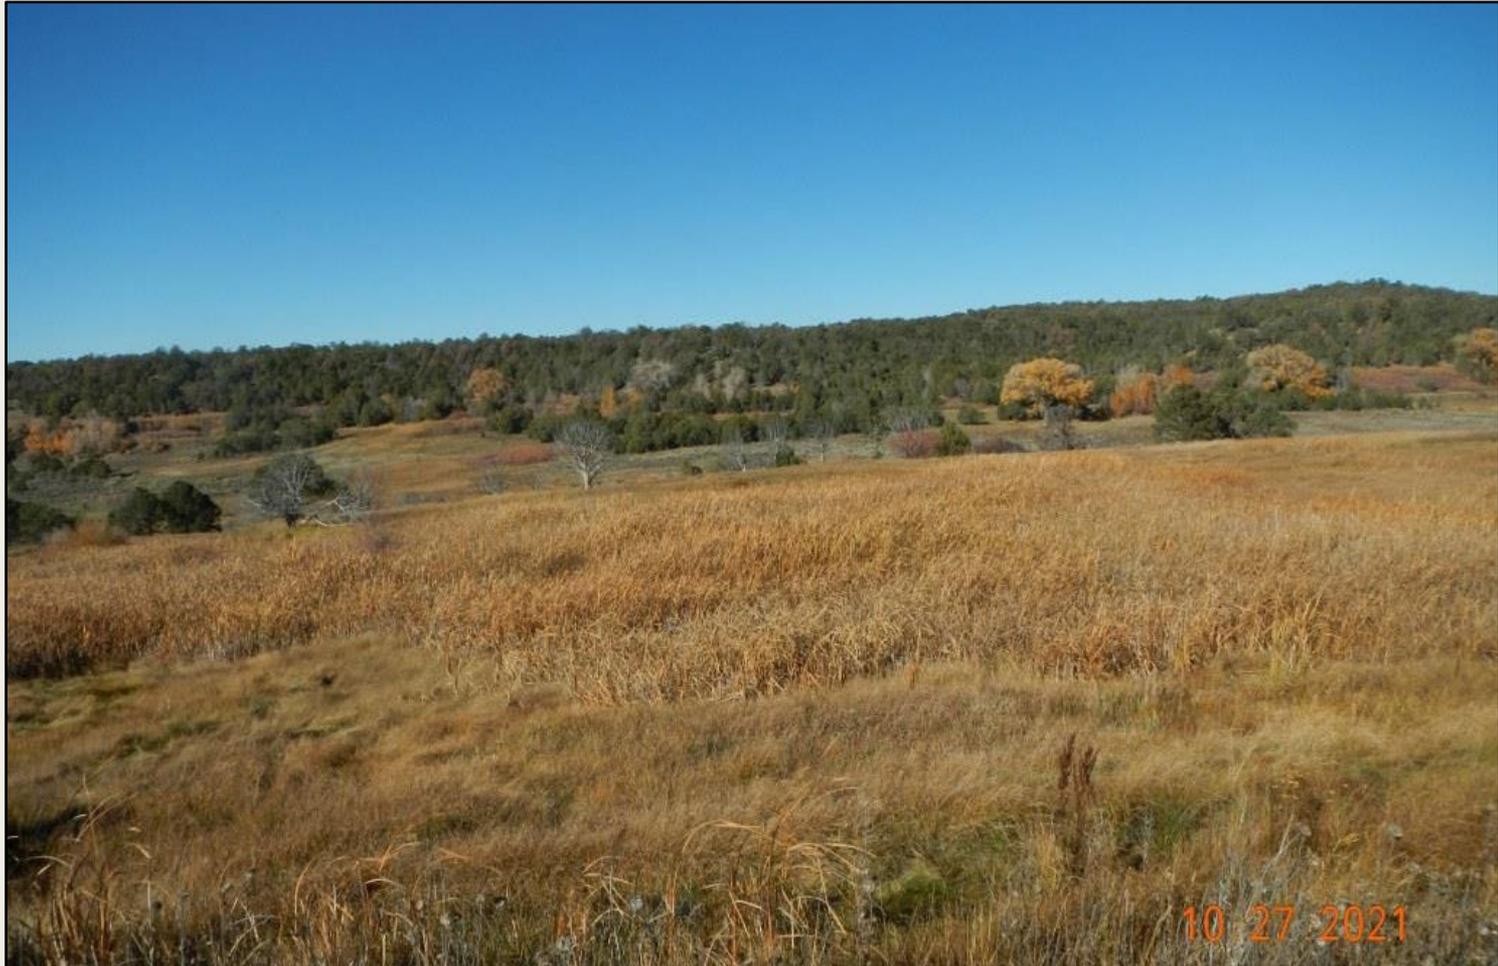
Photo 4. View of the reference area comprised of irrigated grass field with grasses such as meadow brome, orchard grass, perennial ryegrass, as well as wetland vegetation such as cattails, rushes, and foxtail barley.
