Location Name: Craig 8-1 Location ID/API #: 309619

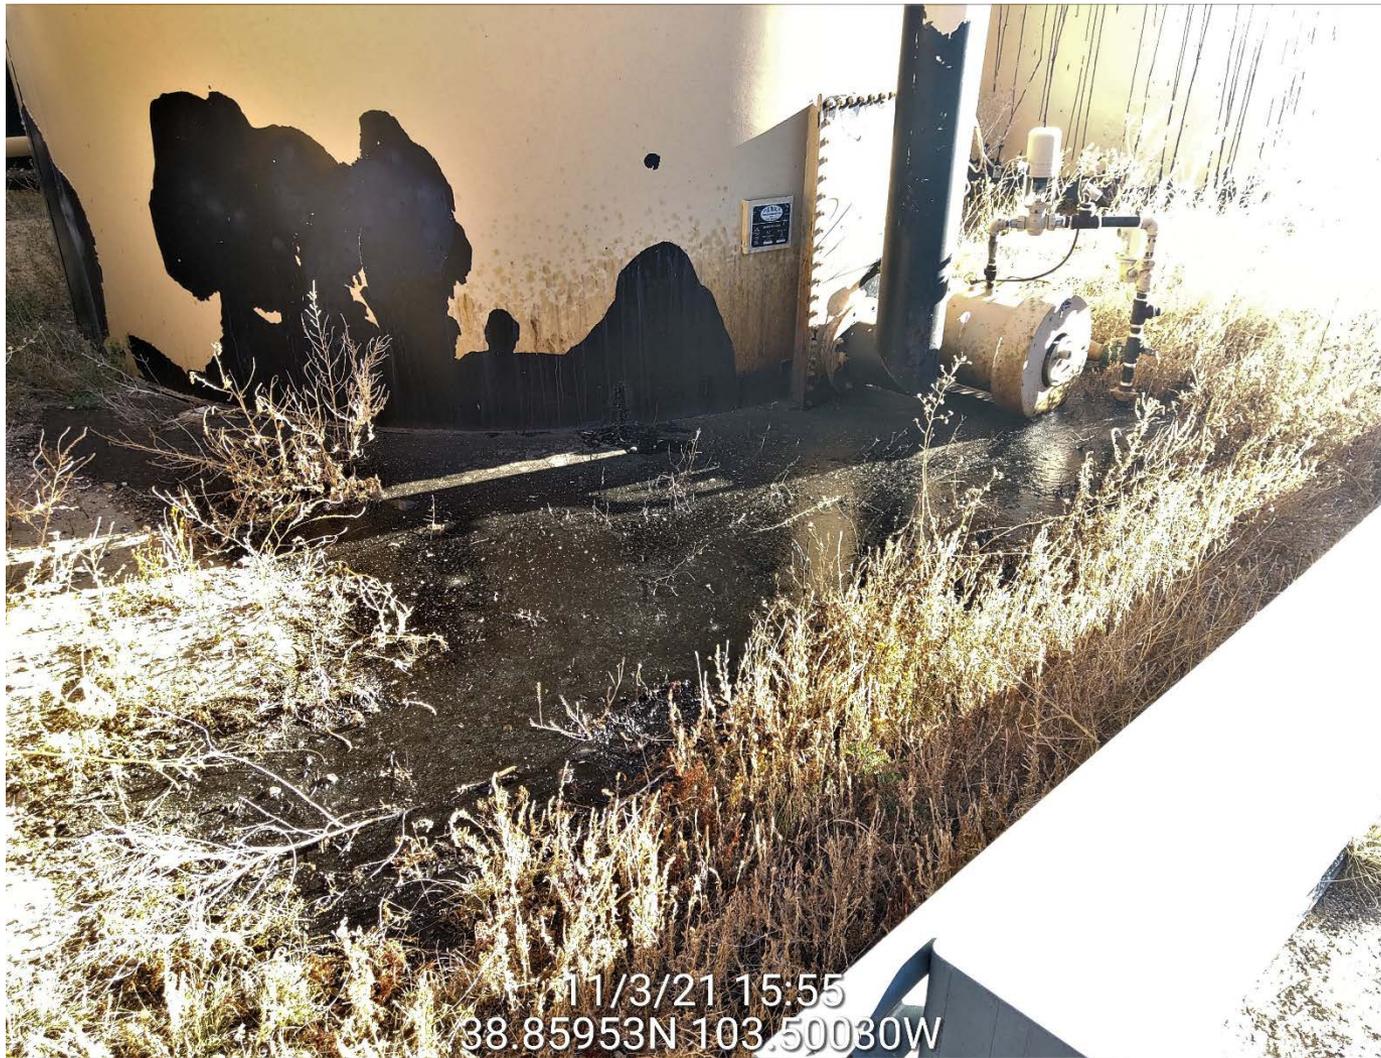
11/3/21 15:55
38.85953N 103.50030W

**Inadequate containment around tank battery. Gap between
containment wall and ground on corner of tank battery**
