Inspection Photos
Operator: Simcoe
API: 067-07722
Date: 1/27/2022

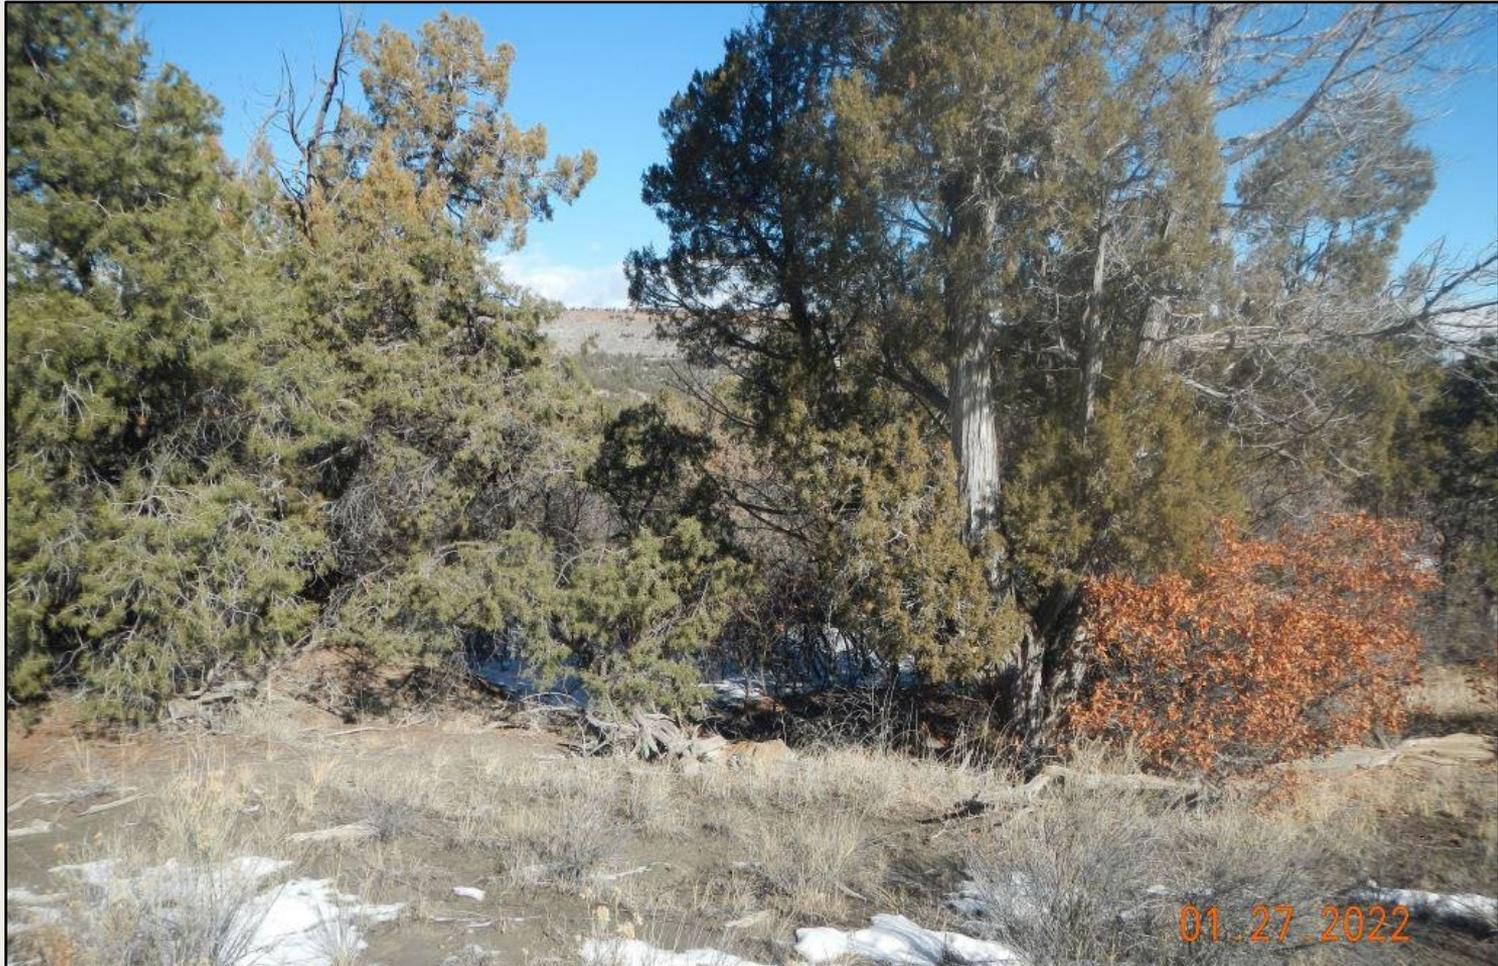
Photo 8. View of reference area comprised of pinyon and juniper woodland with gambel oak, yucca, Indian ricegrass, antelope bitterbrush, and mountain mahogany in the understory.
