Inspection Photos and Issue Report

7/14/2022

Operator: CHEVRON USA INC #16700

Facility #424210 (Location #324350)

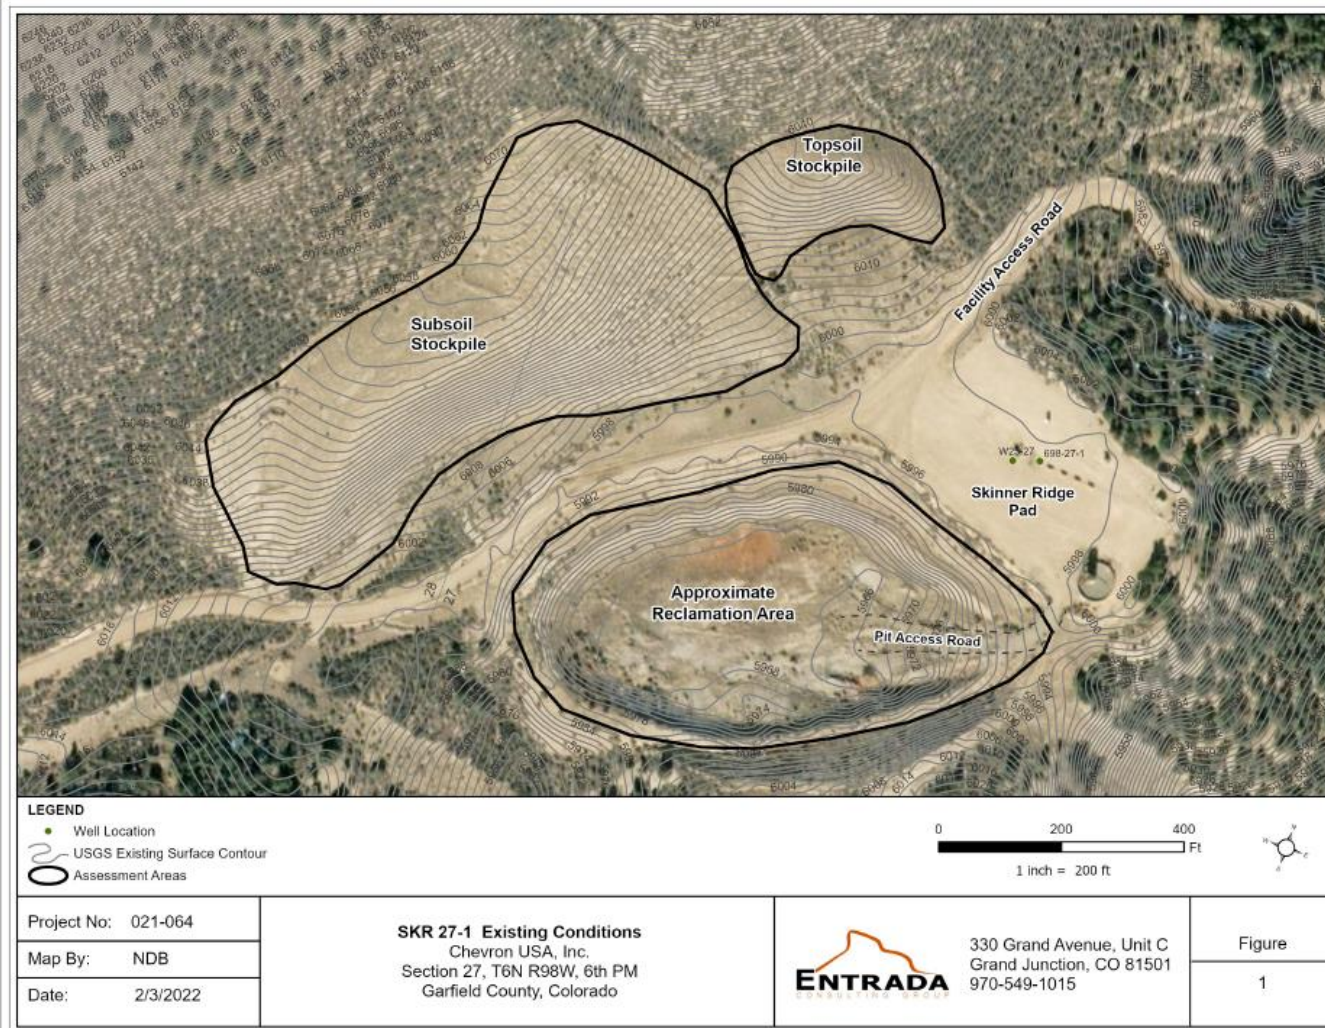
Figure taken from the 915.b request, reclamation plan (#402973868). Image provides an overview showing the location of the Pit Facility ("Reclamation Area"), subsoil stockpile, and the topsoil stockpile reclamation areas.
