April 12-14 API# 05-123-05372

Storm Water / Reclamation Location Status as of 3-26-23

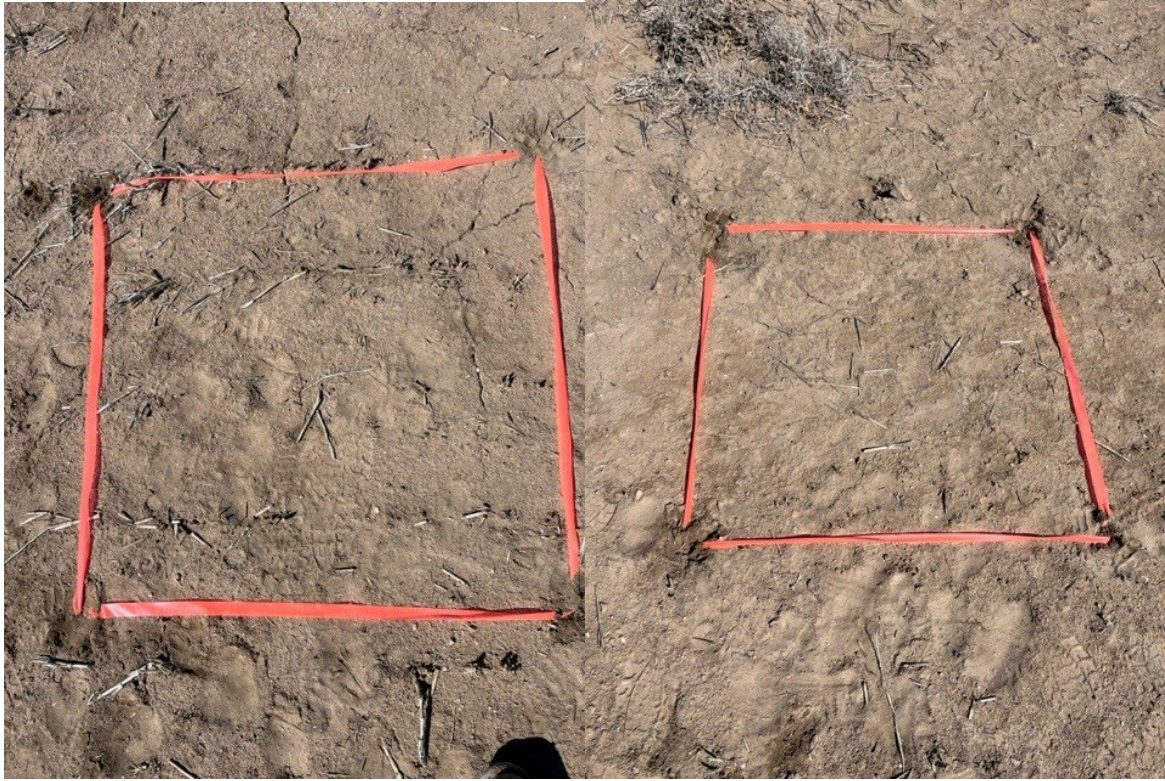
45' east of pad edge of disturbance

Current vegetation samples surrounding the April P&A'ed location and the existing tank battery. All taped areas are 36"+ (basically) square.
