Inspection Photos

Operator: LARAMIE ENERGY LLC #10433

Location Number: 335595

CC/0697-15-23 Pad, #335595 Issue Report

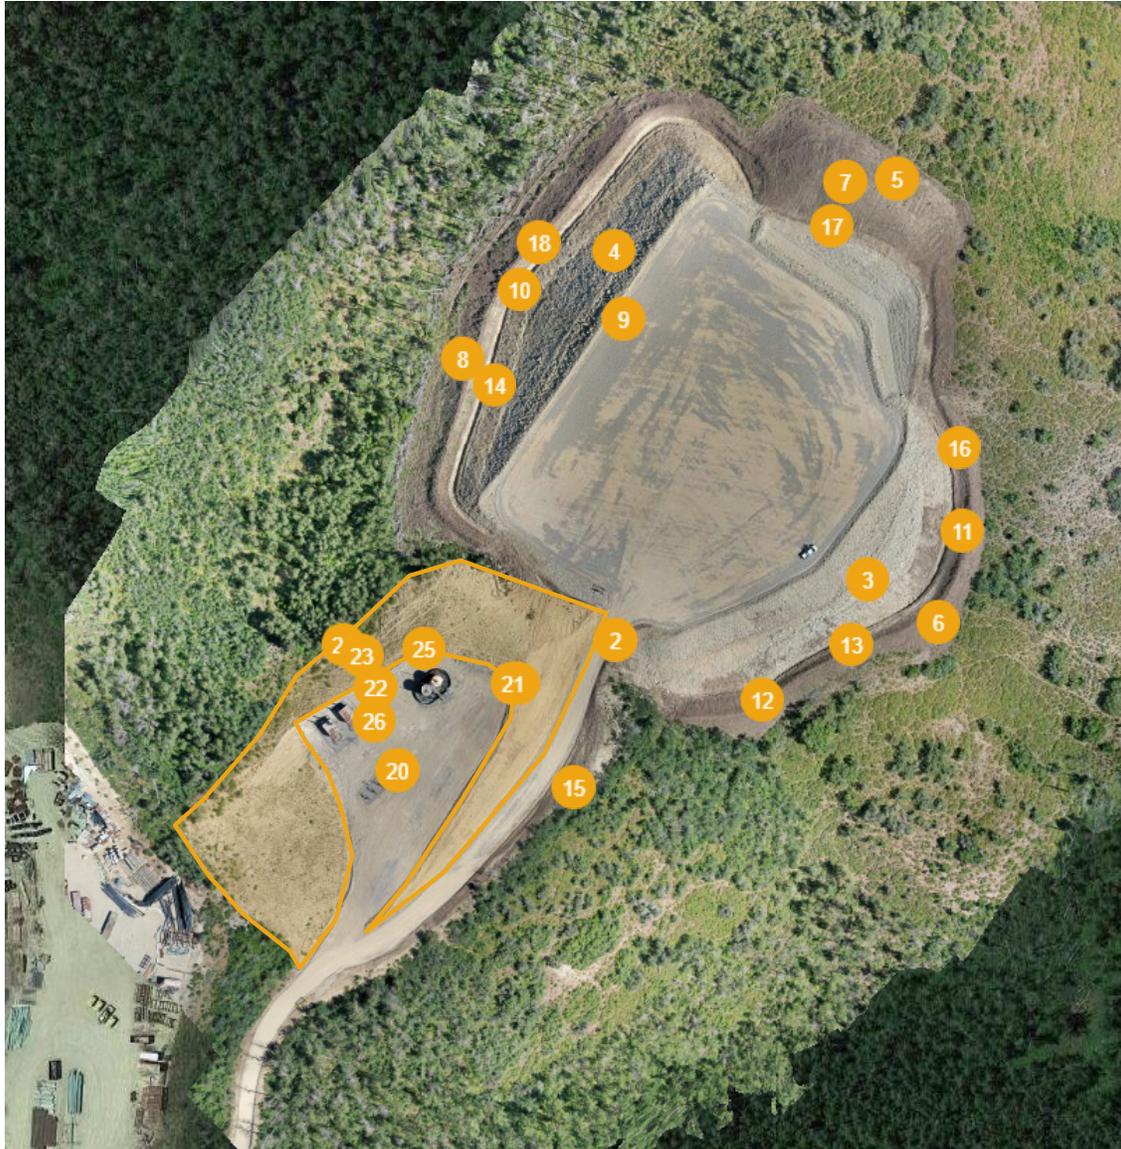
20 - Observation

Summary: Slopes predominantly bare and un stabilized. Stormwater and Erosion control measures to stabilize slopes, as well as and to manage runoff in a manner that minimizes erosion, degradation and sediment transport inadequate on the Location. Interim areas not progressing towards 1003 reclamation standards.
