**COLORADO**  
Energy & Carbon Management  
Commission  
Department of Natural Resources

REM 28246, Facility 116587 Date 4/9/24, all photos taken by ECMC Staff Kris Neidel

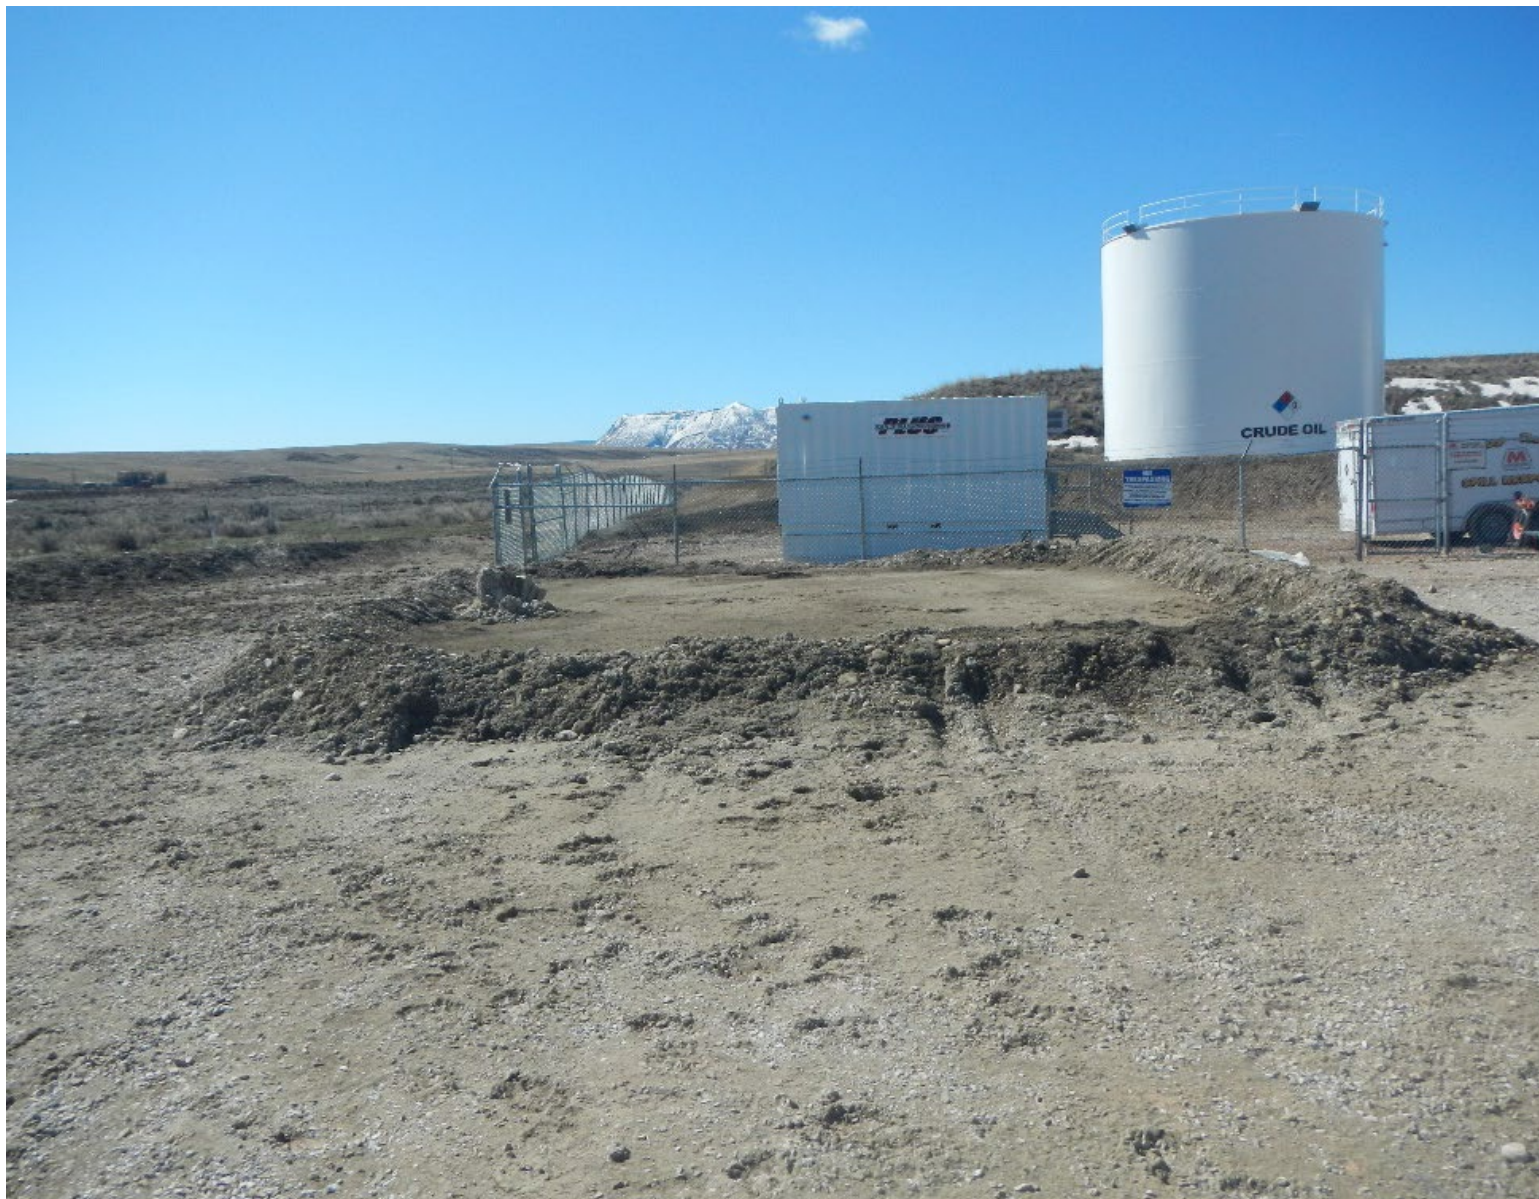
Photo #6 Photo taken on Marathon Iles Facility property. Surface water pooled, No hydrocarbon or other debris observed as a results of the 4/3/2024 Marathon tank overflow.

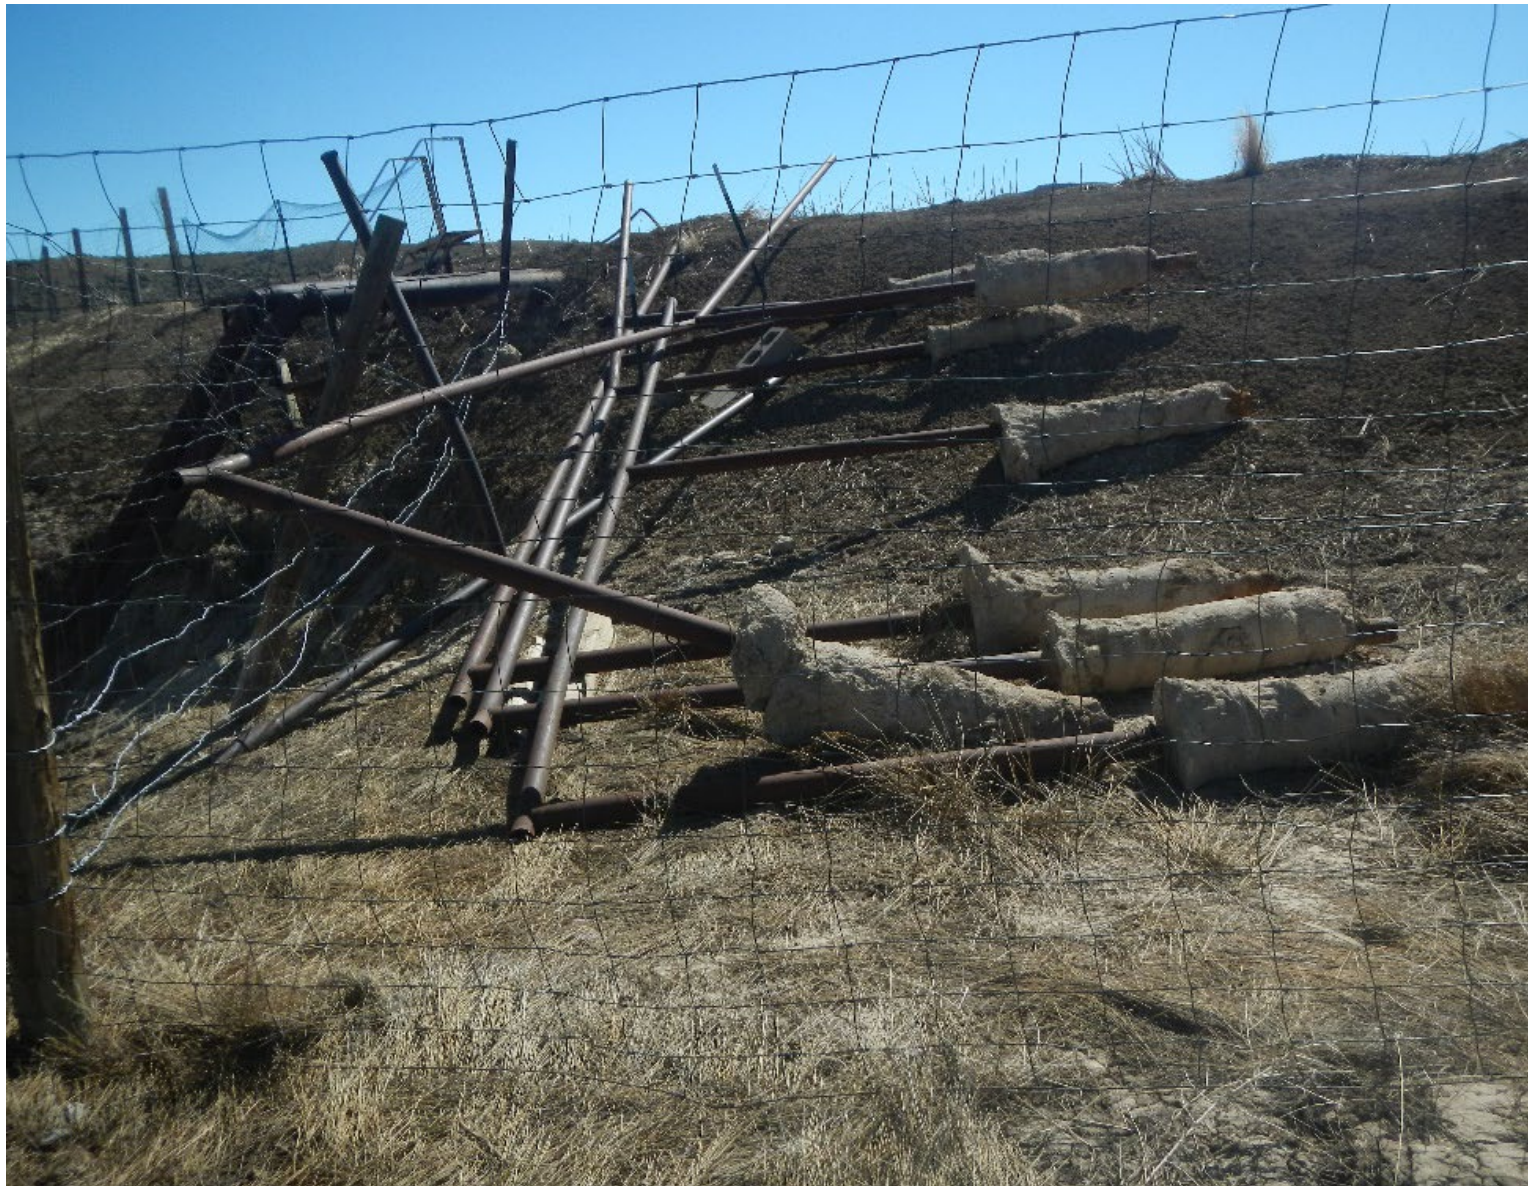
REM 28244, Facility 116587 Date 4/9/24, all photos taken by ECMC Staff Kris Neidel  
Photo #41 perimeter fence of pit facility 116587. Note: debris and trash.
