Construction and Stormwater Inspection

Operator: PROVIDENCE OPERATING LLC DBA POCO
OPERATING - 10694

Location ID: 451646

Inspection Photos
Location Name: Brighton Lakes 20-17
Location ID: 451646

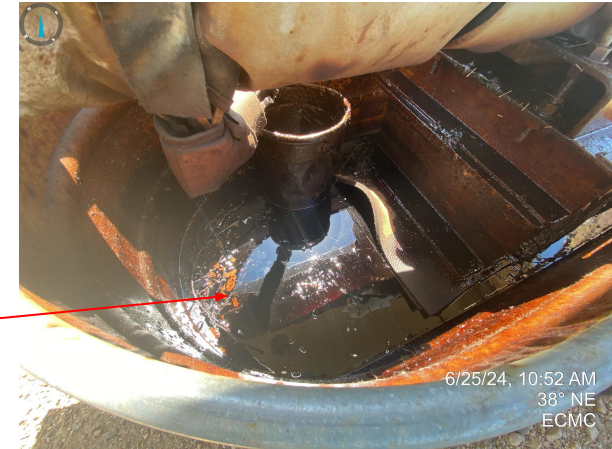
Photo 28. No wildlife netting observed around secondary containment on west end of location. Additionally, free fluids need to be properly removed and disposed of.
