# Inspection Photos

**Operator:** SWN PRODUCTION COMPANY LLC

**Location ID:** 313149

**Inspection Doc:** 696206163

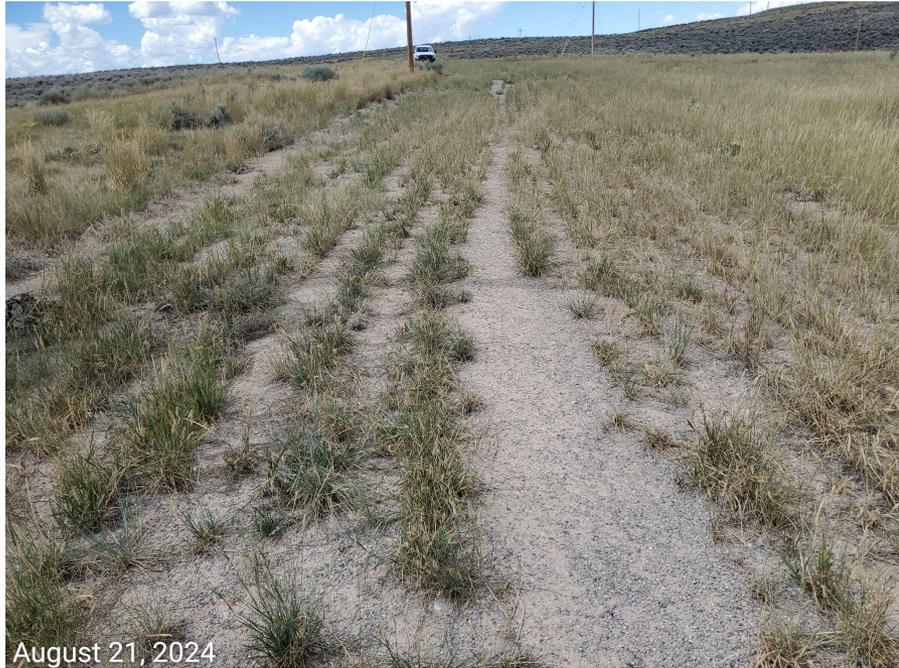
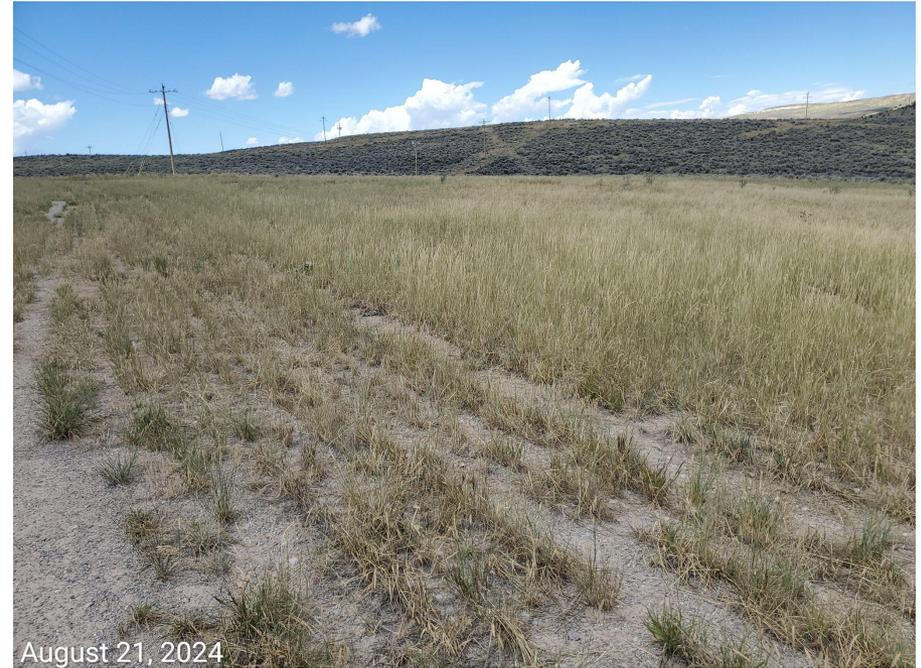
**Photo 9:** Photos 9-10 taken from the south end of the Pit Facility Location. Photos provide an overview from west, northwest, northeast to east.

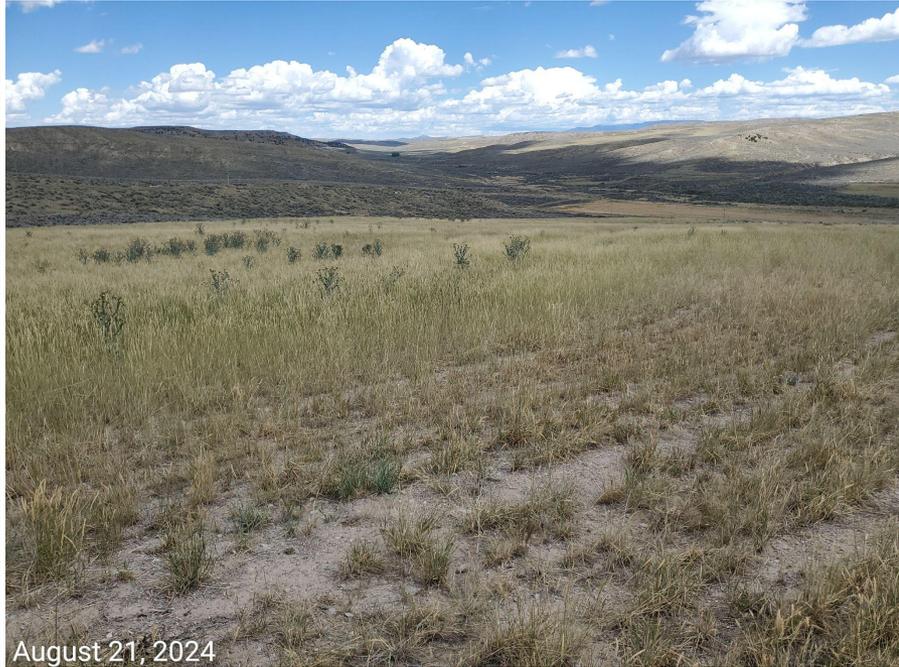
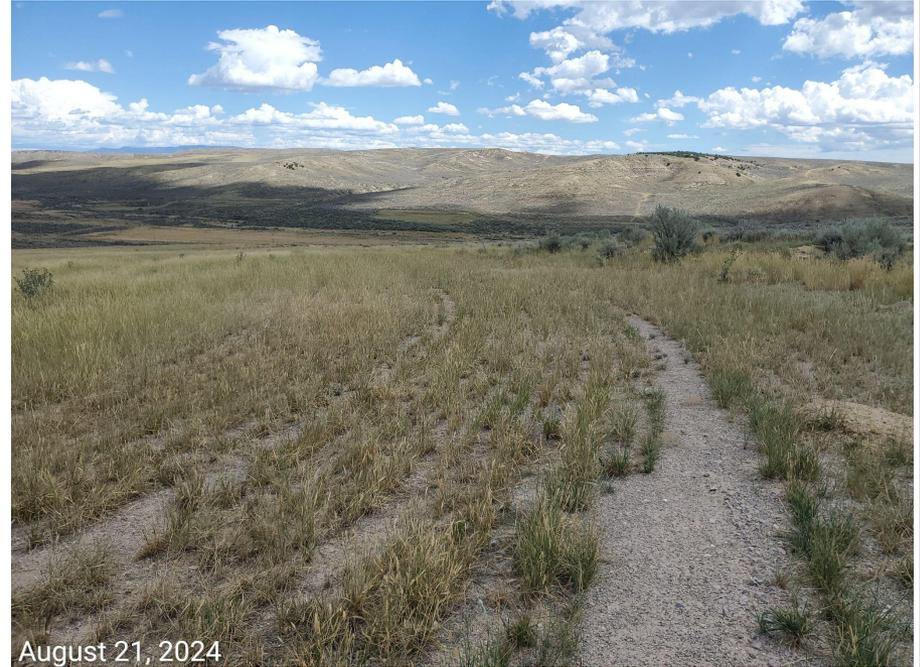
**Photo 10:** See comments under photo 9.

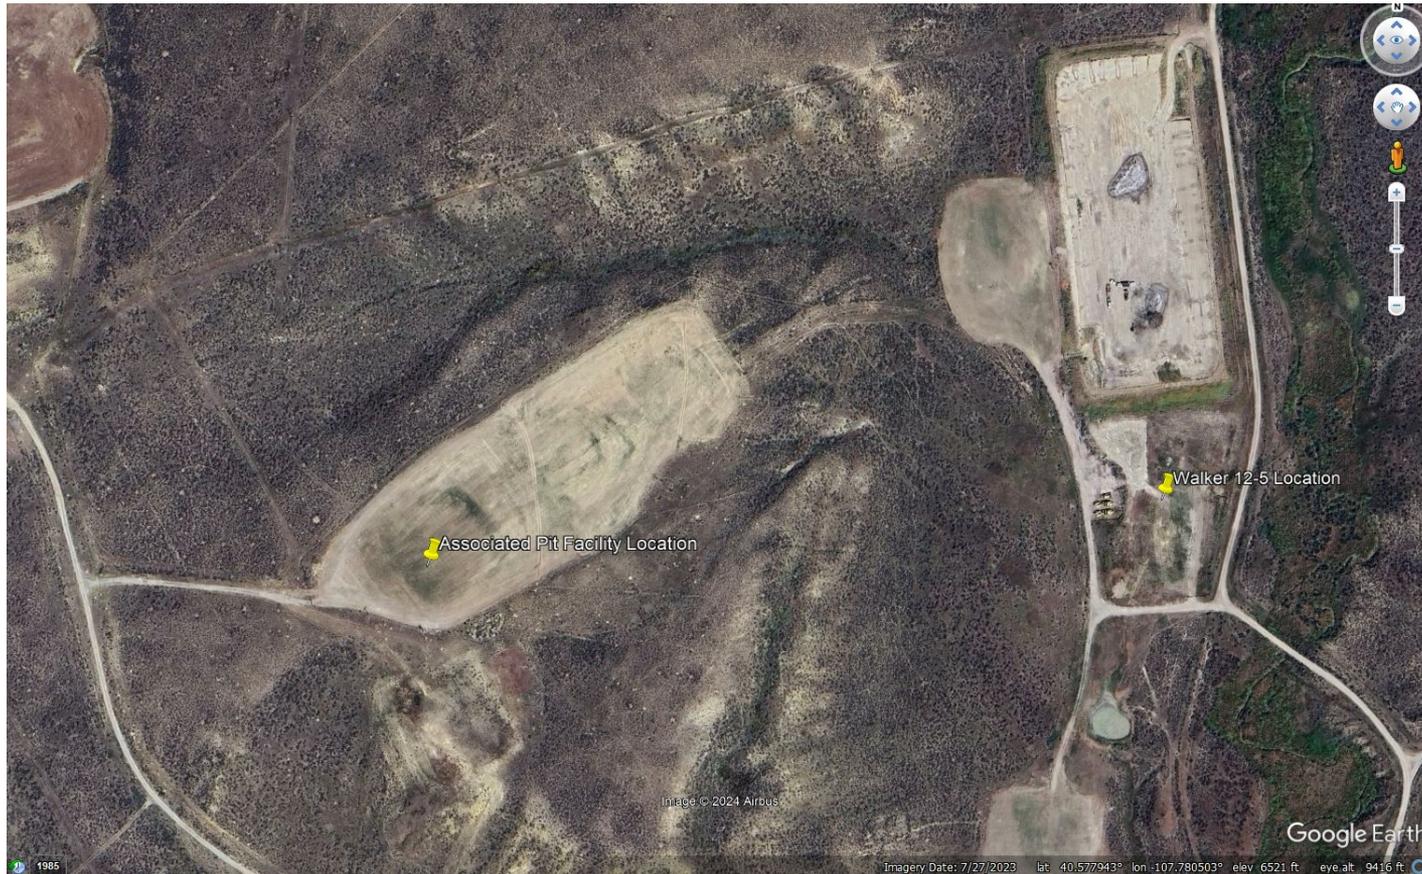
**Photo 15:** 2023 Google Earth Aerial Imagery. Photo shows the location of the Pit facility site associated with the Walker 12-5 Location.
