**Operator: 8 North**

**Location Name: EVERITT-611N61W 14NWSW**

**Loc ID: 302935**

**Inspection: 696300869**

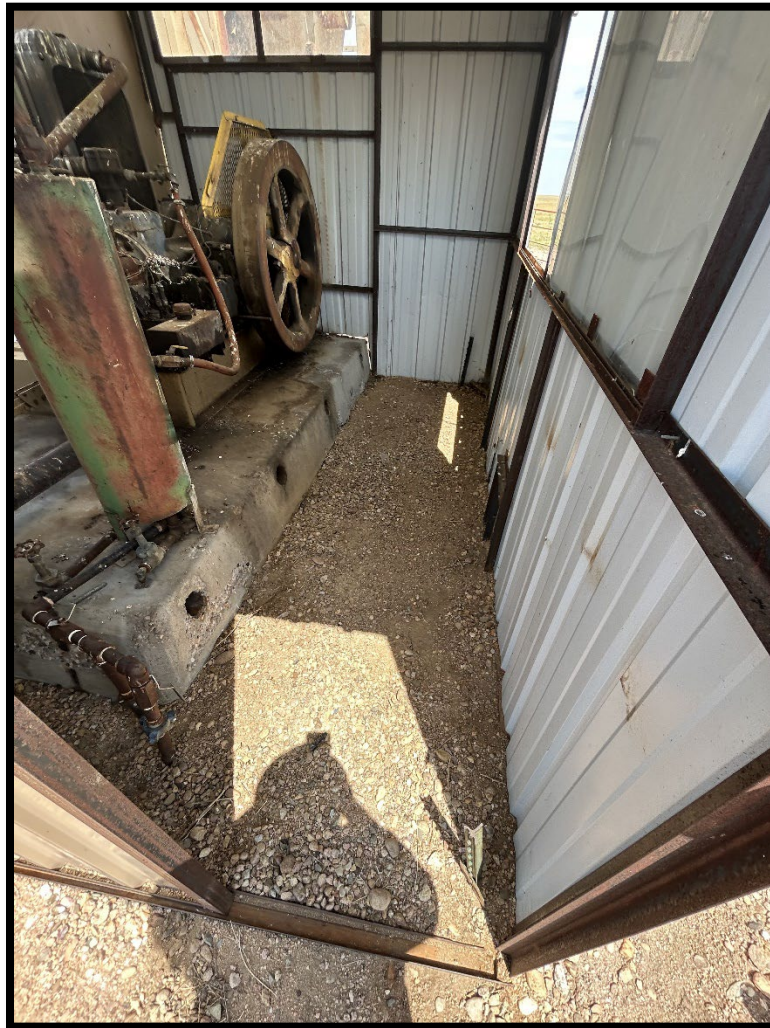
**CA:** Stained Soil at Gas Engine, see photo 3. Properly treat or dispose of oily waste in accordance with 907.e.

**CA Resolution:** Operator has provided photo evidence to show that the stained soil has been appropriately removed/cleared and mechanical issues leading to the leak have also been addressed.
