Inspection Photos

October 22nd, 2024

Operator: Simcoe LLC - 10749

Inspection Photos
Location Name: Bondad Ute 1-36 2
Location ID: 307021

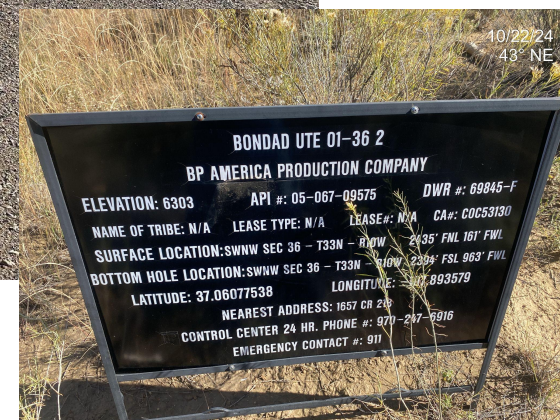
Photo 1. View of the well pad taken from the access point facing center. Note: well sign is not reflecting current operator.
