# SITE-SPECIFIC QUALITY ASSURANCE & QUALITY CONTROL AUDIT

## Final Reclamation Complete Notice – Cropland Drone Imagery

### PERMIT CLOSURE REPORT – CROPLAND

**Location Name** Hirsch Pad/29-C

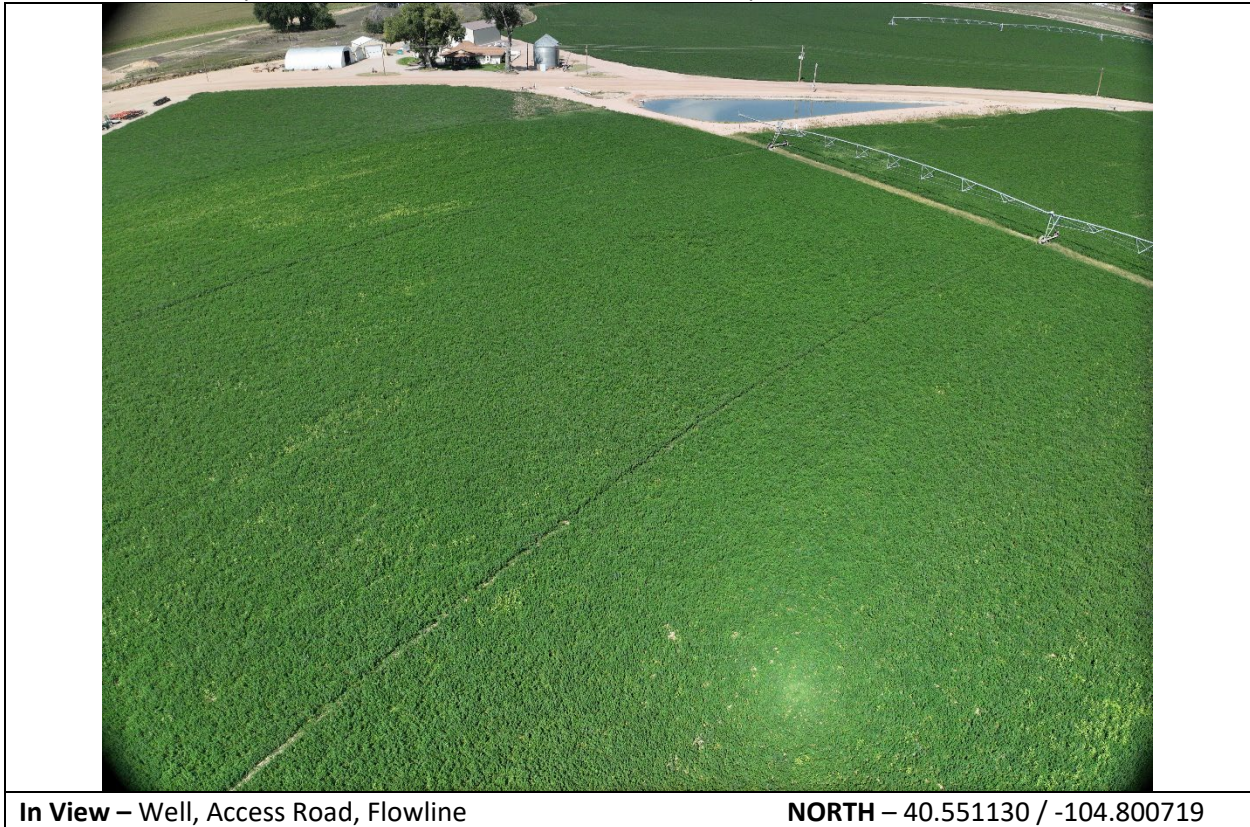
Cardinal directional photos of the site. Reference overview map.

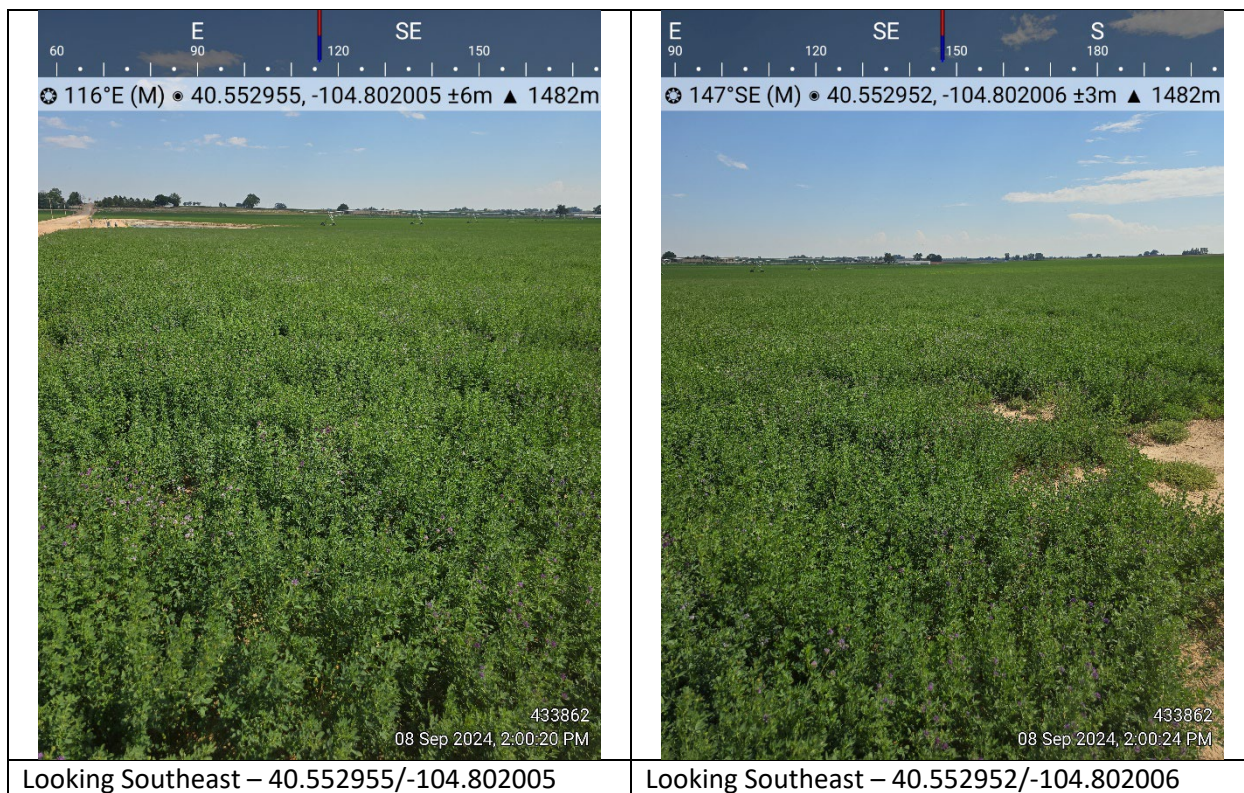
<p>433862 08 Sep 2024, 2:00:31 PM</p>
Alfalfa – 40.552946/-104.802026	Alfalfa – 40.552949/-104.802023

Handheld photos taken from the access road to the north looking Location ID [433862](#) wellhead.

No handheld photos taken from Location ID [433862](#) wellhead location due to crop height.
