# PCU FED/B27-197, #485795 Annotation Report

# PCU FED/B27-197, #485795 Field Note Report

**Operator:** CAERUS PICEANCE LLC - 10456

**Location ID:** 485795

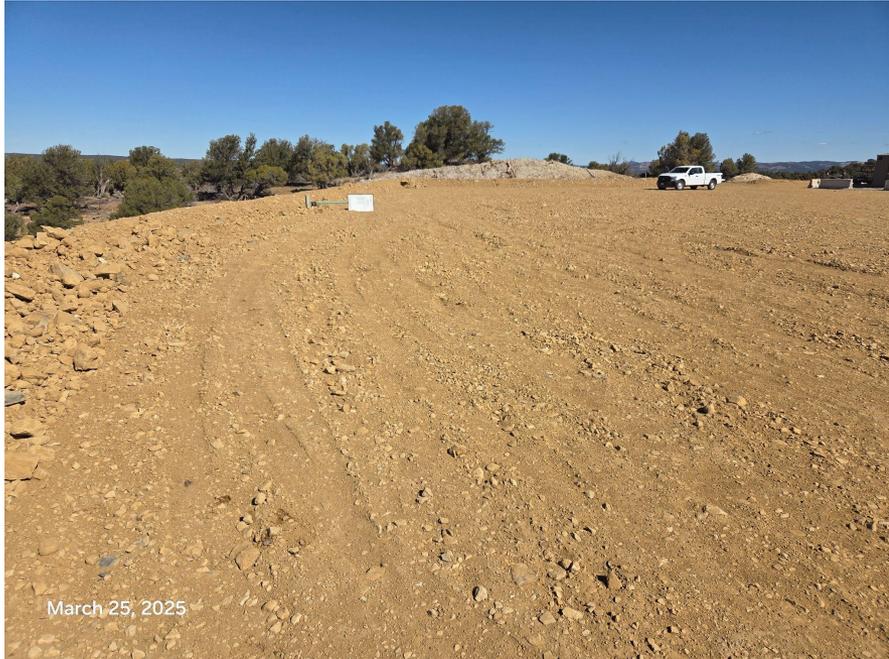
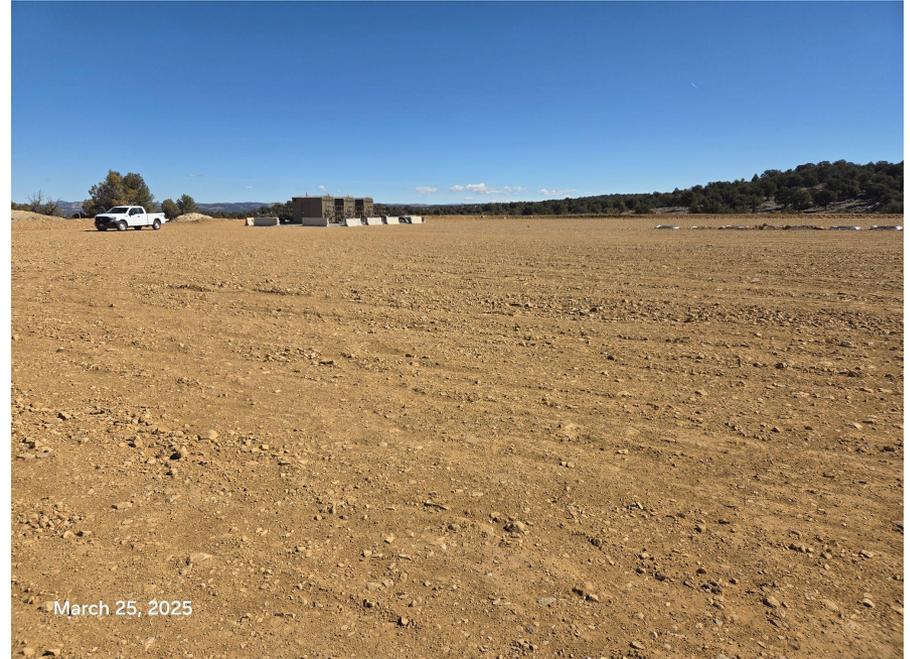
**Photo 2:** See comments under photo 2-3 taken from the west end of the Location. Photos provide an overview of the Location from north, northeast, southeast to south.

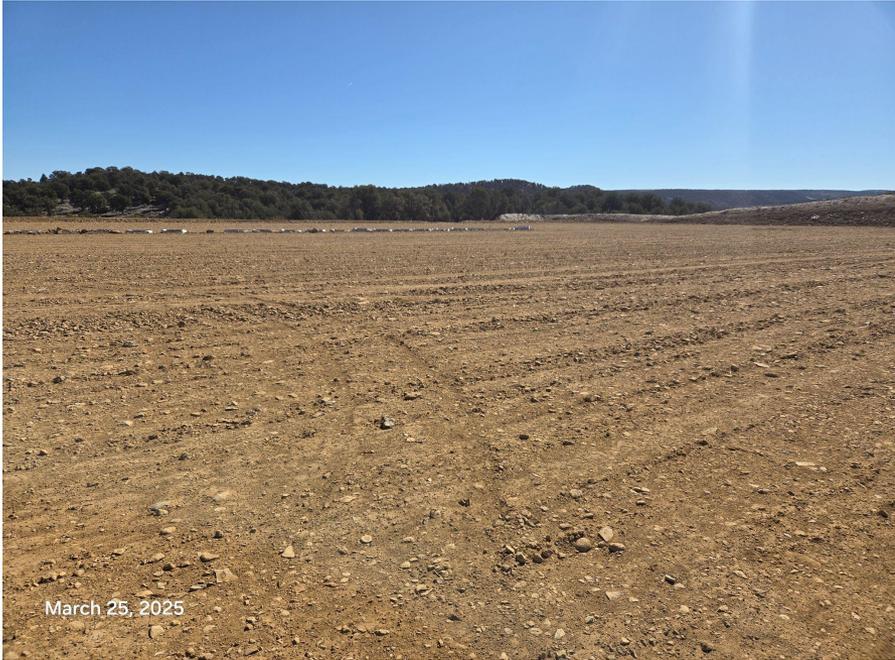
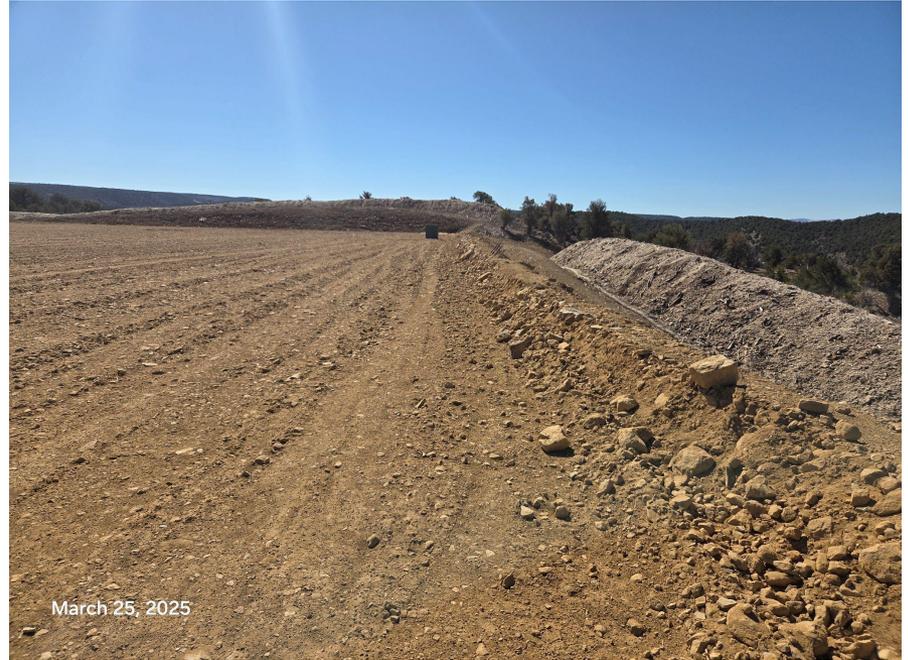
**Photo 3:** See comments under photo 2.

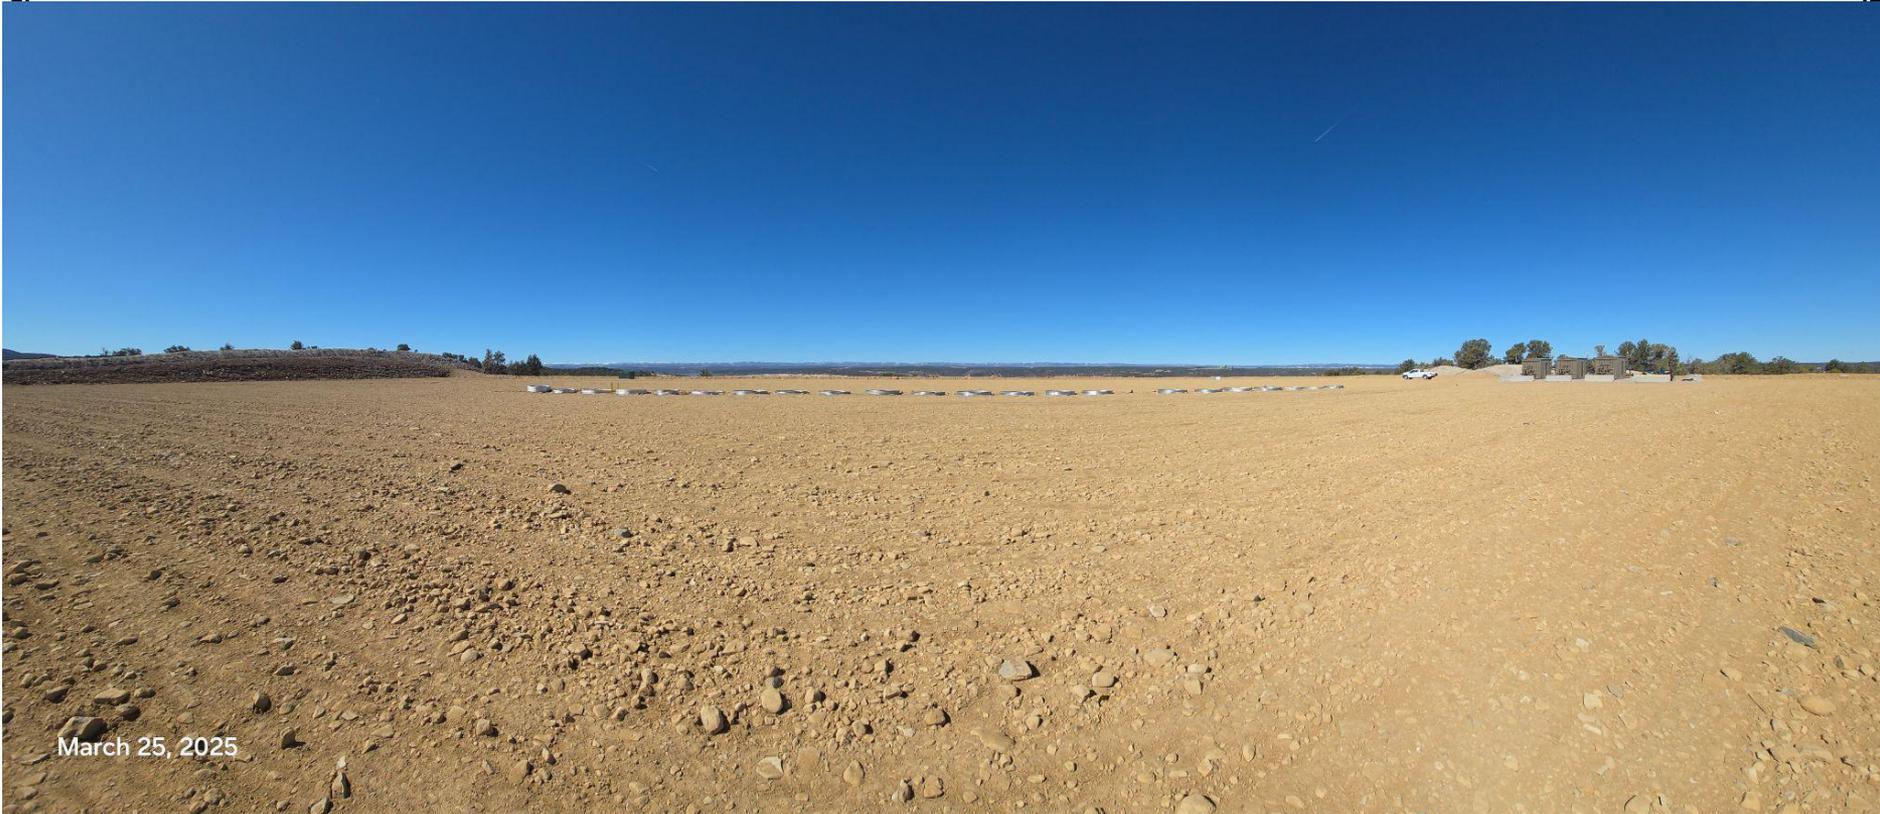
**Photo 5:** Photo taken from the east end of the Location, facing west. Photo shows conductors set on the Location.

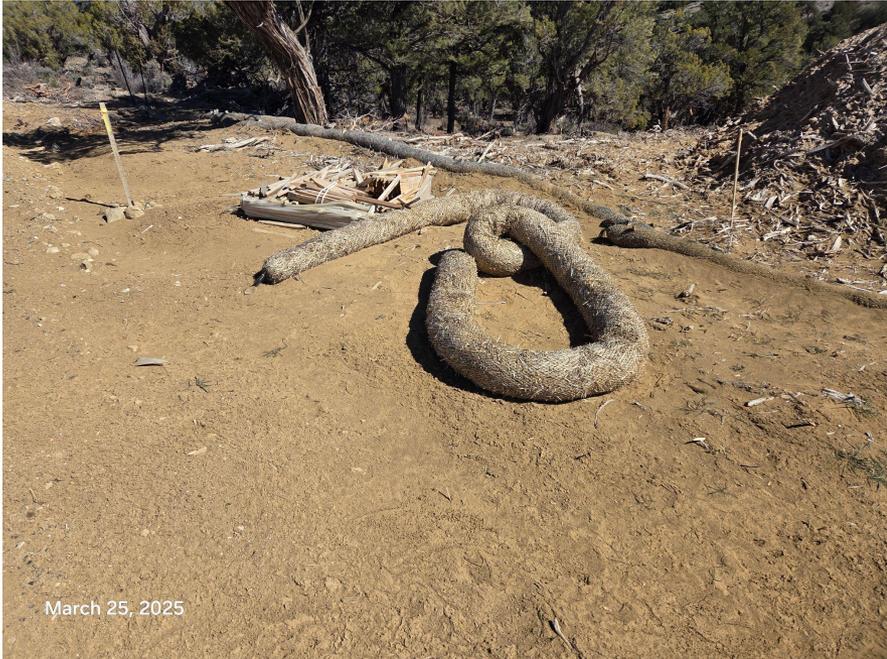
**Photo 6:** Photo shows unused erosion log, stakes and pallet stored on the north end, and the cut slopes at the south end of the Location.

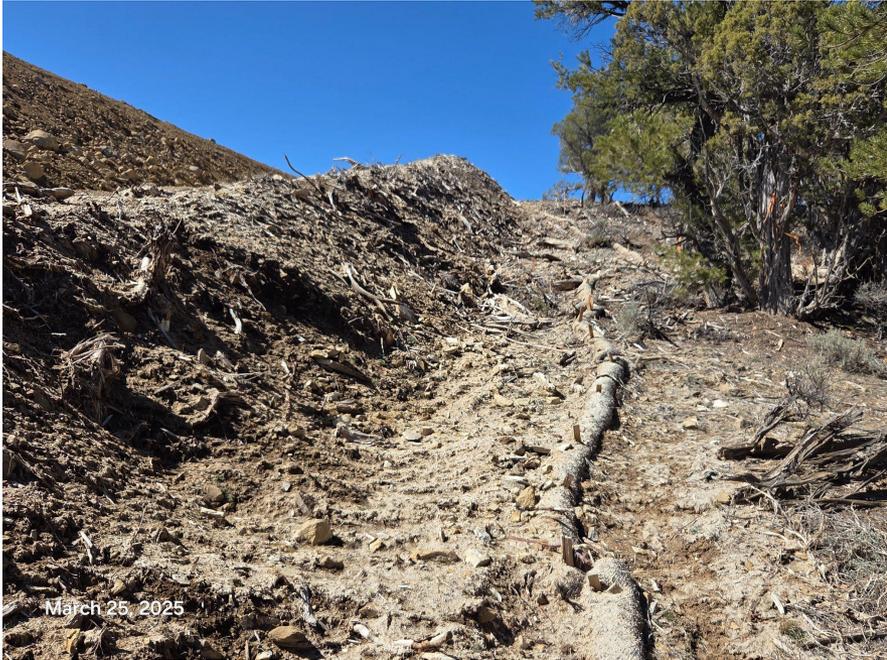
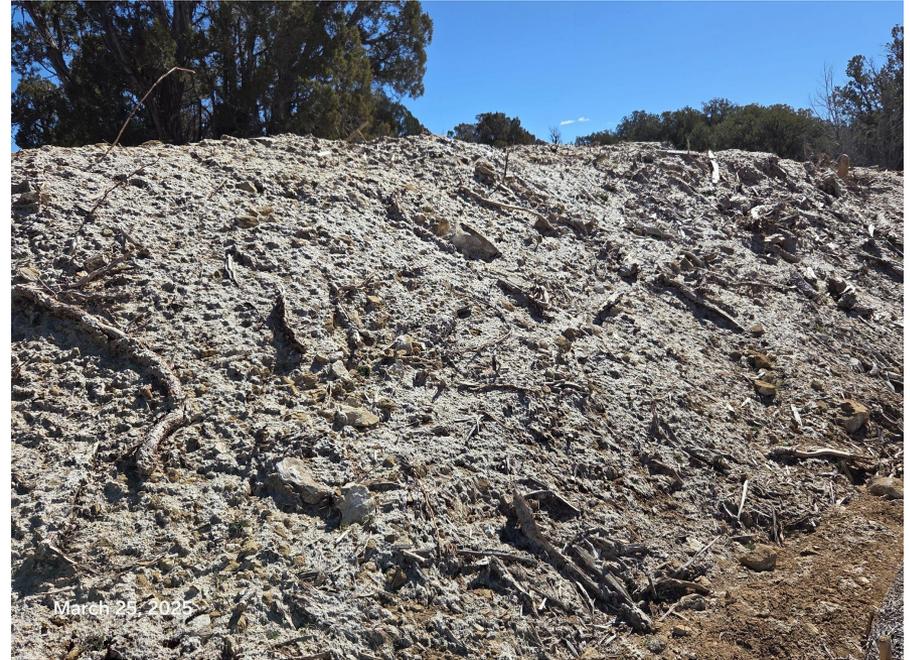
**Photo 17:** Photos taken from the topsoil stockpiles on the south and north ends of the Location; hydromulch at these stockpiles appeared to be in proper functioning condition at time of inspection.

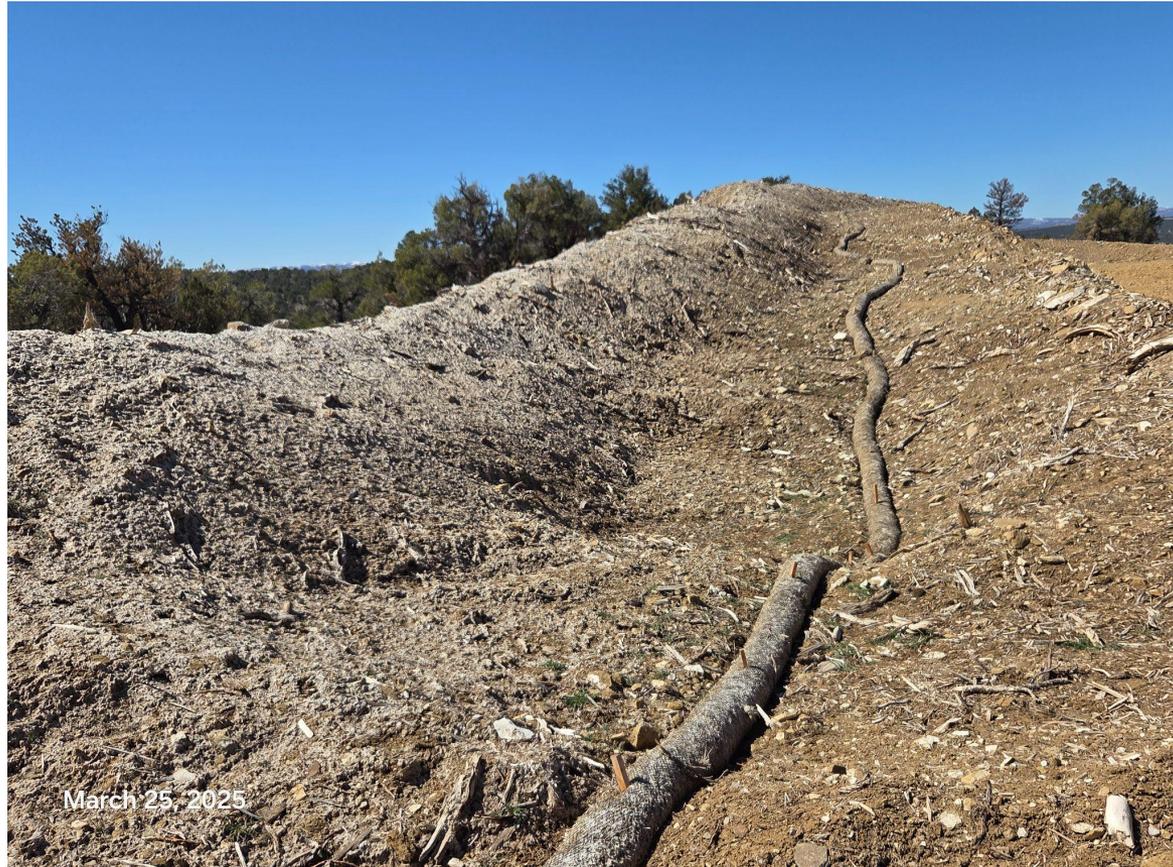
**Photo 18:** See comments under photo 17.

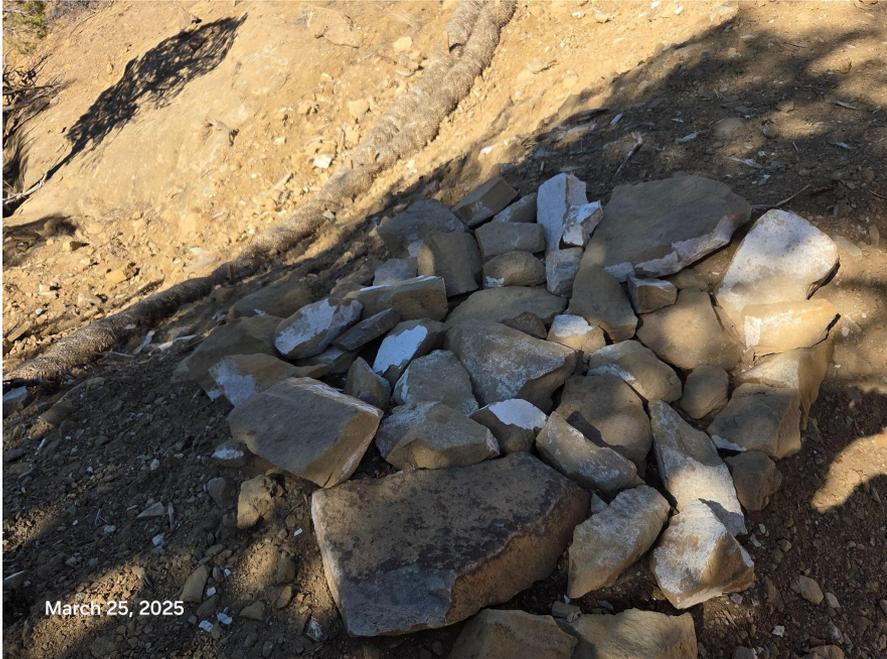
**Photo 21:** Photos taken from the sediment trap on the northeast end of the Location. Sediment traps on the Location have not been installed with a properly engineered outlet. Outlets at the Northwest and southwest sediment traps are inadequate in size; the slopes at the outlets are only partially armored; soils below the outlets are loose, unconsolidated soils. Additionally, outlets at all three traps have not been constructed with geotextile lining in conjunction with the rip-rap material per good engineering practice.

**Photo 23:** Photos taken from the sediment trap on the northwest end of the Location. See comments under photo 21. Photo right example showing outlets at all three traps have not been constructed with geotextile lining in conjunction with the rip-rap material per good engineering practice.

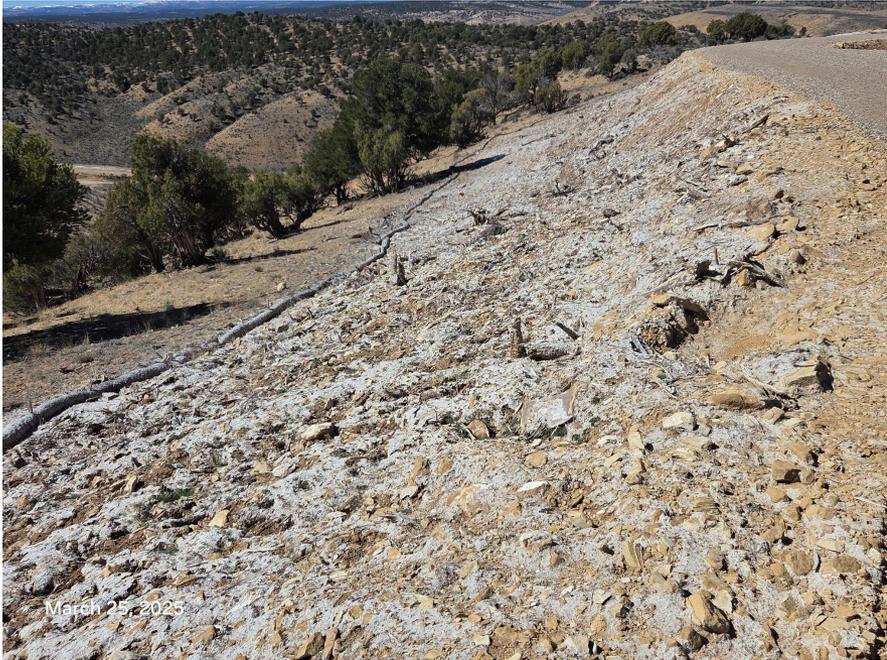
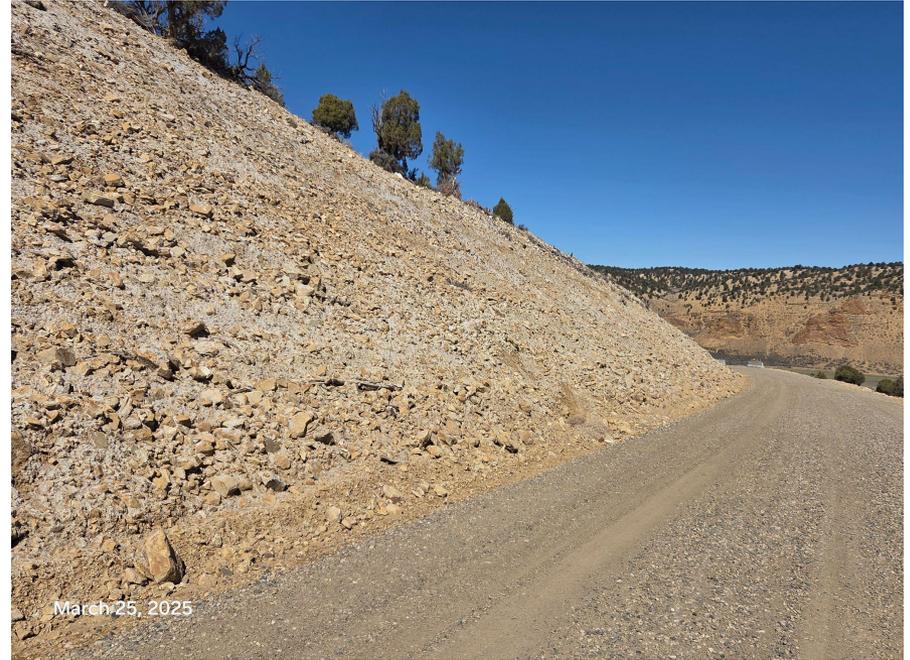
**Photo 28:** Photos taken from the access road. Photos examples showing hydromulch applied to the cut and fill slopes of the road.
