Inspection Photos

Operator: TEP ROCKY MOUNTAIN LLC #96850

Location ID: 323868

Inspection Doc: 718100399

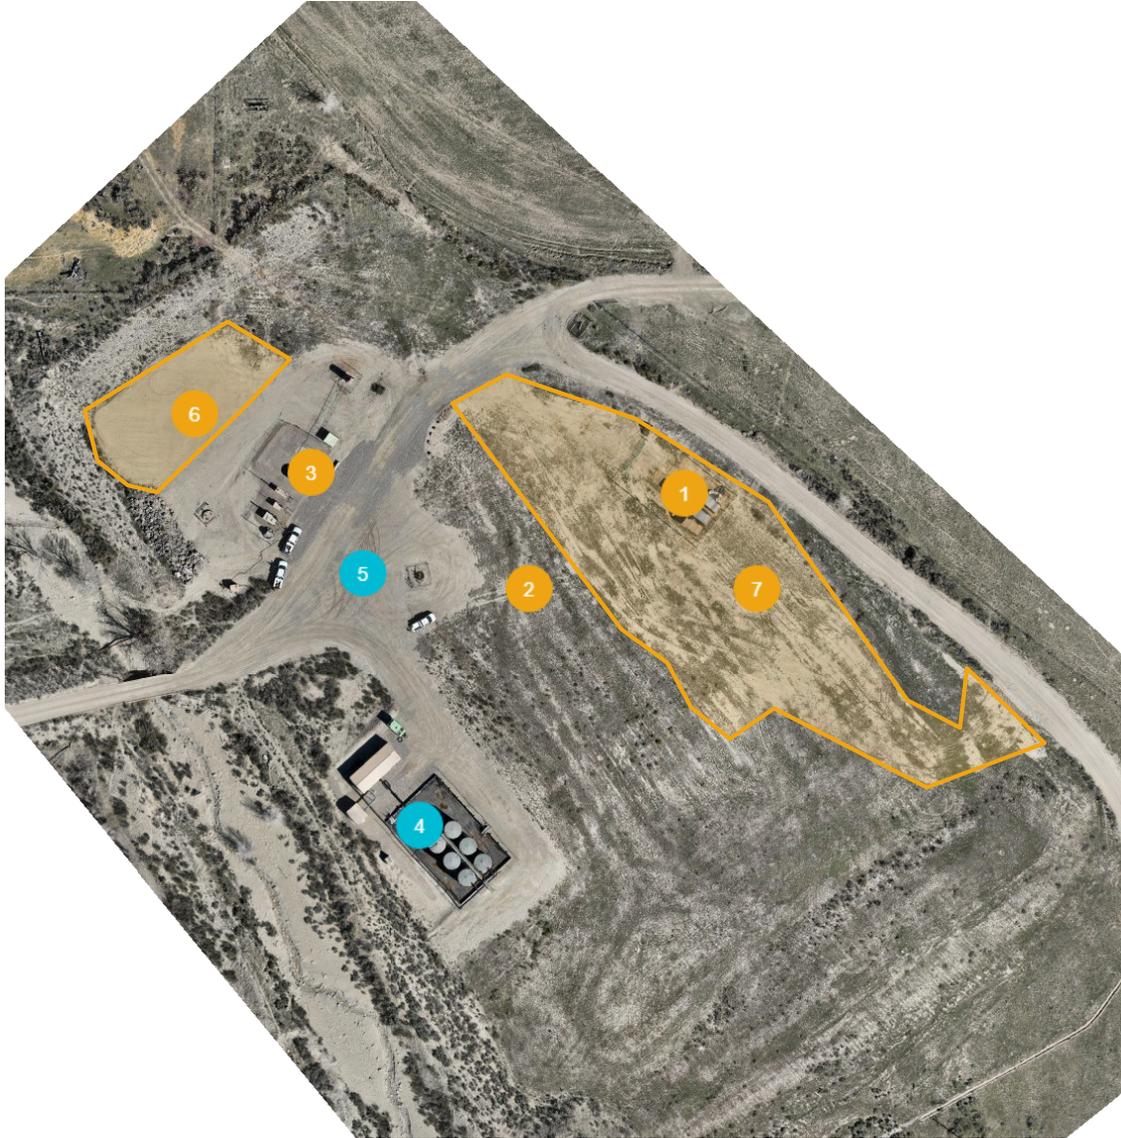
Hay storage on Interim Areas	-1.49 US ft	39.4922546, -107.8588649	1612824.9 US ft, 2334366.6 US ft
2

Tracking	-3.84 US ft	39.4920518, -107.8592894	1612754.1 US ft, 2334244.9 US ft
3

Secondary Containmnet	-3.20 US ft	39.4922975, -107.8598857	1612847.9 US ft, 2334079.0 US ft
4

Temporary Juhan Booster Station	0.08 US ft	39.4915526, -107.8595914	1612574.5 US ft, 2334155.0 US ft
5

Tracking controls show disrepair.	-3.60 US ft	39.4920838, -107.8597478	1612769.1 US ft, 2334115.9 US ft

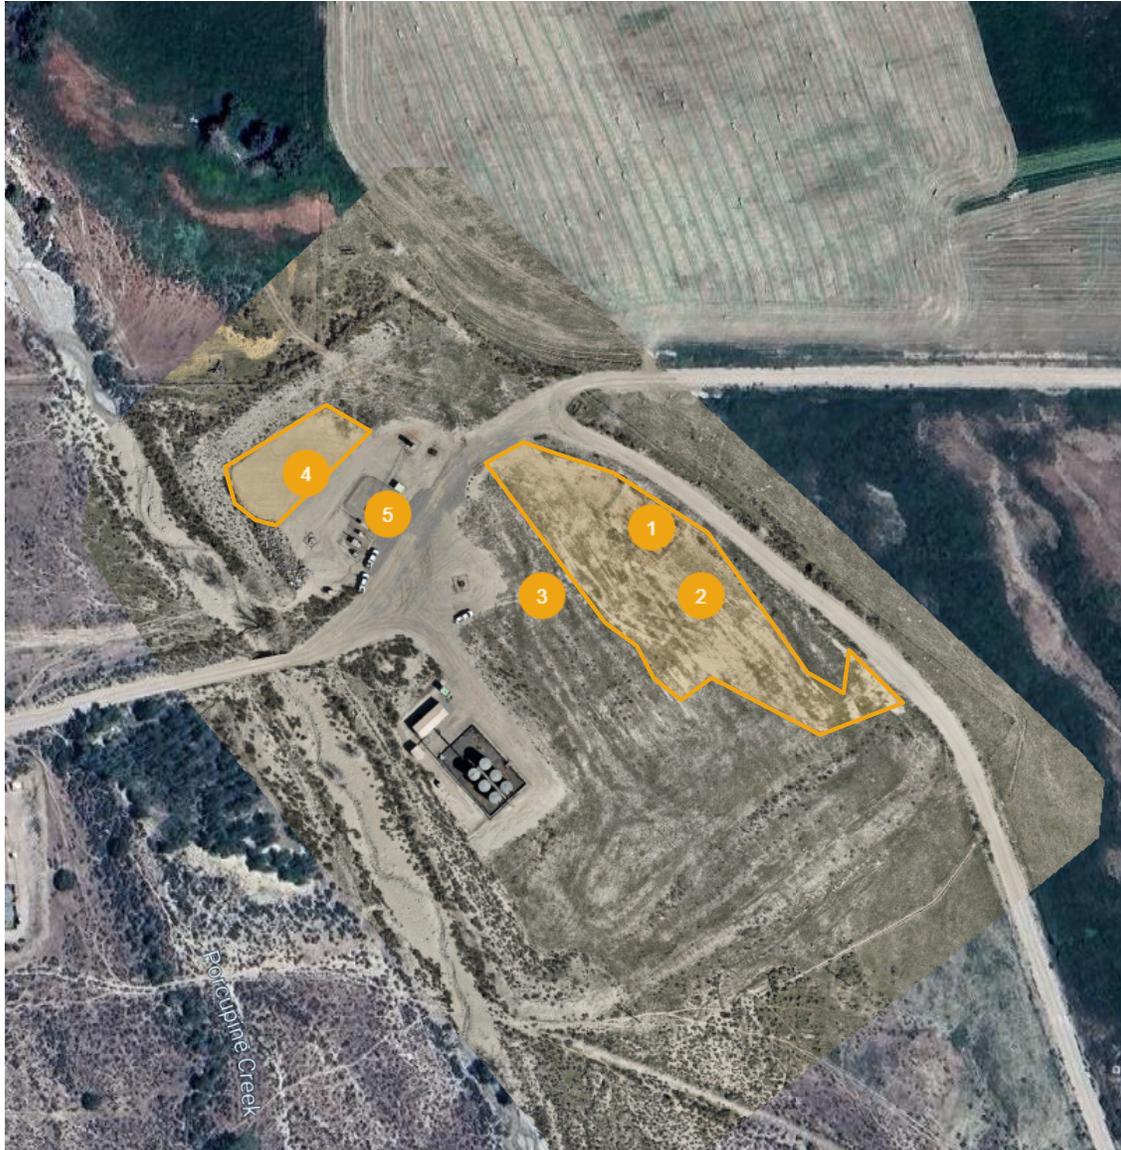
5 - Observation

Wildlife protection BMPs missing or insufficient.
