Inspection Photos

Operator: BLACK HILLS PLATEAU
PRODUCTION LLC - 10150

Location ID: 312420

Inspection Doc: 718100478

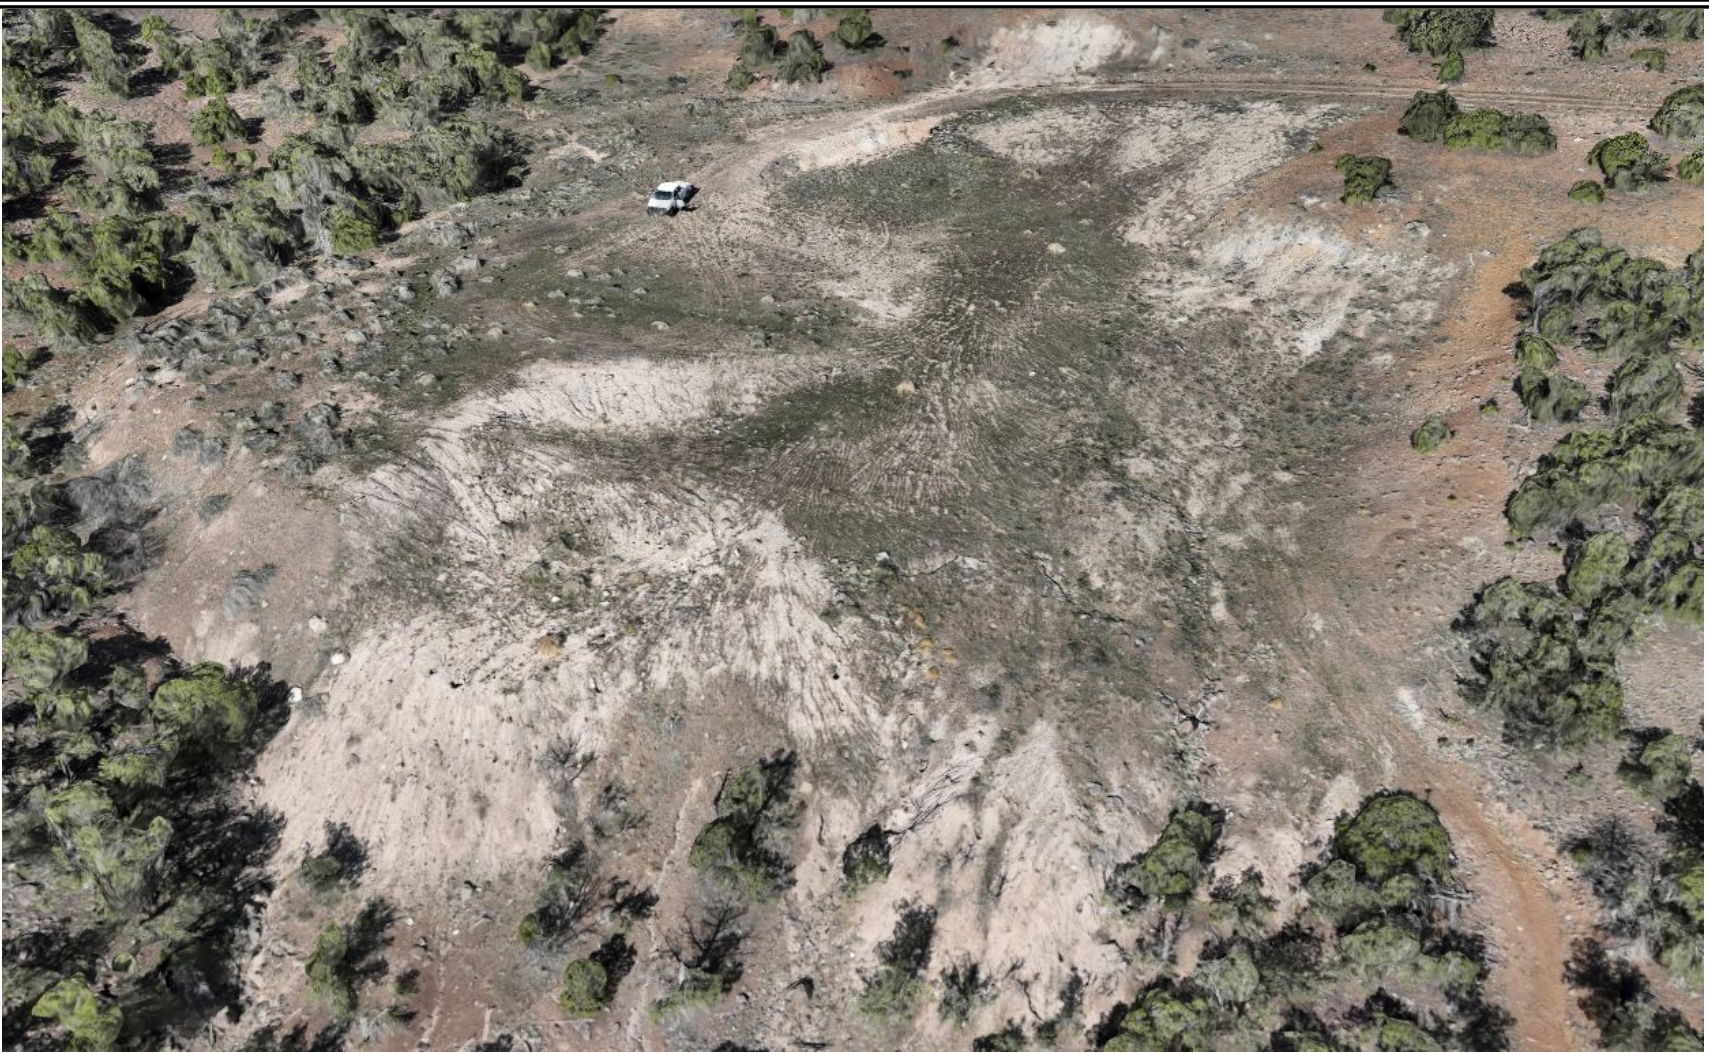
Photo 22: 3D model of the Location developed with use of a sUAS- imagery dated 4/14/2025. Imagery taken from the northeast of the Location facing southwest.

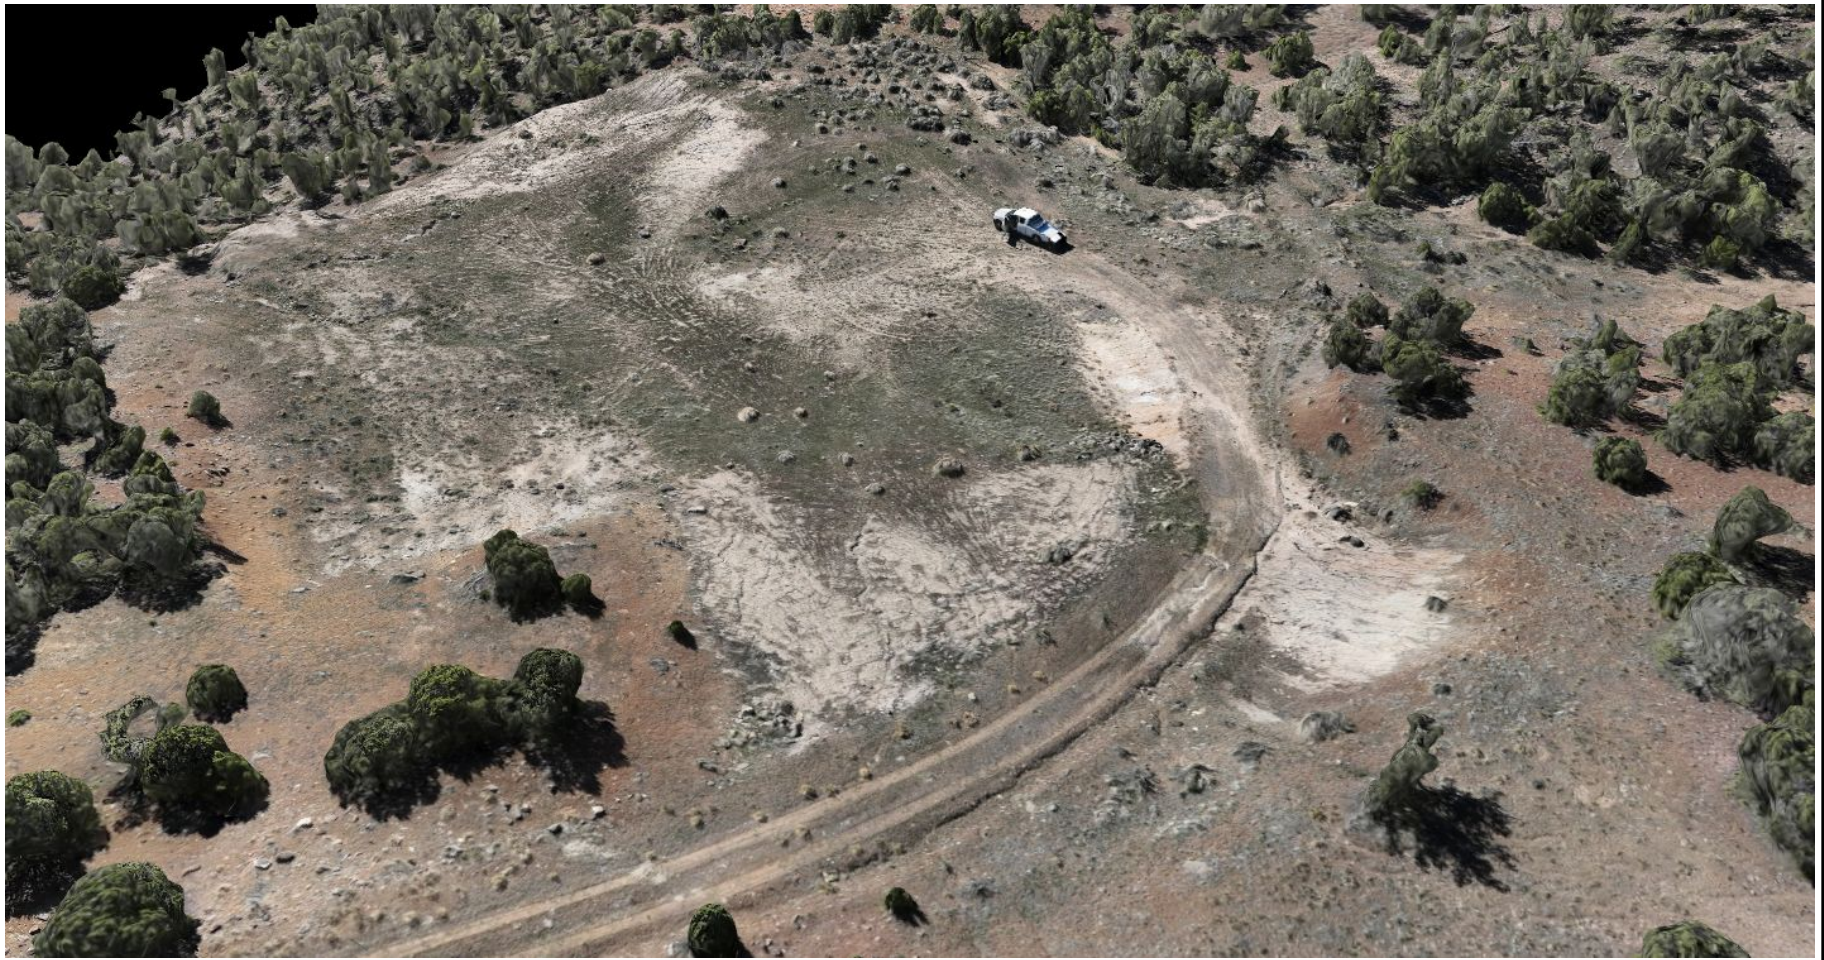
Photo 23: 3D model of the Location developed with use of a sUAS- imagery dated 4/14/2025. Imagery taken from the northwest of the Location facing southeast.

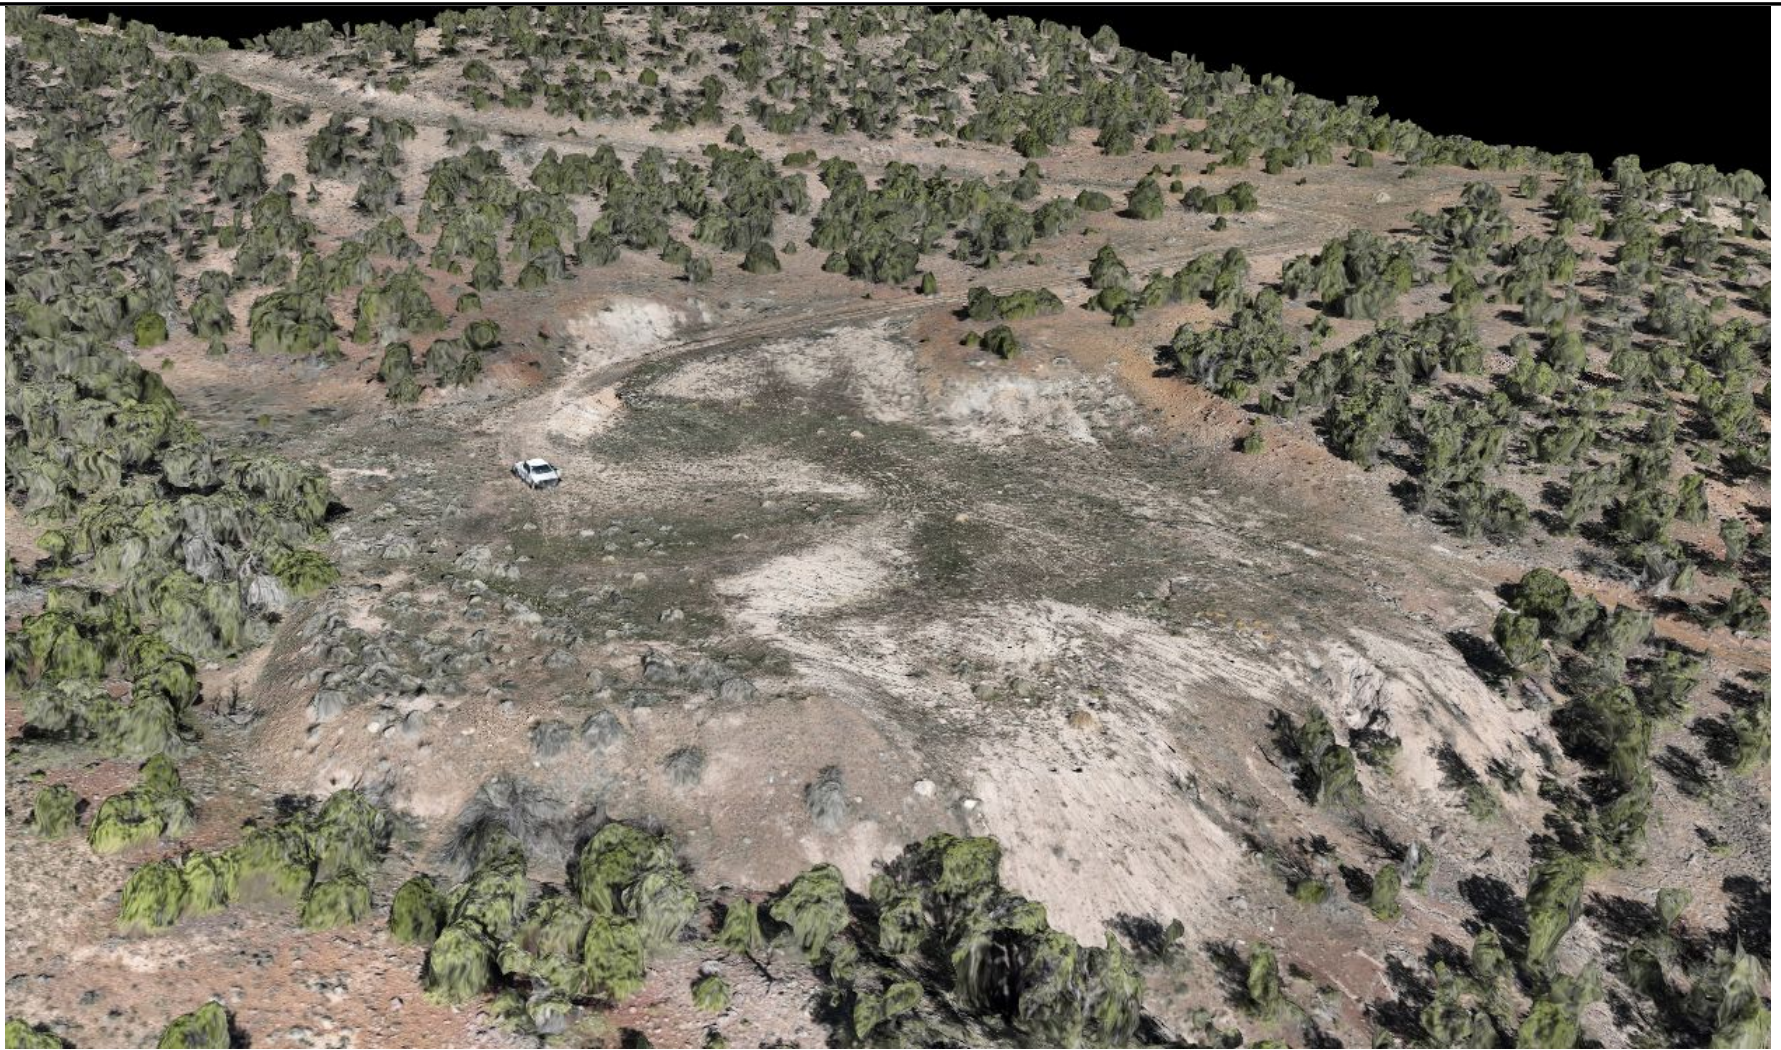
Photo 24: 3D model of the Location developed with use of a sUAS- imagery dated 4/14/2025. Imagery taken from the east of the Location facing northwest.

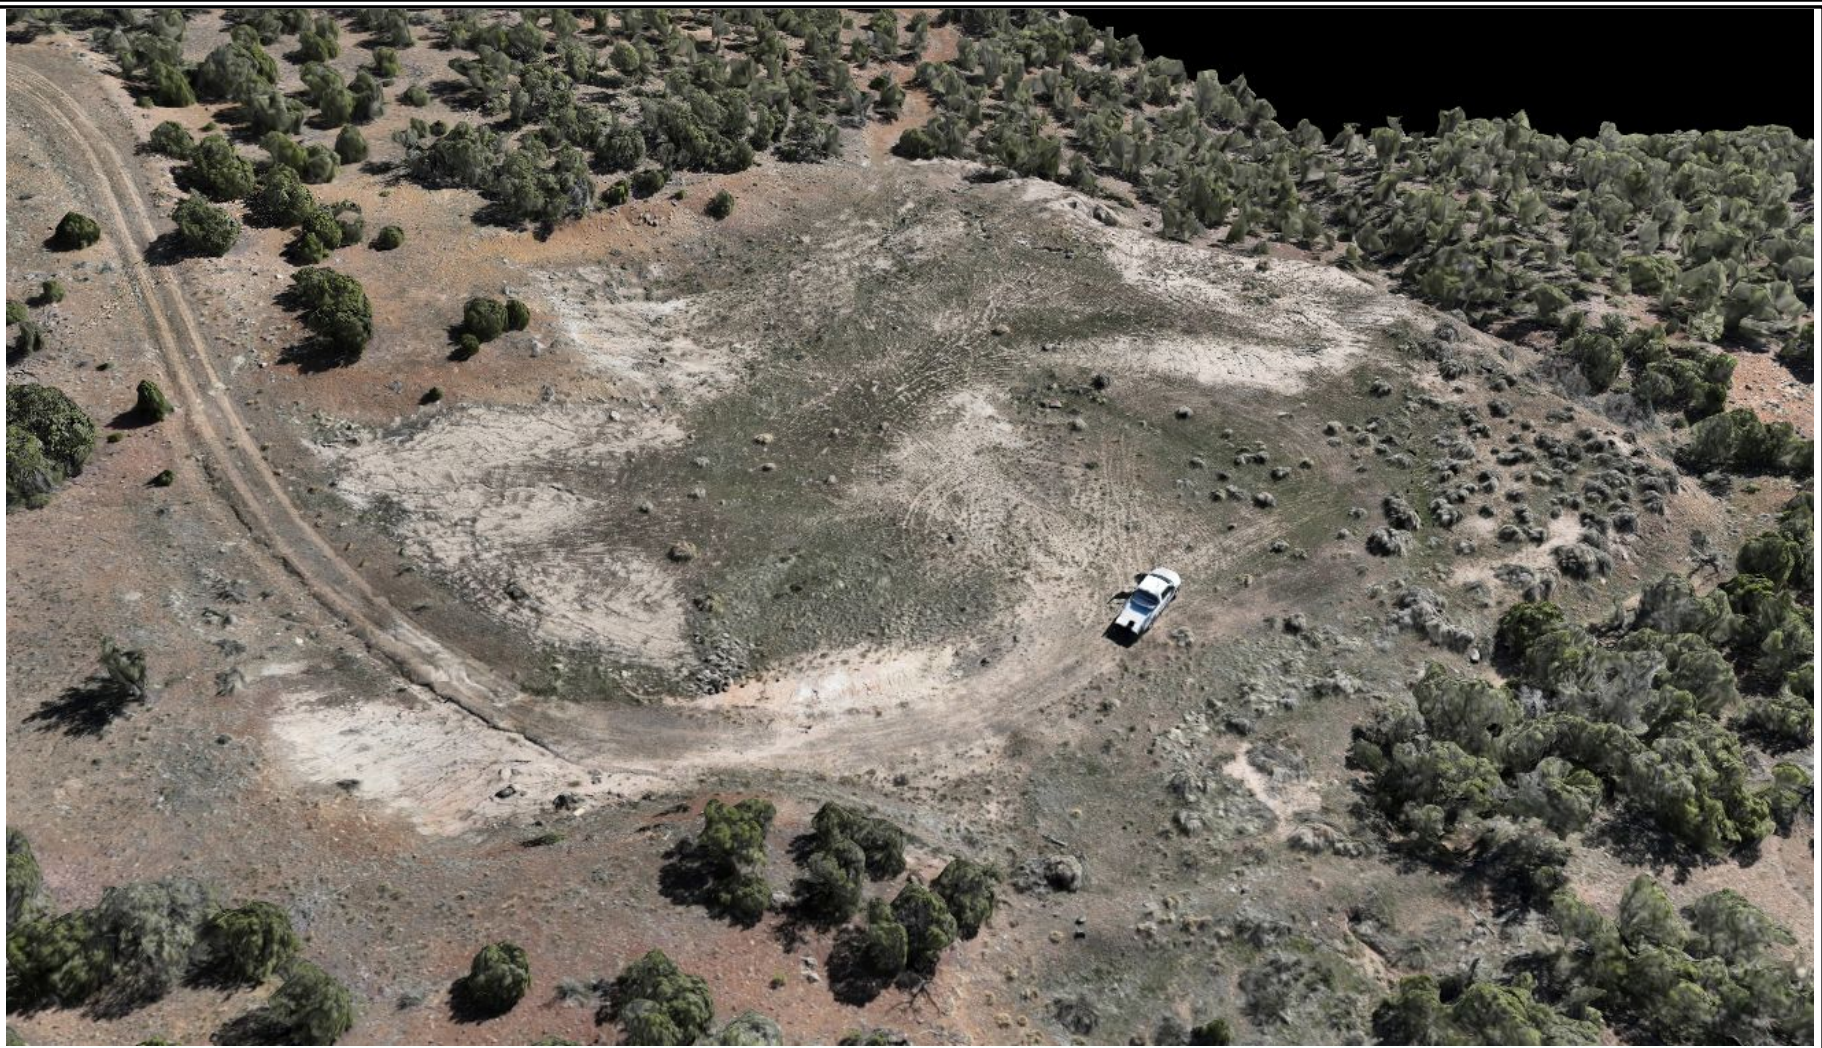
Photo 25: 3D model of the Location developed with use of a sUAS- imagery dated 4/14/2025. Imagery taken from the southwest of the Location facing northeast.

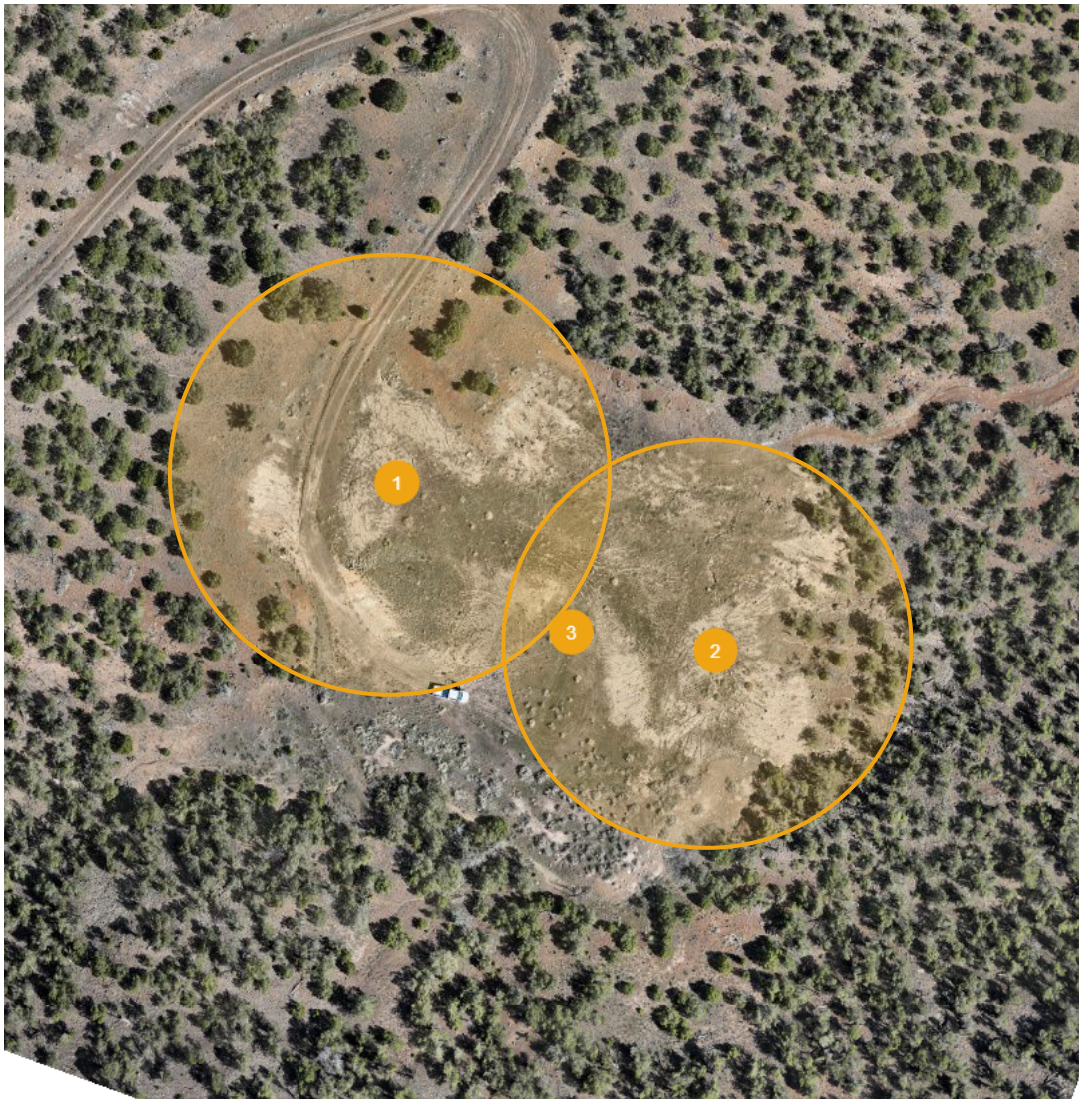
Label	Title	Lat, Long	Area	Radius	Perimeter
1 ●	Erosion, Degradation and Sediment Transport	39.2187191, -108.1650233	1.12 acres	124.79 ft	784.06 ft
2 ●	Erosion, Degradation and Sediment Transport	39.2184557, -108.1643846	0.97 acres	116.07 ft	729.29 ft

Summary:	Marker does not comport with 434.a.(5) requirements
Created:	Apr 23, 2025, 10:56am by Aaron Trujillo
Cost of Repair:	—
Lat/Long:	39.2184914, -108.1646728
Northing:	1515541.9 US ft
Easting:	2245171.6 US ft
Elevation:	-5.16 US ft
NAD83(2011) / Colorado Central (ftUS) (US survey foot)

Summary:	Persisting erosion, degradation and sediment transport throughout Location.
Created:	Apr 23, 2025, 10:56am by Aaron Trujillo
Cost of Repair:	—
Lat/Long:	39.21846, -108.16438
Area:	0.97 acres
Radius:	116.07 ft
Perimeter:	729.29 ft

Summary:	Persisting erosion, degradation and sediment transport throughout Location.
Created:	Apr 23, 2025, 10:55am by Aaron Trujillo
Cost of Repair:	—
Lat/Long:	39.21872, -108.16502
Area:	1.12 acres
Radius:	124.79 ft
Perimeter:	784.06 ft
