ECMC
Environmental
Field Inspection

Tate Tank (479916)
© 04-Jun-25 12:27:13

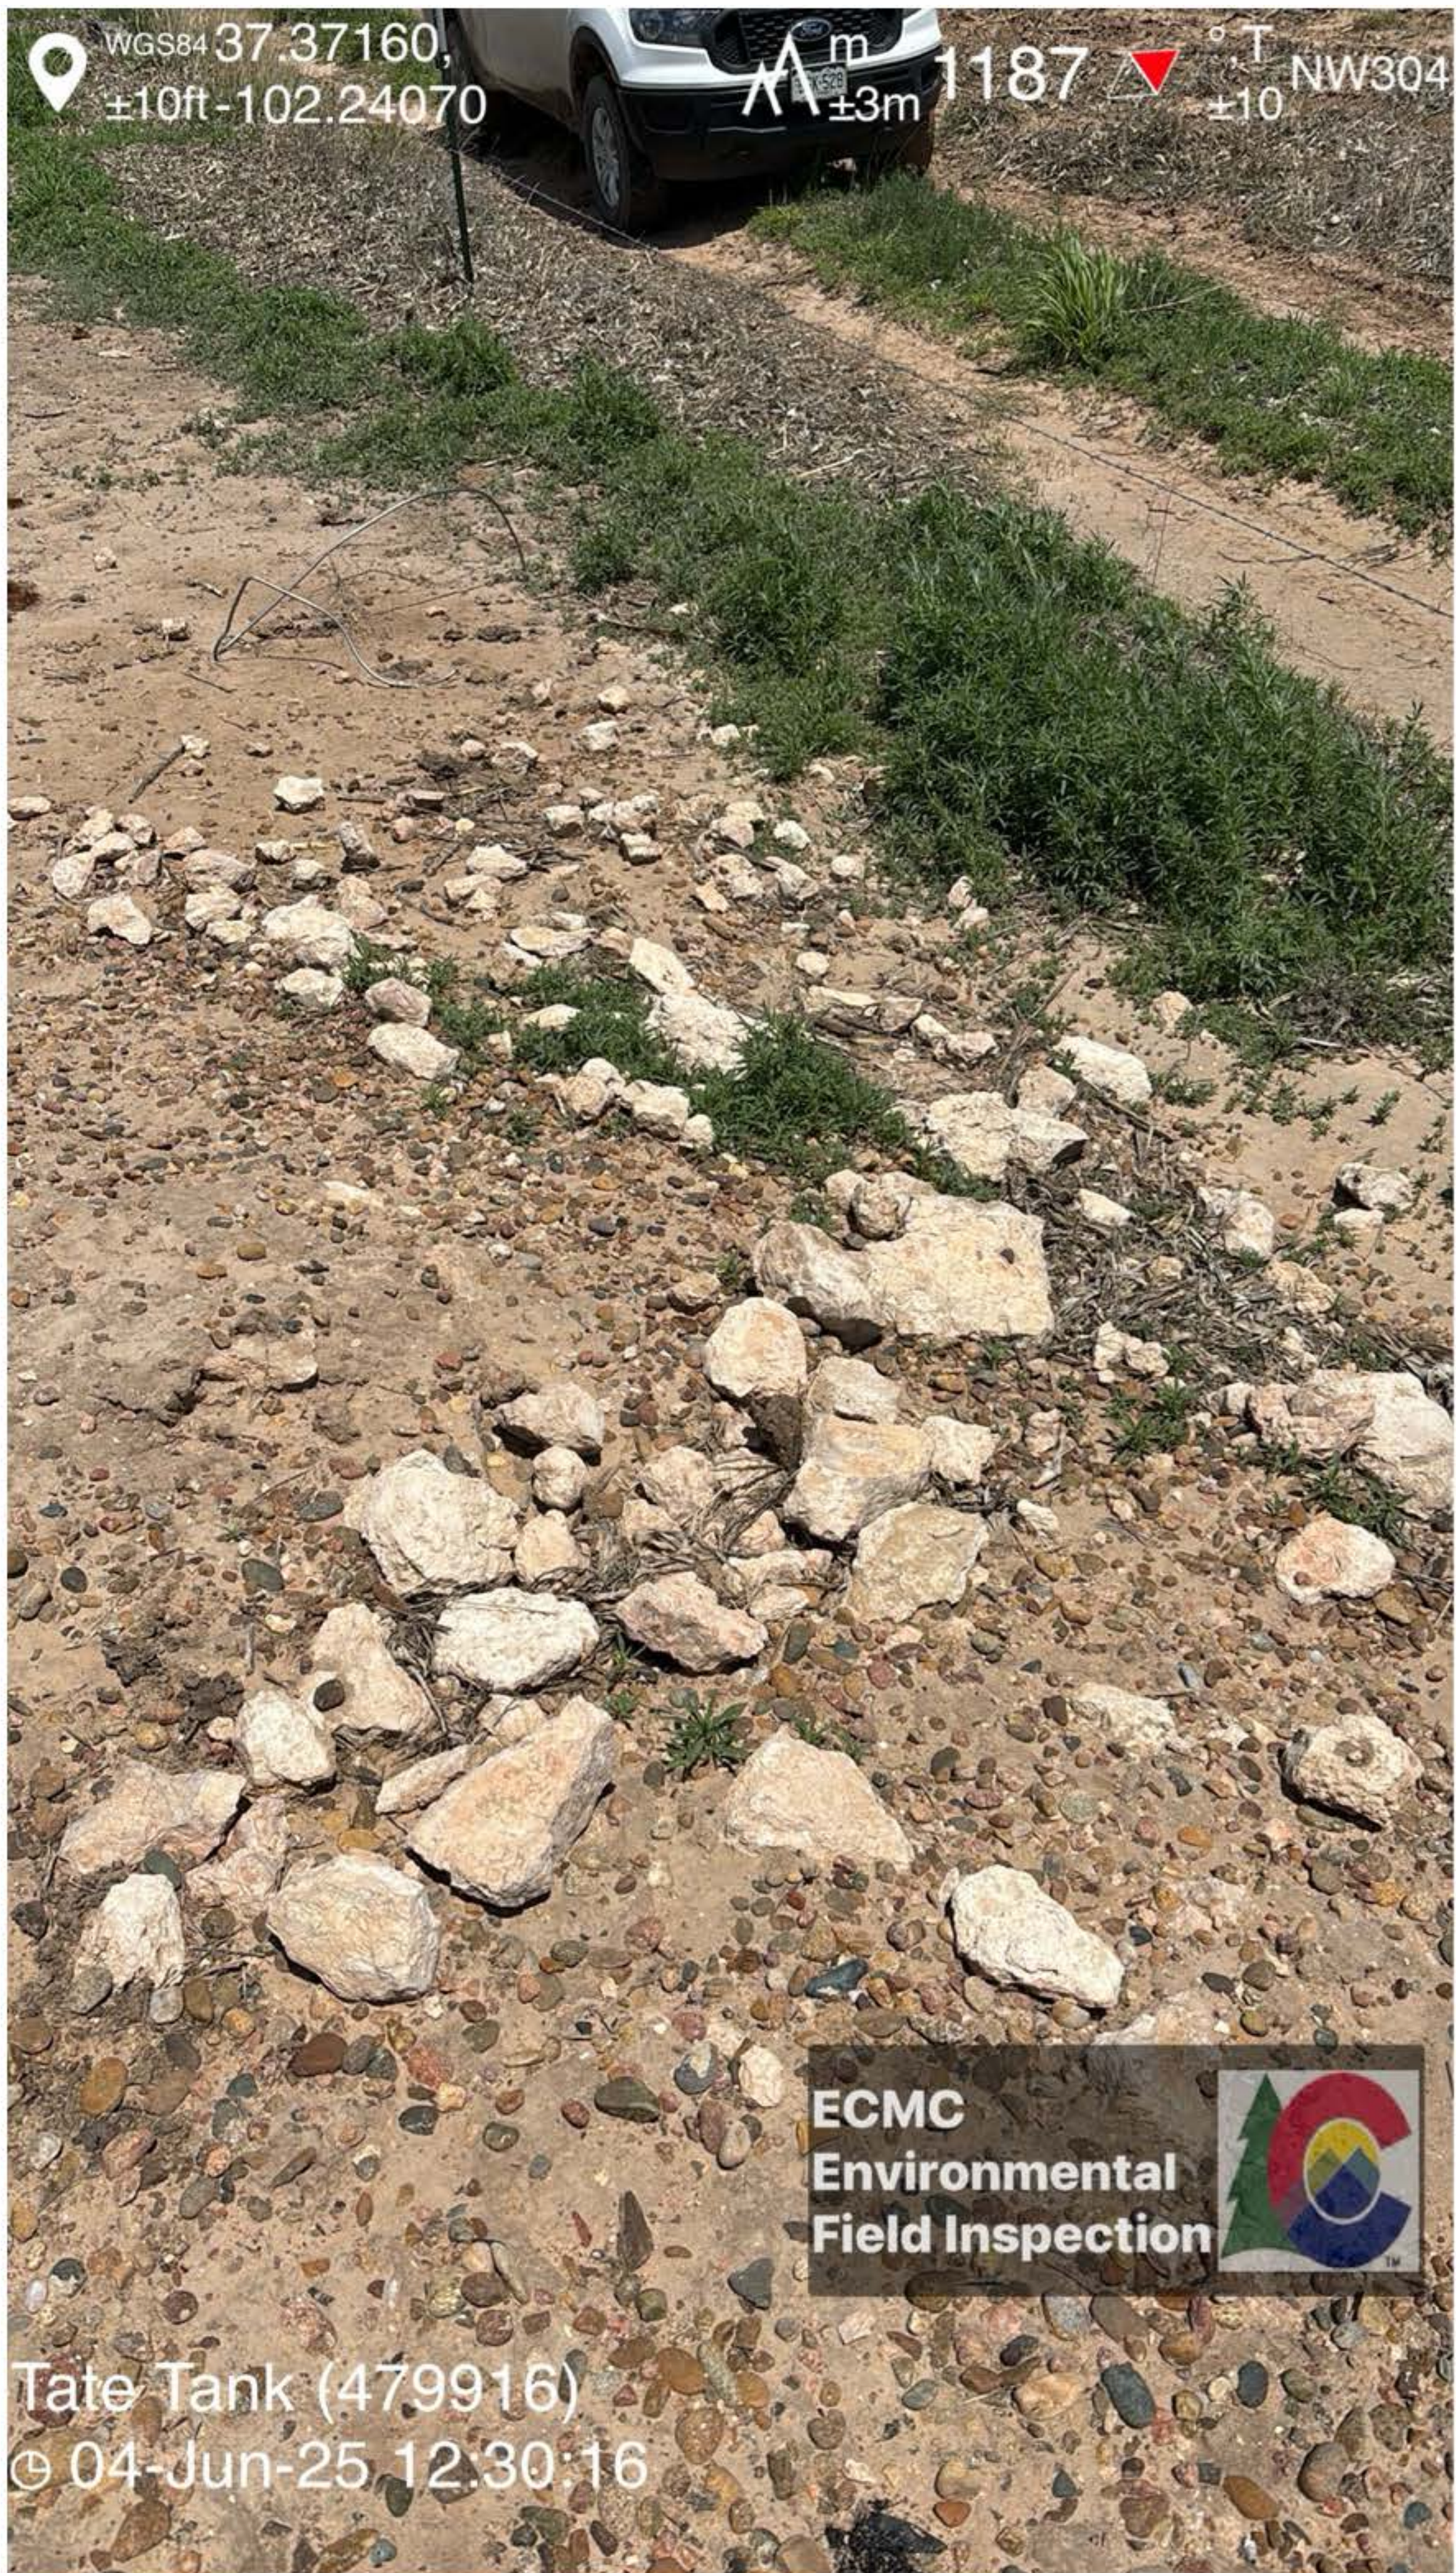
Stained soil adjacent to/down-gradient from open outlet/drain port, east side of ~100-bbl open top fiberglass produced water storage tank
