Nininger Tank Battery
© 30-May-25 11:56:16 AM
ECMC Environmental Inspection

ECMC
Environmental
Field Inspection

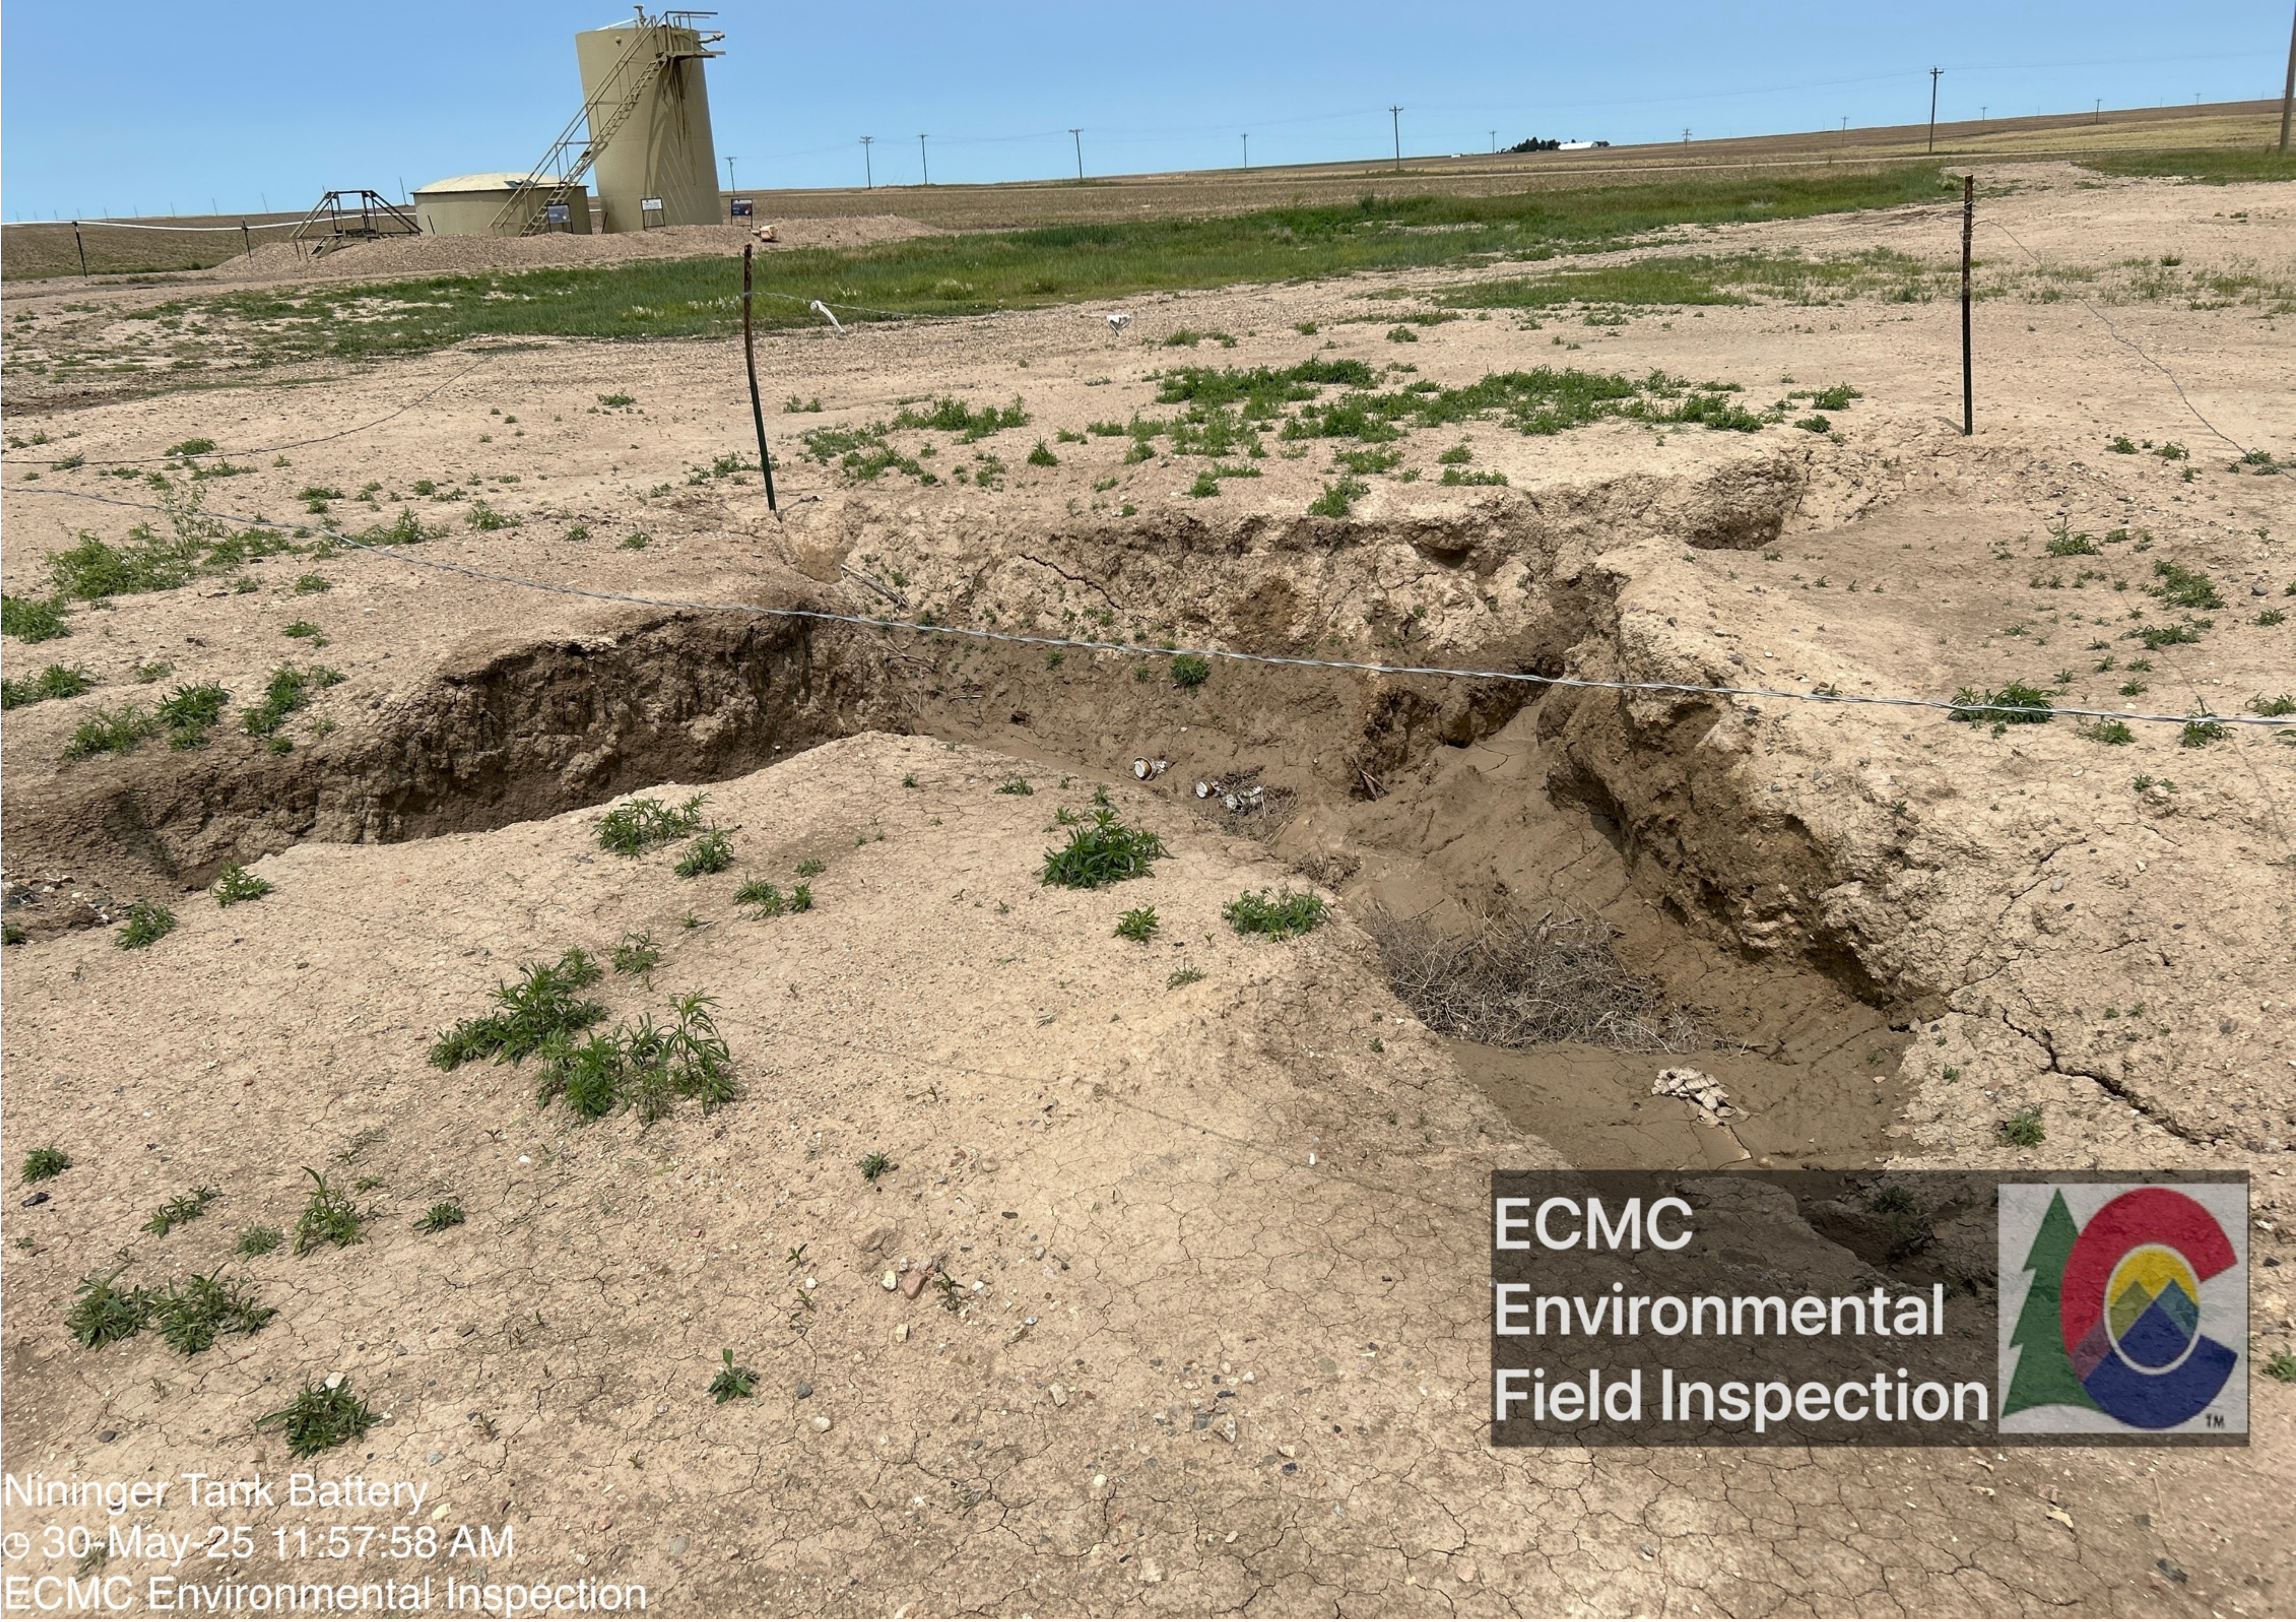
Nininger Tank Battery
© 30-May-25 11:57:32 AM
ECMC Environmental Inspection

No stormwater BMPs are visible. Erosion appears to have occurred at the edges of the excavation.

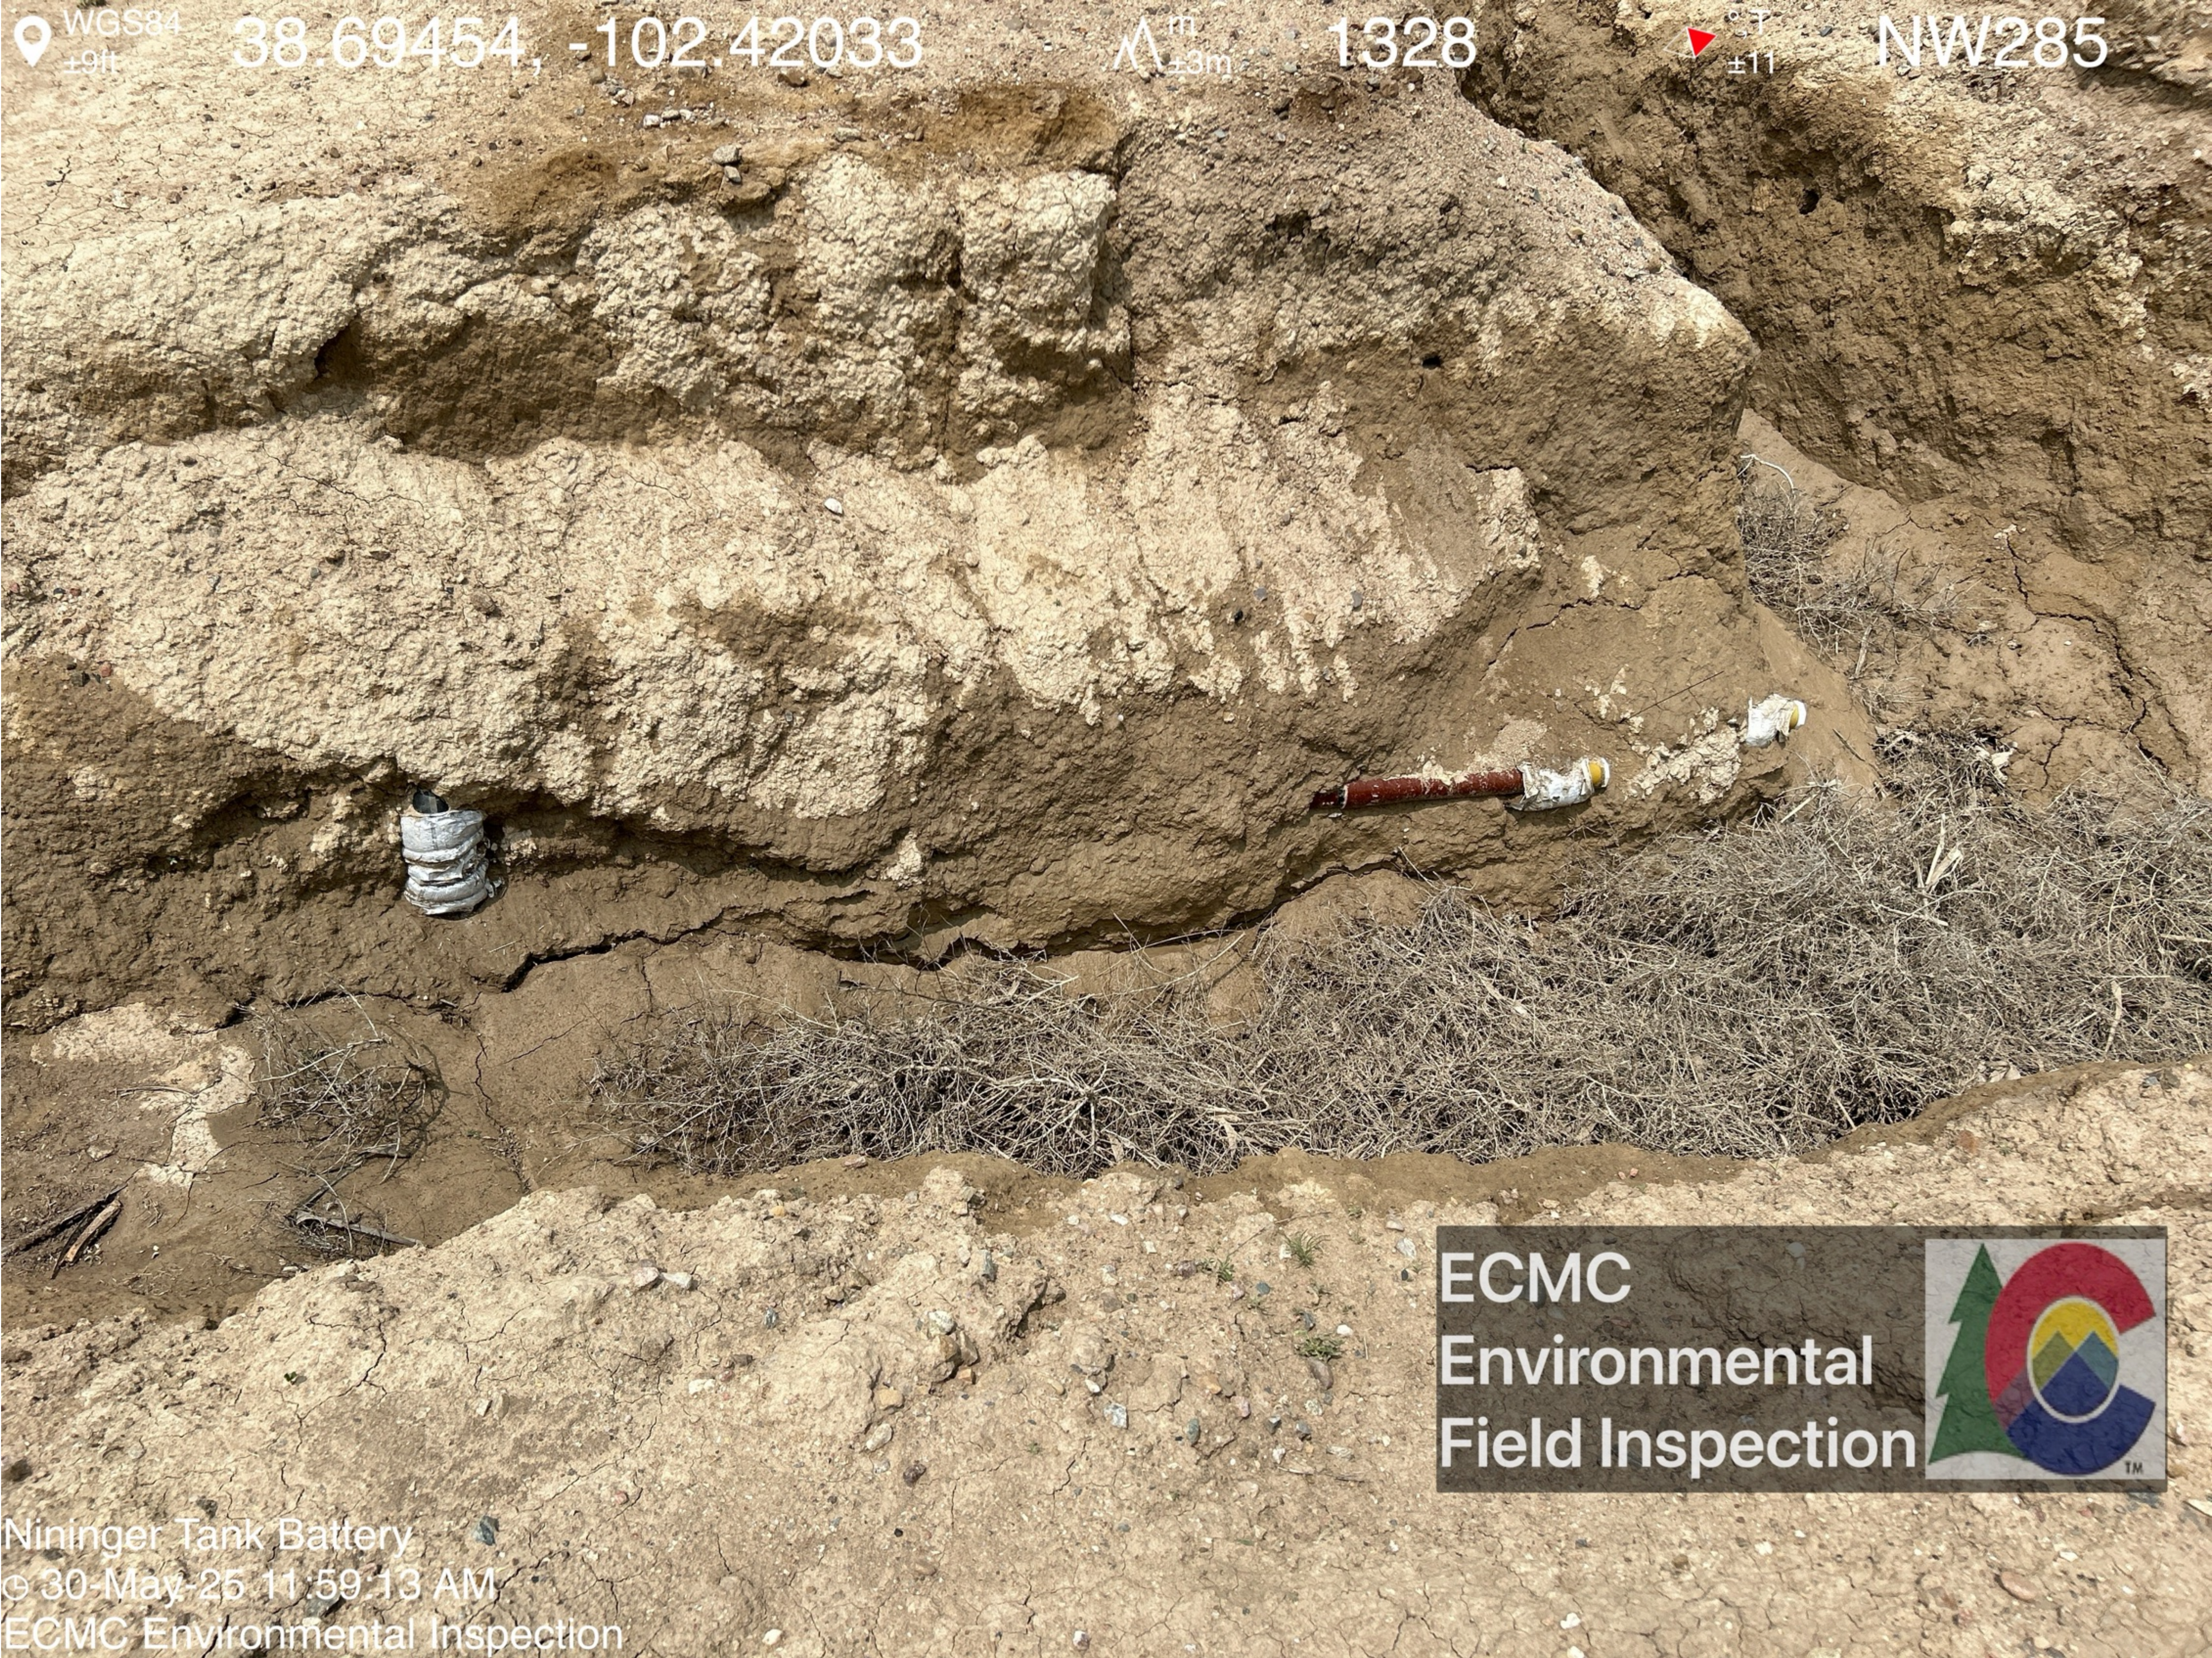
Nininger Tank Battery
© 30-May-25 11:59:04 AM
ECMC Environmental Inspection

Debris and segments of flowline are visible within the open excavation.
