ECMC
Environmental
Field Inspection

Lowe B-2 TB
© 30-May-25 01:43:57 PM
ECMC Environmental Inspection

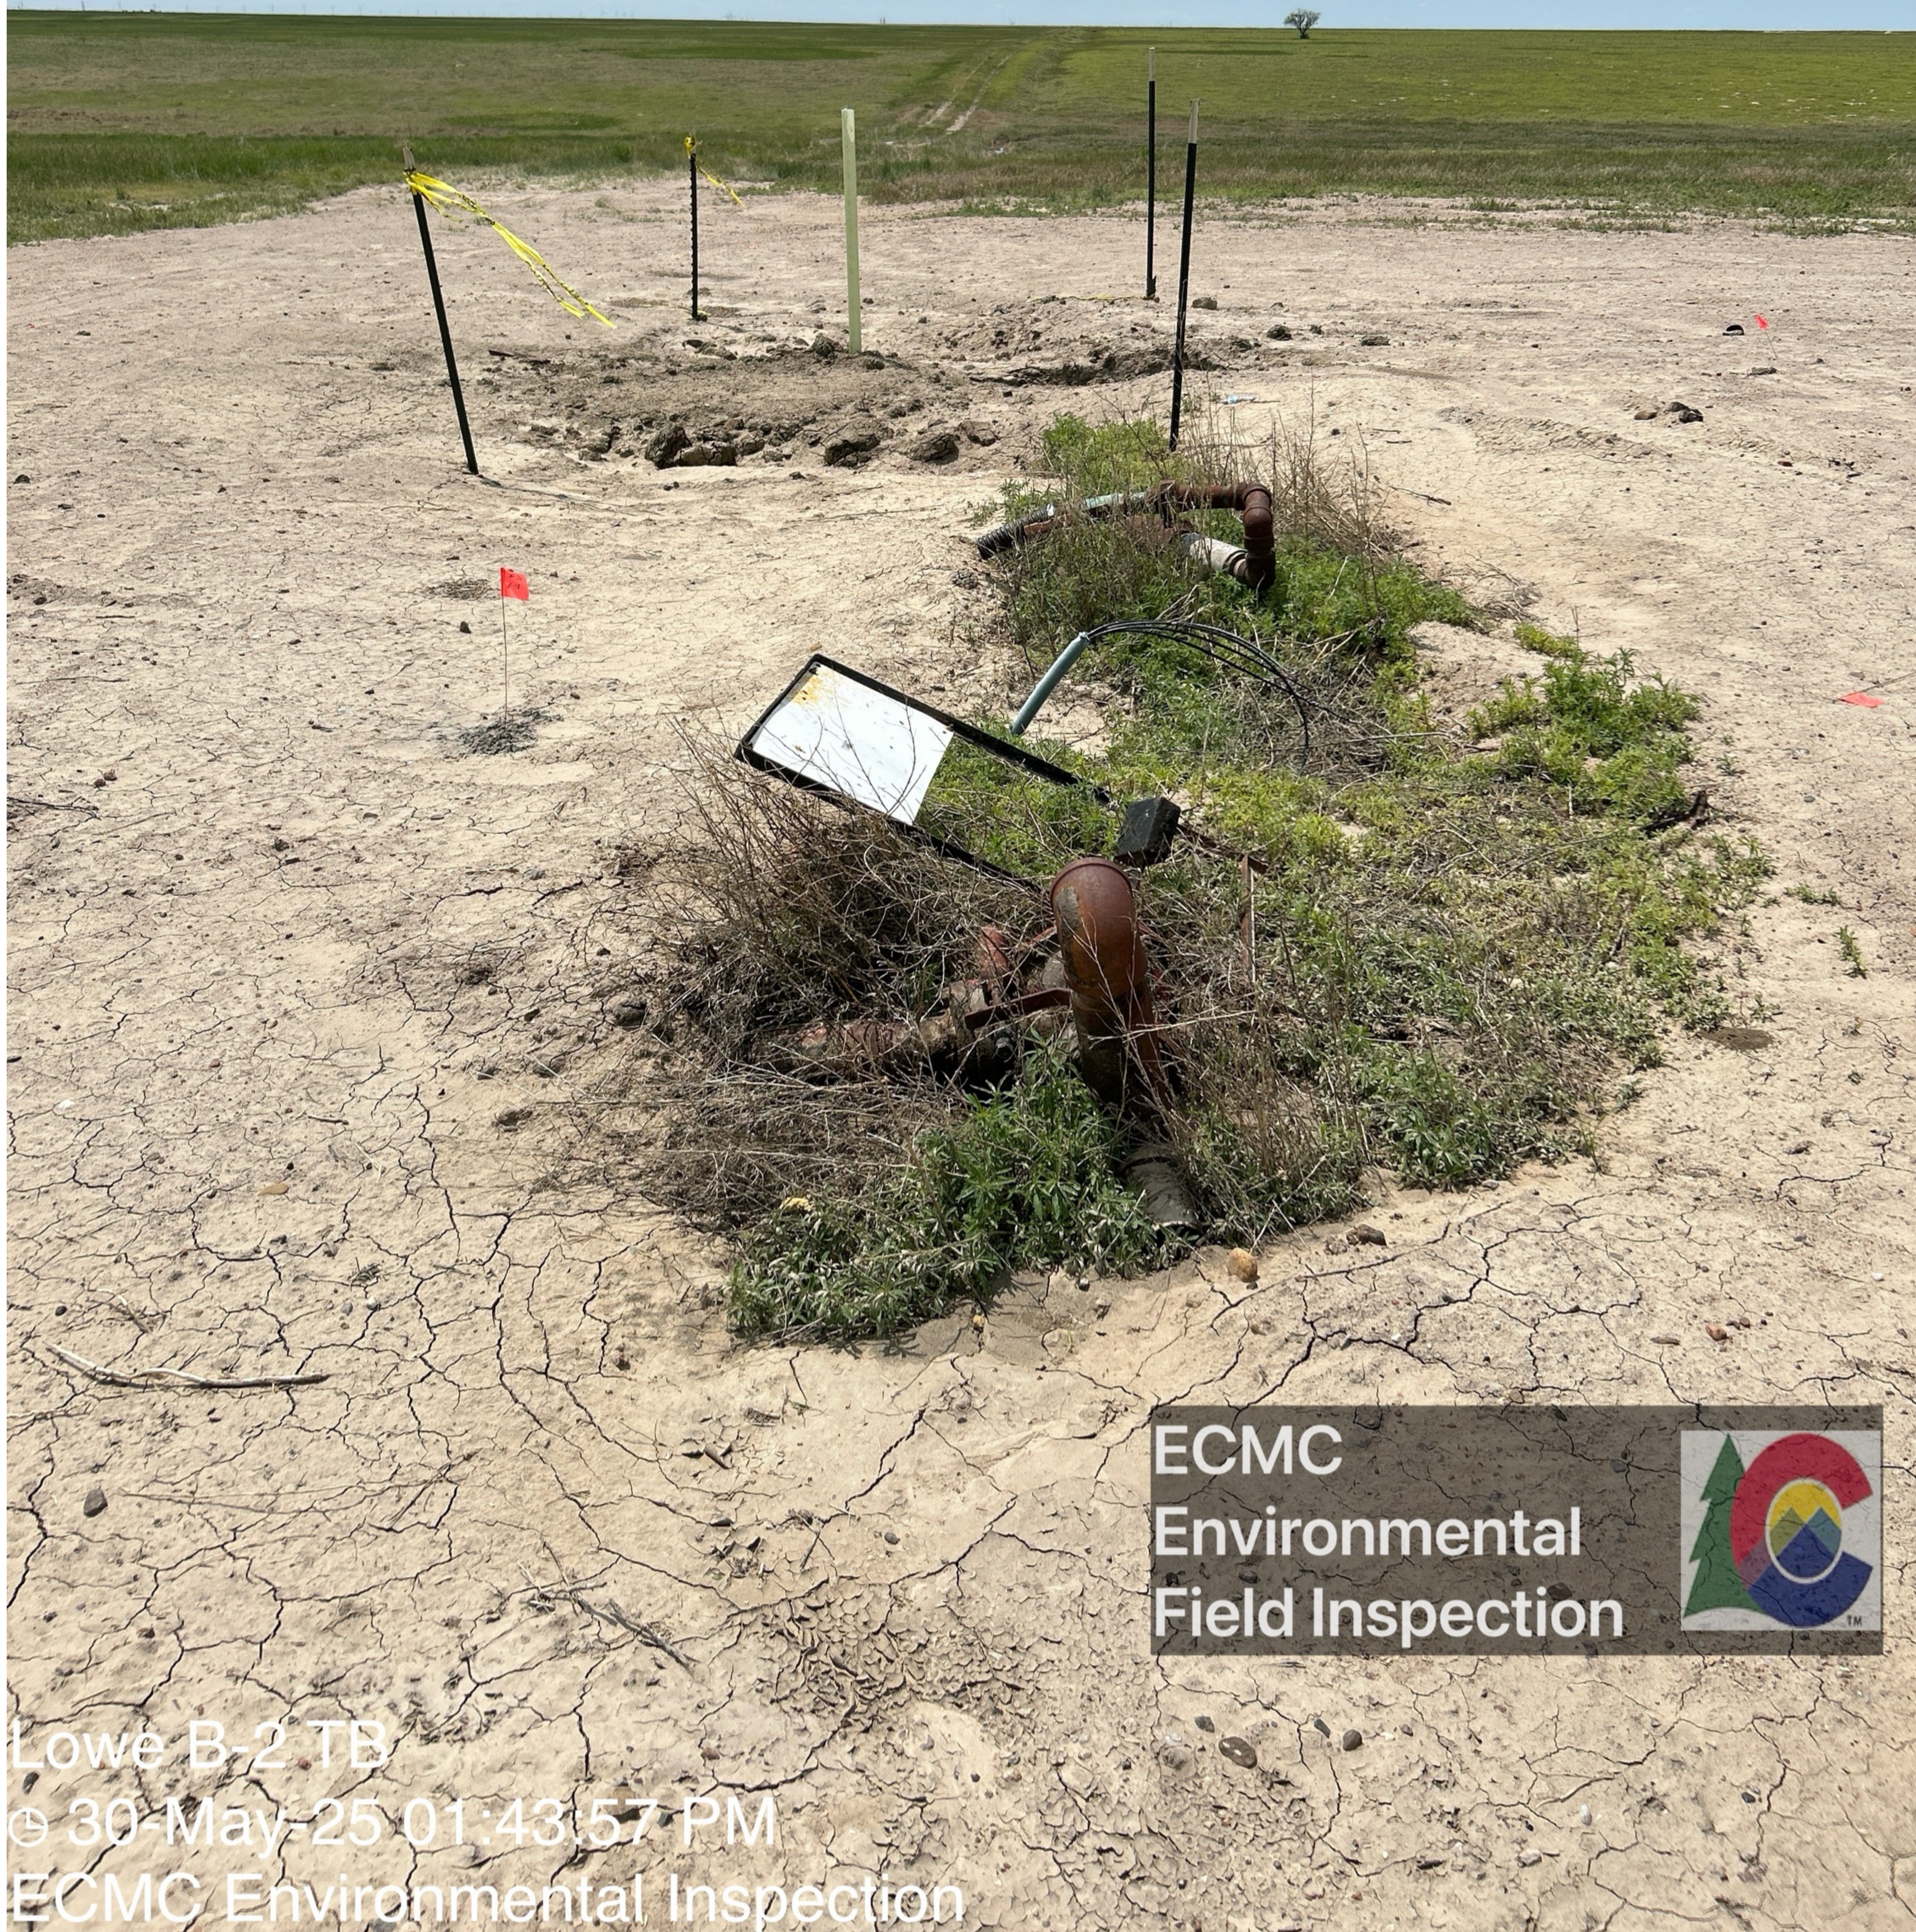
An uncapped light green riser is visible between fence posts in the background; weeds surrounding metal pipes/risers are visible in the foreground.
