SPILL/RELEASE REPORT

Name of Operator: OXY USA WTP LP OGCC Operator No: 66571
Address: 760 Horizon Drive, Suite 101
City: Grand Junction State: CO Zip: 81506
Contact Person: Alonzo Hernandez
Phone Numbers: No: 970.263.3609 Fax: 970.263.3694 E-Mail: alonzo_hernandez@oxy.com

Date of Incident: 12/08/2010 Facility Name & No.: 620-43-32 / 335456 = location ID
Type of Facility (well, tank battery, flow line, pit): tank battery
Well Name and Number: NA
API Number: NA 045-13486
Specify volume spilled and recovered (in bbls) for the following materials:
Oil spilled: ~130 Oil recov'd: Water spilled: ~170 bbl Water recov'd: ~10 bbl Other spilled: Other recov'd:
Ground Water impacted? [] Yes [X] No Surface Water impacted? [] Yes [X] No
Contained within berm? [] Yes [X] No Area and vertical extent of spill: TBD x
Current land use: Rangeland Weather conditions: cool, overcast
Soil/geology description: Happle-Rock outcrop association, 25% to 65% slopes
IF LESS THAN A MILE, report distance IN FEET to nearest.... Surface water: ~270' wetlands: NA buildings: NA
Livestock: NA water wells: NA Depth to shallowest ground water: ~70'
Cause of spill (e.g., equipment failure, human error, etc.): human er

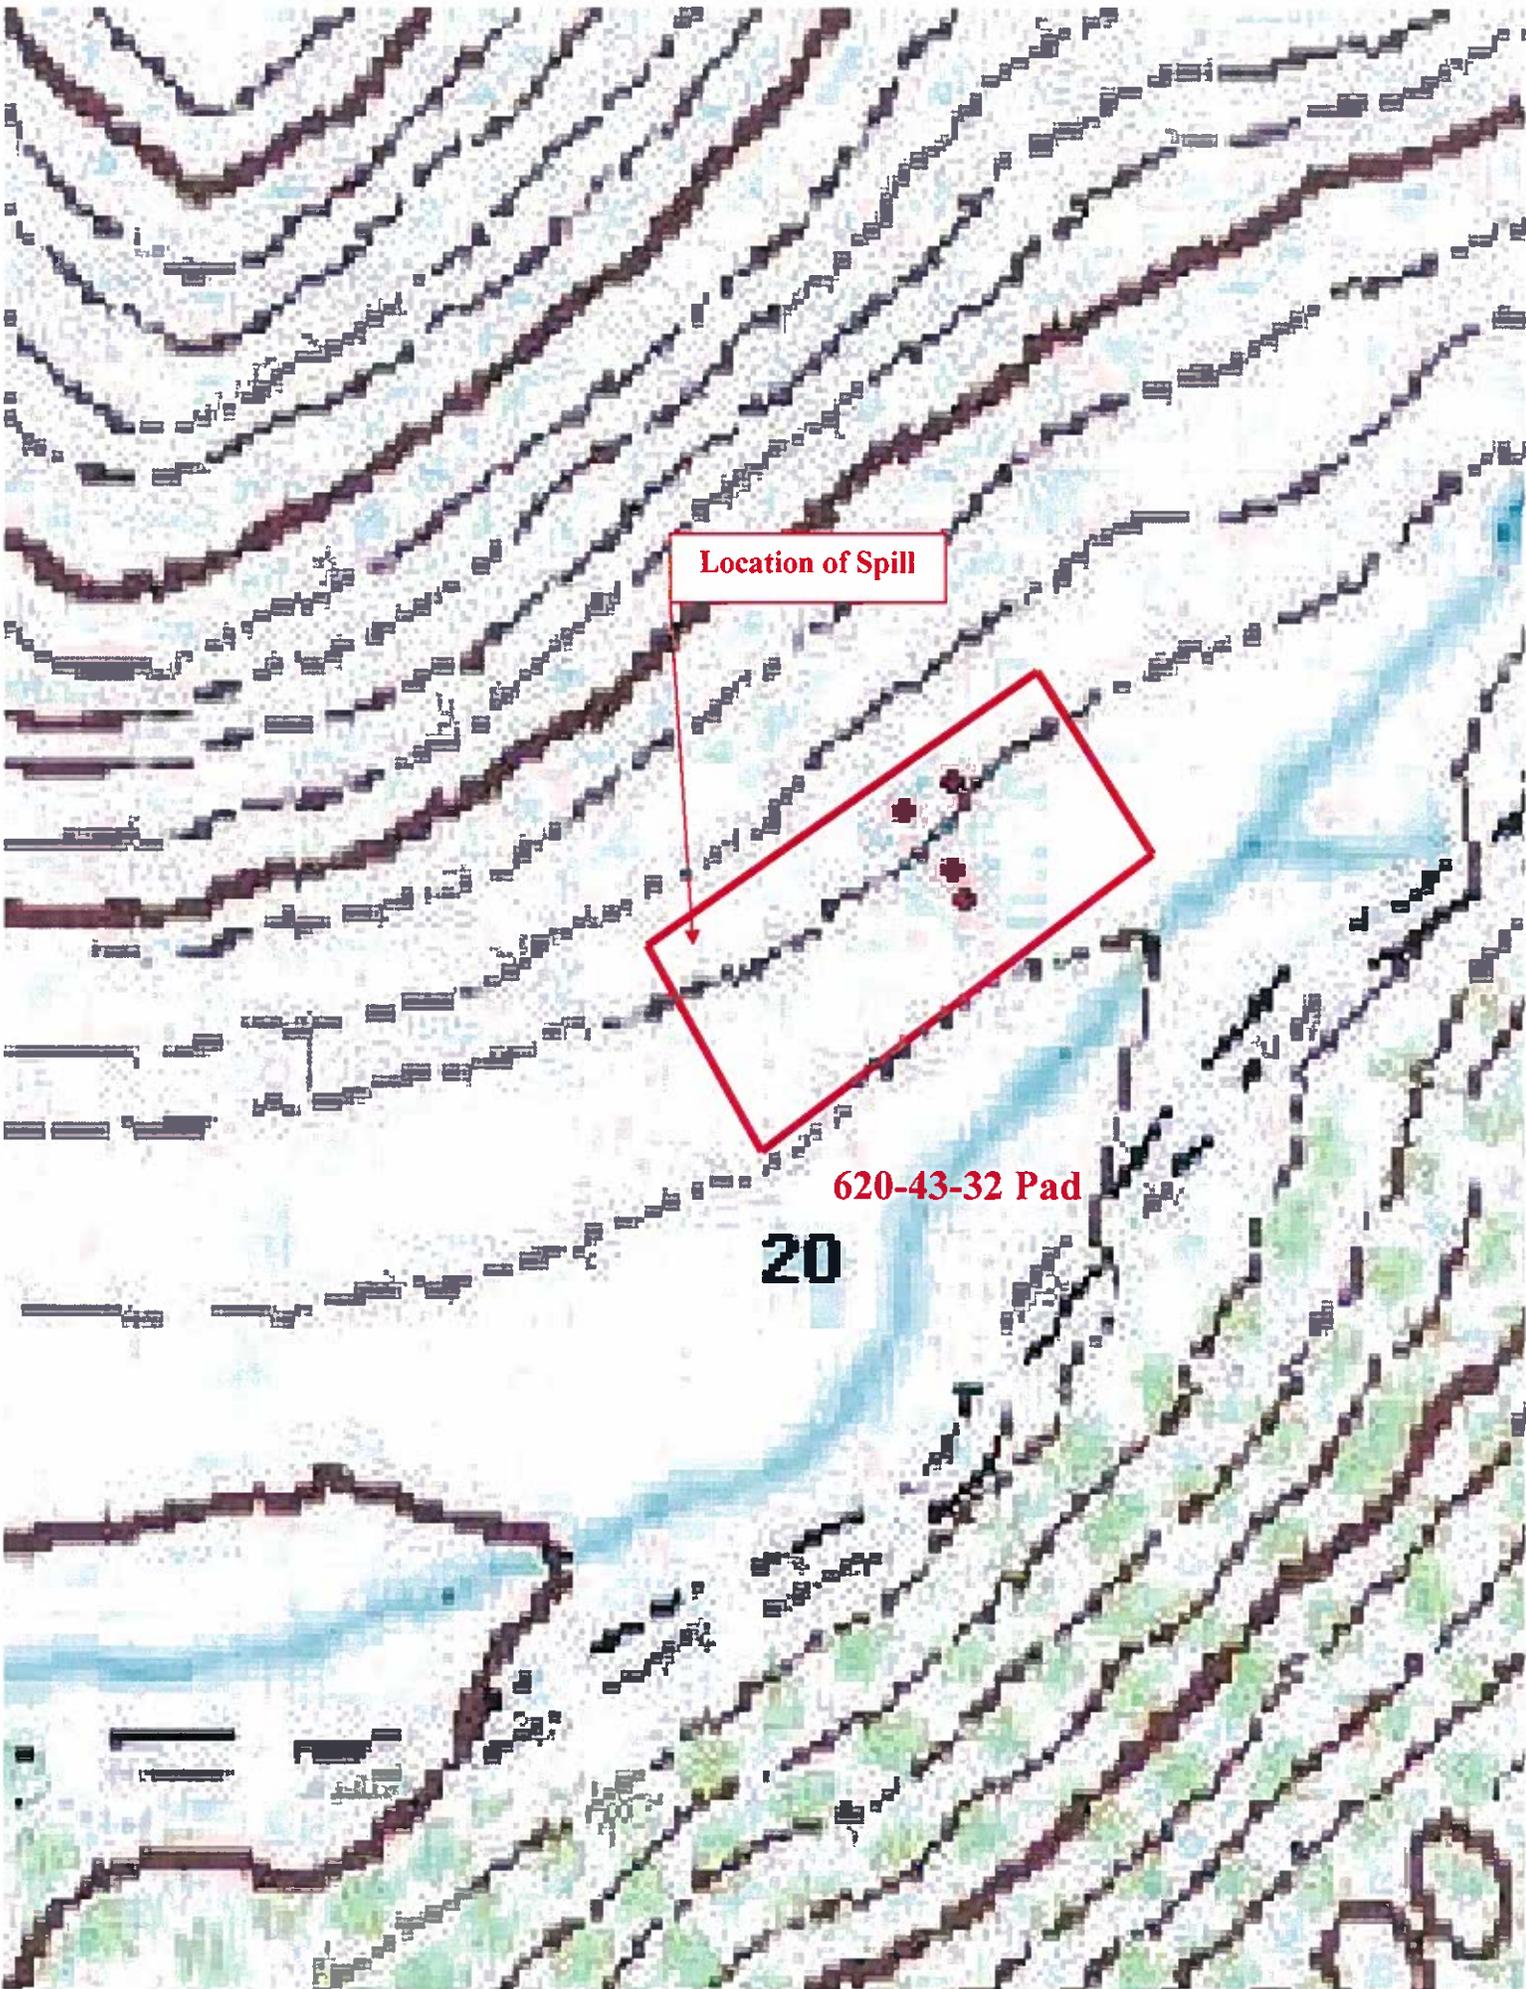
Location of Spill

620-43-32 Pad

Because of valve misalignment, fluids from the water gathering line entered into the 620-43-32 tanks resulting in a produced water and a condensate tank overflow into and adjacent to the unlined secondary containment.
