QUICKSILVER RESOURCES, INC.
ZENON WATER PIT AS-BUILT DRAWINGS
LOCATED IN
SECTION 12, T7N, R93W, 6th P.M.
MOFFAT COUNTY, COLORADO

DATE:	2-22-10
REVISED:	3-5-10 (ADDED ICE LINE & VOLUMES)
1-23-12	(ADDED BREACHES & PIT BOTTOM ELEVATIONS)
6-13-12	(ADDED BREACHES TO PLAN & PROFILE VIEWS)
PROJECT NO:	210-1225
SURVEYED:	BH
DRAWN BY:	HNM
ELECTRONIC FILE:	PITS.DWG
FILE:	2 3 2 0 2

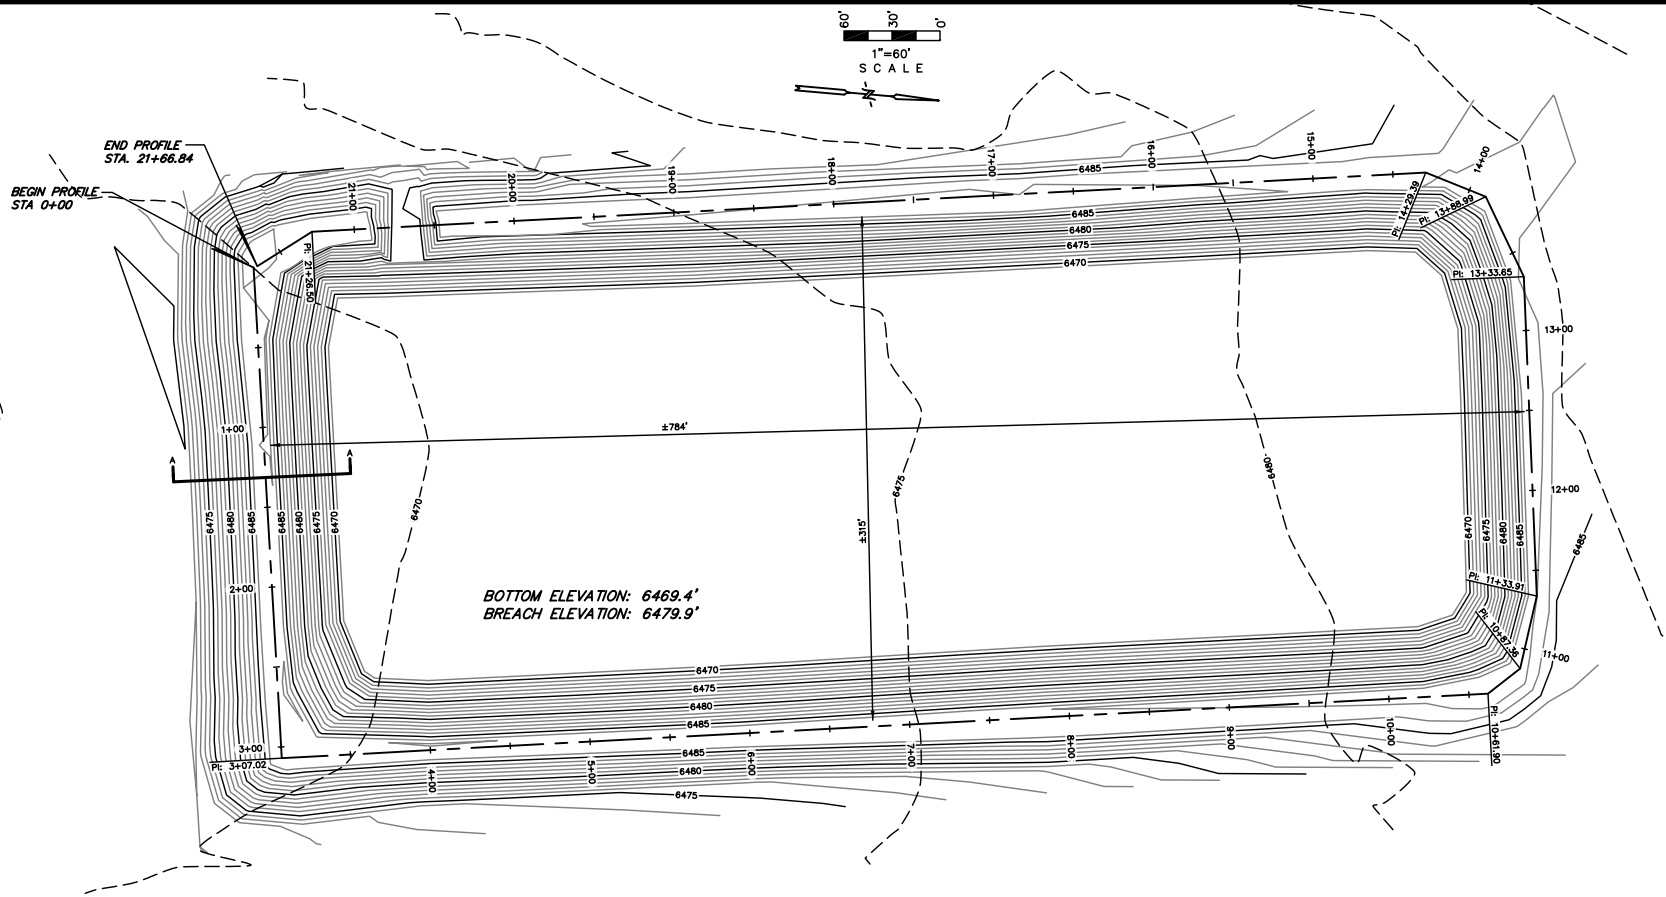
GENERAL NOTES:
- THIS IS AN AS-BUILT OF THE EXISTING HOLDING PONDS LOCATED AS DESCRIBED.
- DASHED CONTOURS REPRESENT PRE CONSTRUCTION GRADE AT 5' INTERVALS.
- SOLID CONTOURS REPRESENT THE AS-BUILT GRADE AT 1' INTERVALS.
- QUICKSILVER RESOURCES CUT BREACHES IN EACH DIKE TO OBTAIN A MAX WATER DEPTH TO OVERFLOW OF 10'
- GLEN MCELROY MEASURED AND SURVEYED THE BREACHES FOR VERIFICATION.

LARGE PIT VOLUME
VOLUME AT TOP OF BREACH = ±364,243 bbl
VOLUME LESS 2' FREEBOARD = ±279,422 bbl
