DC #14 Well Pad Form 2A Kinder Morgan CO2 Company, LP

INTRODUCTION

This Form 2A stormwater report includes the Best Management Practices (BMPs) and reclamation plans for Kinder Morgan's proposed GP #26 well pad in accordance with Colorado Oil and Gas Conservation Commission's (COGCC) Form 2A requirements. BMP diagrams and additional general stormwater information is included with Kinder Morgan's Master Stormwater Management Plan (MSWMP) for oil and gas construction activities for McElmo Dome and Doe Canyon. The MSWMP can be obtained from Kinder Morgan and is in accordance with Colorado Department of Public Health and Environment (CDPHE) stormwater guidelines. The Kinder Morgan contact person is Bob Clayton and his contact information is below:

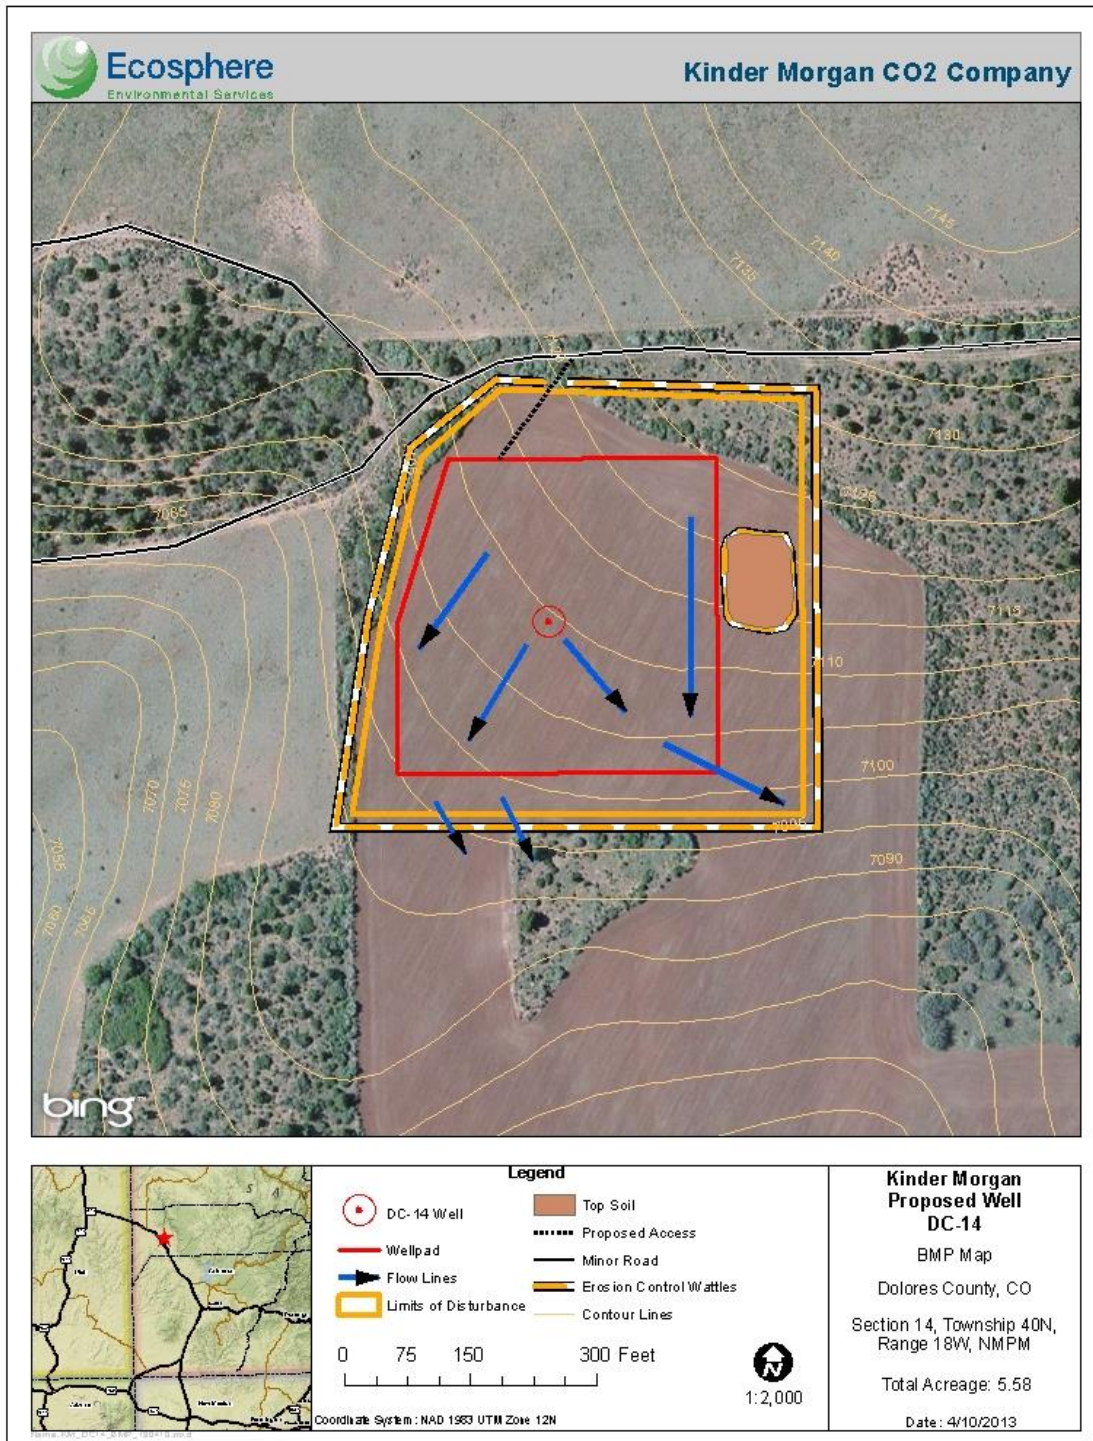
DC #14 Preconstruction BMP MAP

The following tables list site-specific BMPs identified by Ecosphere during the field visit conducted on April 2, 2013. Site-specific BMPs should be installed pre-construction and during the construction process. BMP diagrams are included in the MSWMP. BMPs would be maintained or amended by Kinder Morgan as site conditions change throughout the construction and reclamation process. Stormwater inspections would occur as stipulated in the MSWMP and required by the Colorado Department of Public Health and Environment (CDPHE). A map showing the BMP locations is attached. Site-specific BMPs be maintained until vegetation reaches 70 percent of the pre-construction cover as mandated by the COGCC and CDPHE.
