Schematic wellbore diagram – Before plugging

**Eagle Operating, Inc.**

Emerald #C 125

API# 05-103-40008

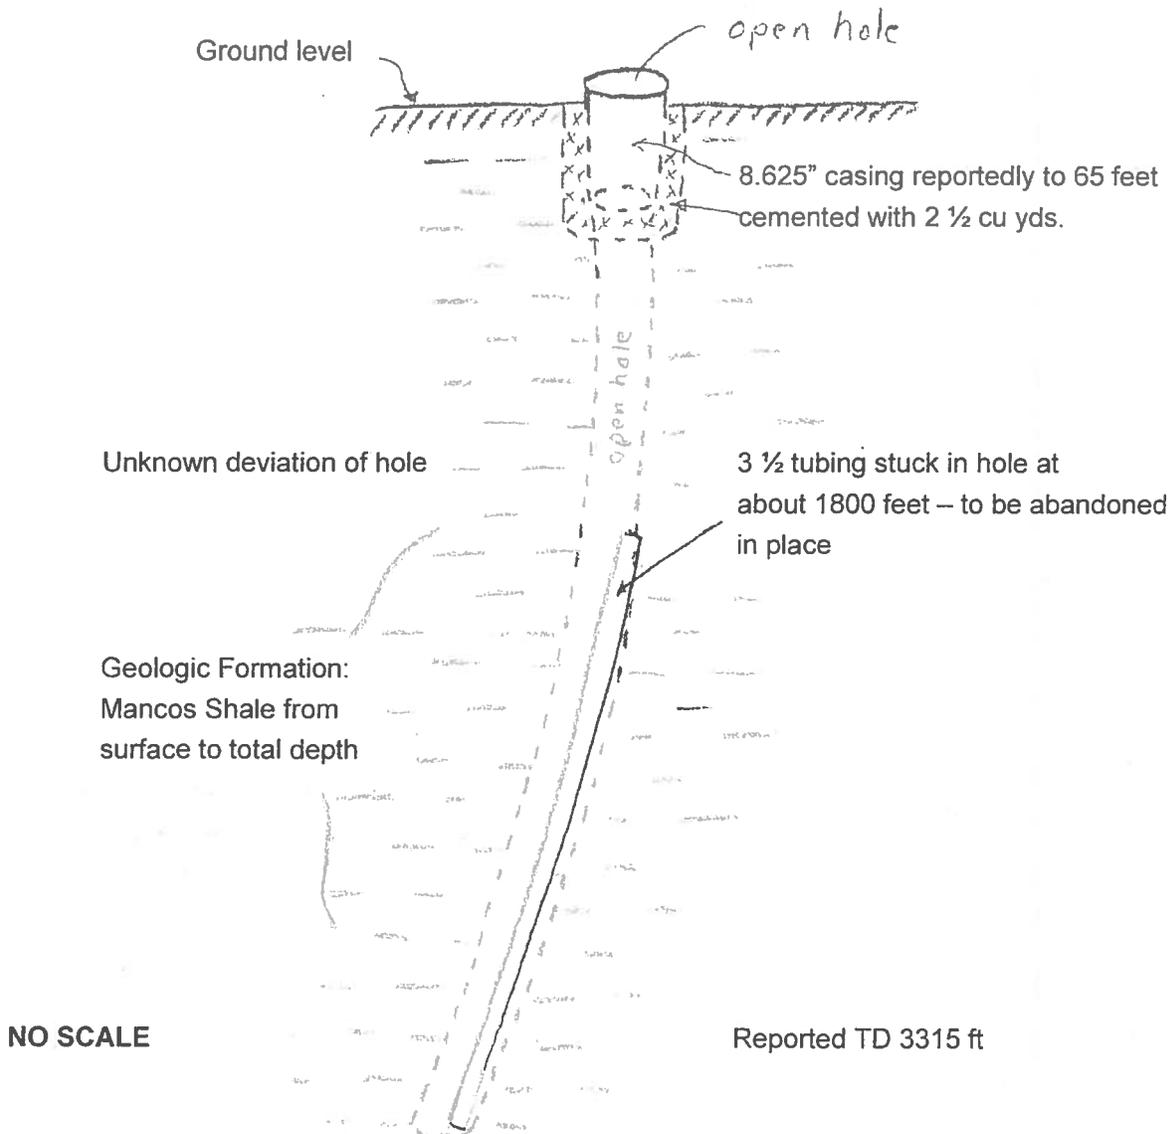
Proposed P&A May/June 2015

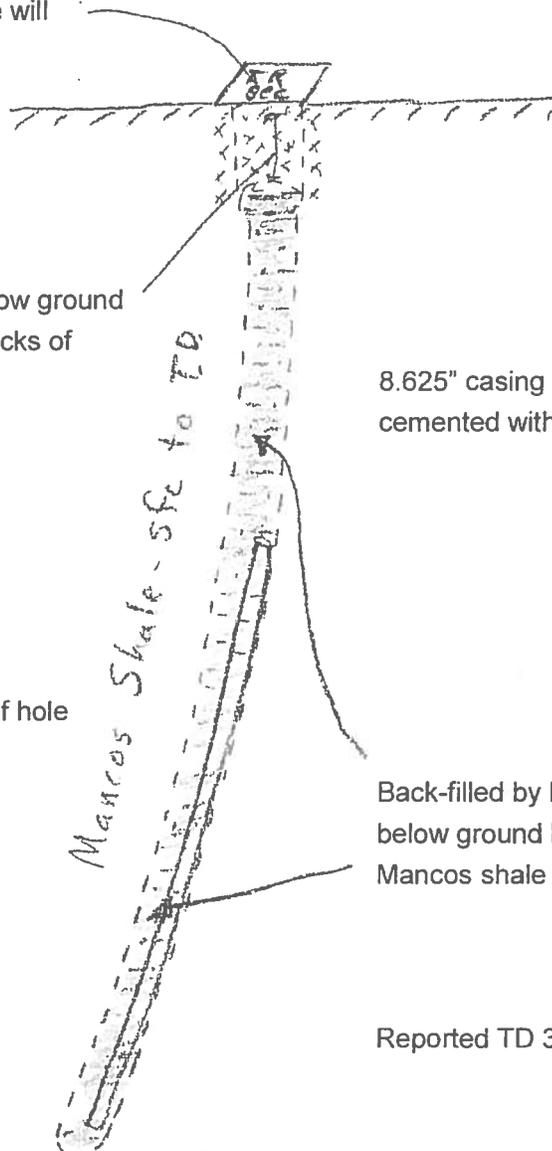
Schematic wellbore diagram – After plugging

A location steel plate will  
Be welded on top

Ground level

Surface to >50 ft below ground  
level filled with 25 sacks of  
Hydrated sakrete

8.625" casing reportedly to 65 feet  
cemented with 2 1/2 cu yds

Unknown deviation of hole

*Mancos Shale - sfc to TD*

Back-filled by hand from TD to >50 ft  
below ground level with native  
Mancos shale available near site

Reported TD 3315 ft
