Tower Multi-Well Plan

Topsoil Salvage Plan

Duraroot, LLC

July 2020

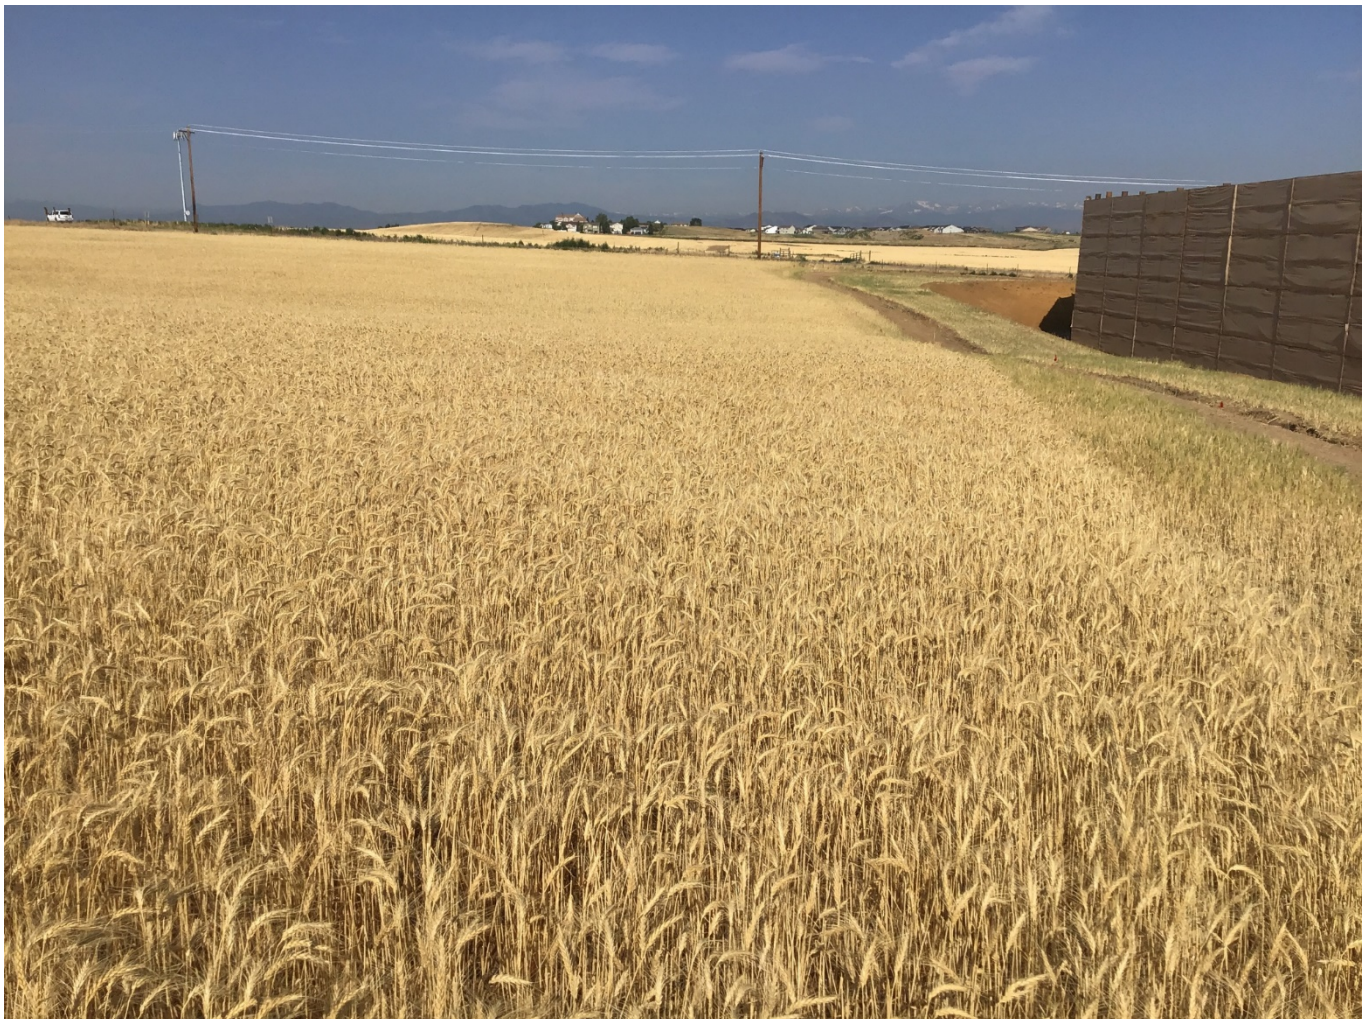
Figure 2. Field conditions directly southwest of the Tower Multi-Well Pad location.

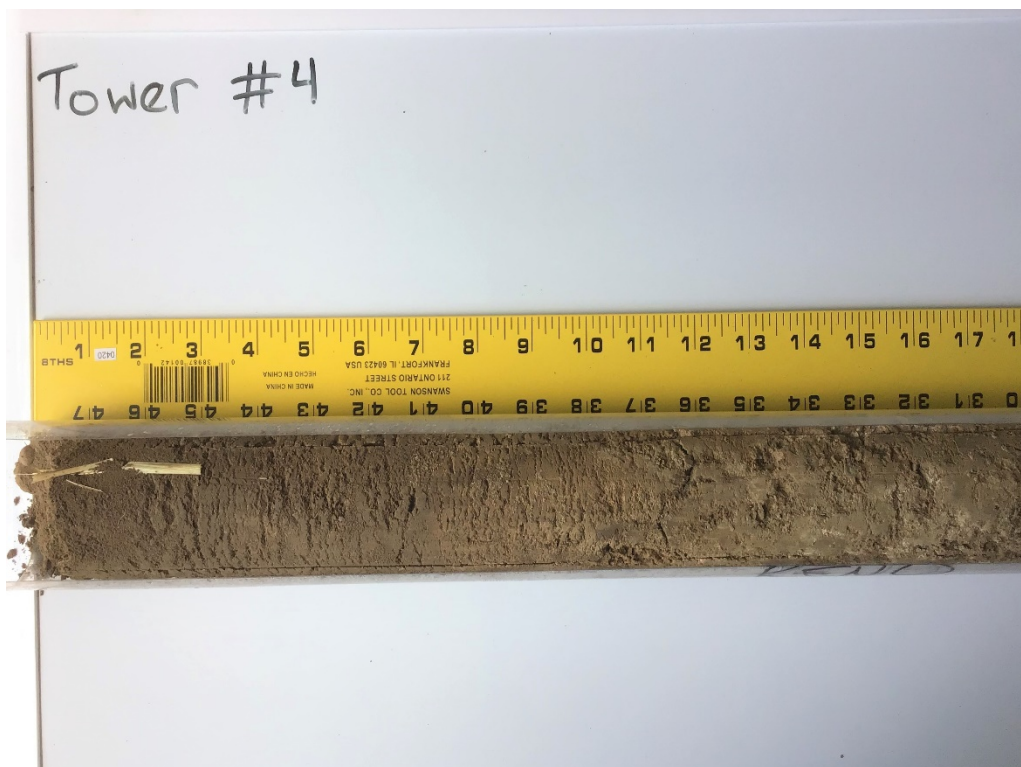
Figure 6. Soil core collected at the Tower Multi-Well Pad location (Soil Sample 4).

- **Soil effervescence:** Effervescence is used to estimate soil lime (CaCO_3) content, as HCl reacts with CaCO_3 to produce CO_2 . Effervescence with 10-percent HCl solution was observed in Samples 1, 4, and 5 throughout each soil core from the surface throughout the soil profile with stronger effervescence reaction observed with depth indicating the presence of CaCO_3 . Effervescence was observed in the lower subsoil depth in Samples 2 and 3.
