PIONEER
NATURAL RESOURCES USA, INC.

RE: Request to Further Review Denied Applications for Production Pits

Sleeping Dog 41-8/Tr

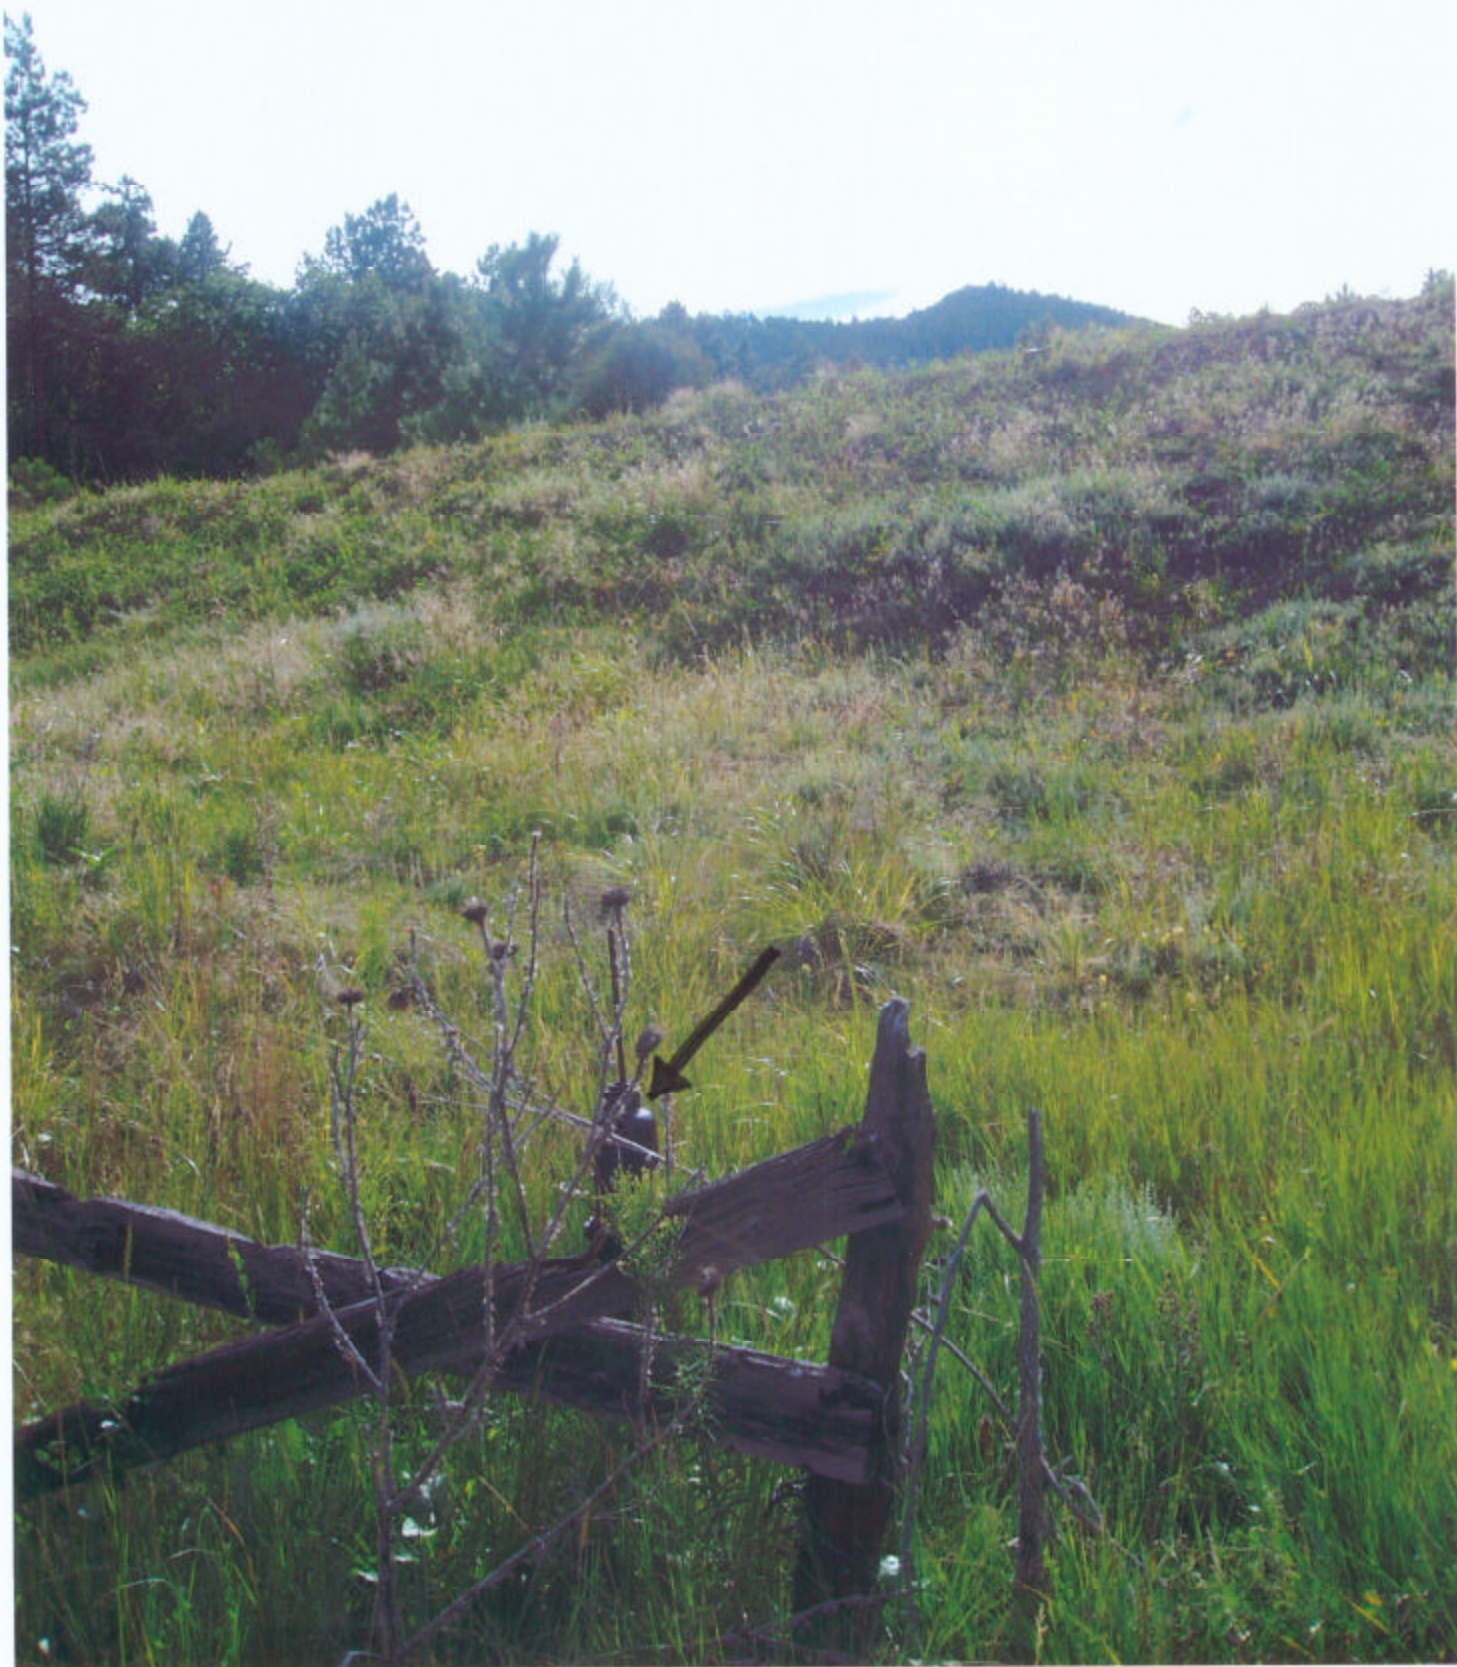
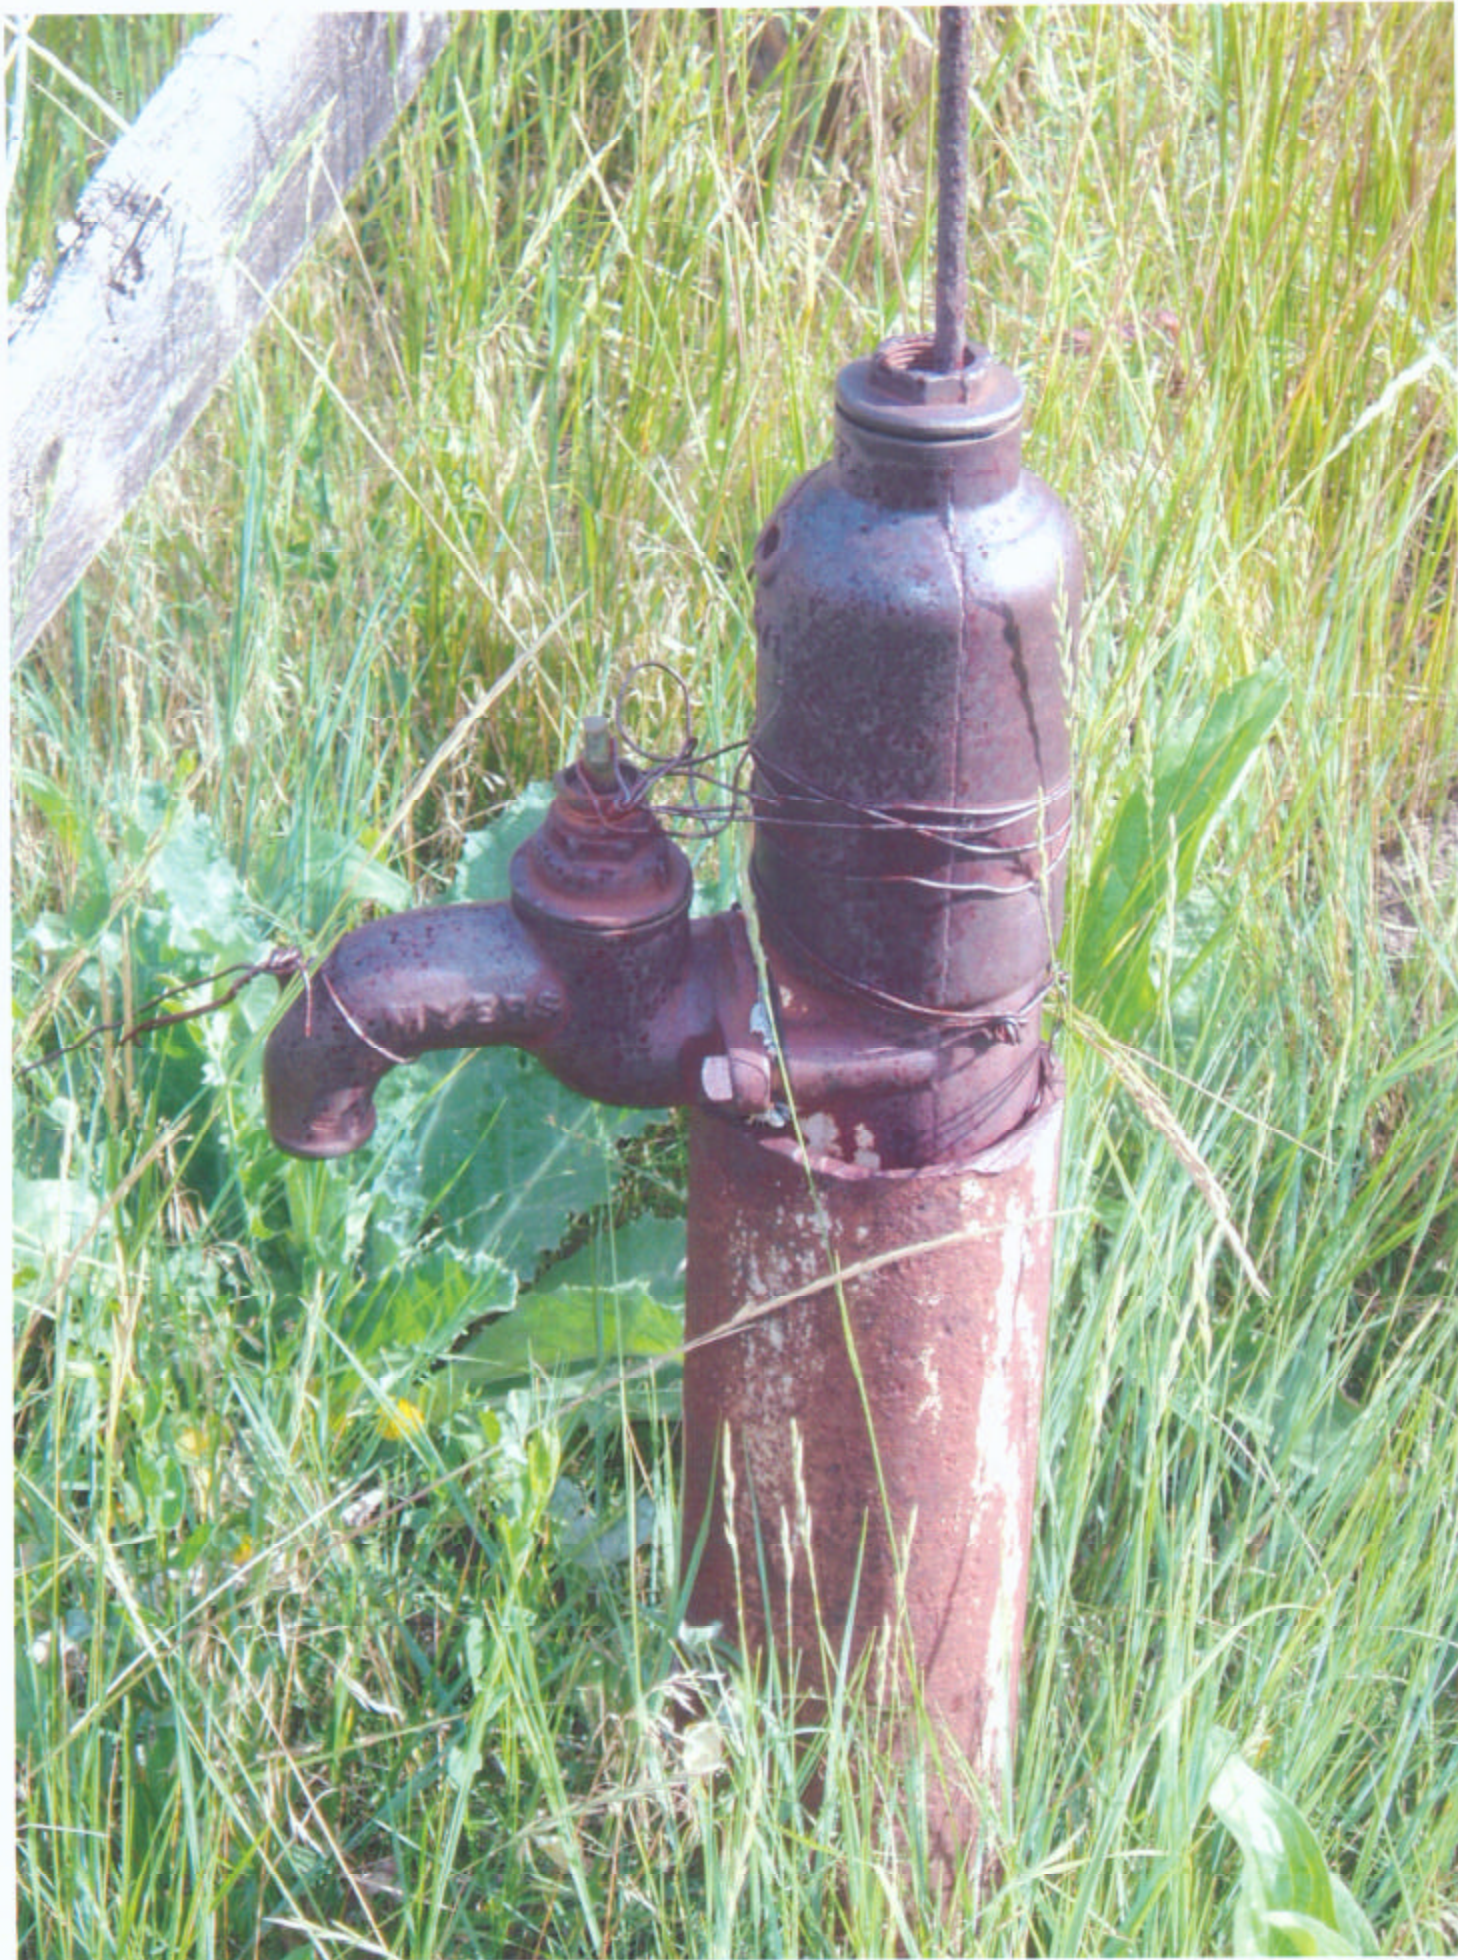
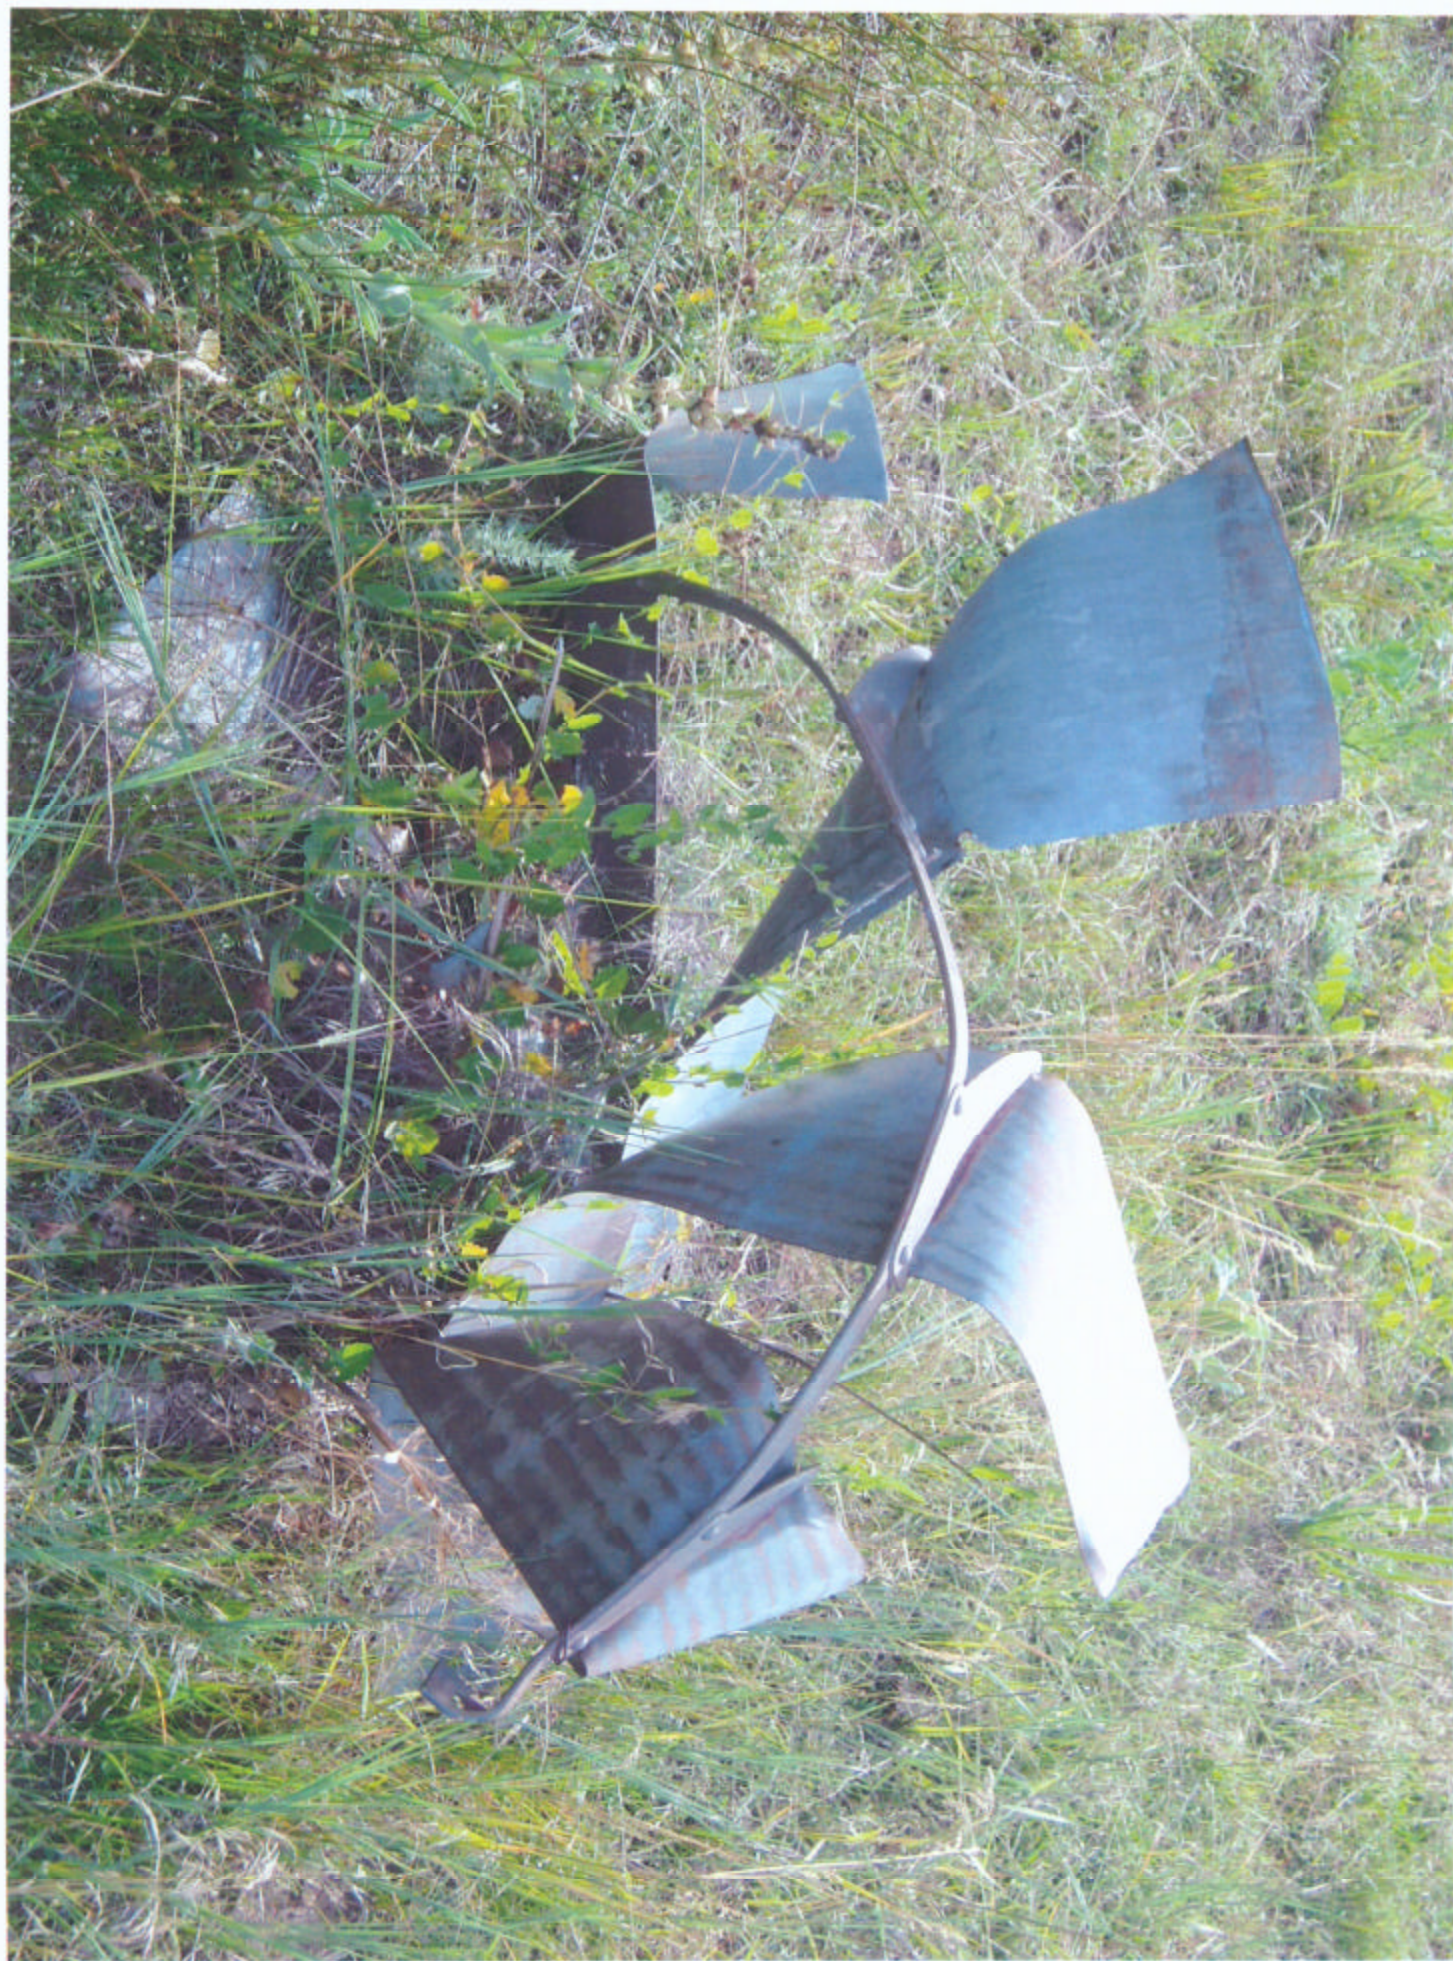
DOMESTIC WATER WELL - PERMIT # 95576

PXD Response: A site investigation of this location identified the alleged domestic water well to be broken and completely inoperable (see photos), the well also functioned as a stock water well, rather than a domestic water well. Produced water from the Sleeping Dog 41-8 and Sleeping Dog 41-8 Tr is going into a water gathering system that is surface discharged at a permitted outfall approximately one-half mile west of this location. Under the CDPS permit, produced water at this outfall is discharged into Frio Canyon. Pioneer requests that the Commission permits one pit at this location, solely for emergency purposes. The pit will have a posted "no dumping" sign and will not routinely store produced water.

LOCATED DOWN GRADIENT FROM SLEEPING DOG 41-8/TR
