RE: 2006 Fruitland Outcrop Monitoring Report, Archuleta County, Colorado

FRUITLAND OUTCROP MONITORING REPORT

ARCHULETA COUNTY, COLORADO

OCTOBER 2006

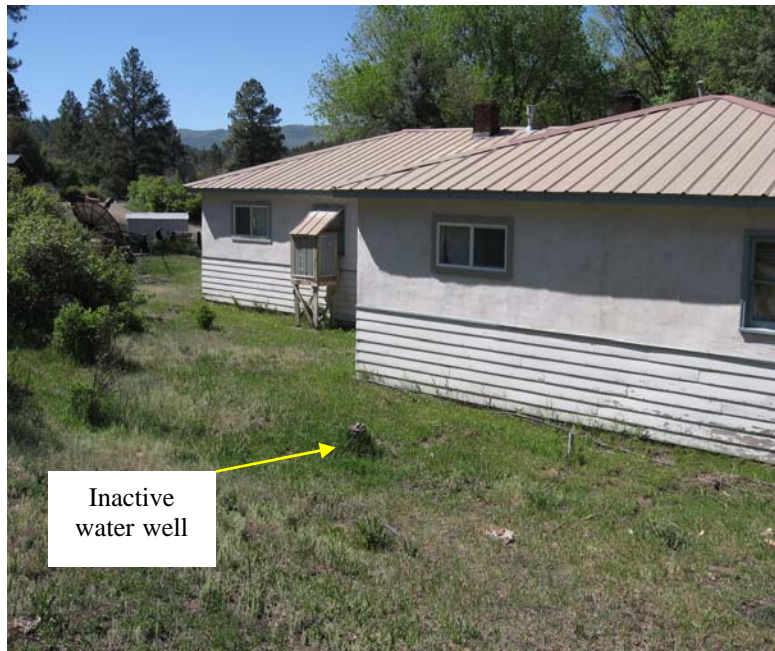
Susie
Candelaria
Residence.

LTE collected a subsurface methane measurement from the inactive water well location behind the Susie Candelaria residence. Construction information obtained from Gilbert Candelaria suggests that the well is most likely screened in the Kf. In September 2005, methane was detected in the well casing of this water well at a concentration of 5,000 ppm (10% LEL). During the most recent monitoring event, methane was detected in this water well at a concentration of 2,500 ppm (5% LEL). No methane was noted in the soil surrounding the well during either monitoring event. A detailed map of the soil gas survey performed at the Candelaria Ranch is presented as Figure 5.

LTE recommends abandonment of the inactive water well behind the Susie Candelaria residence. The well is currently seeping methane gas at a concentration of 2,500 ppm (5% LEL). The close proximity of the well to the residential structures increases the risk for the accumulation of explosive vapors in confined spaces.

As stated in the January 2006 monitoring report, the presence of an inactive water well with seeping methane gas in close proximity to the Candelaria residence poses a potential threat to the residents. The water well is likely screened in the Kf and is acting as a conduit for free gas in the formation. The close proximity of this well to the structure increases the potential for seeping gas to threaten the structure. LTE recommends the abandonment of this well in order to eliminate the potential for the well to act as a conduit for methane seepage.

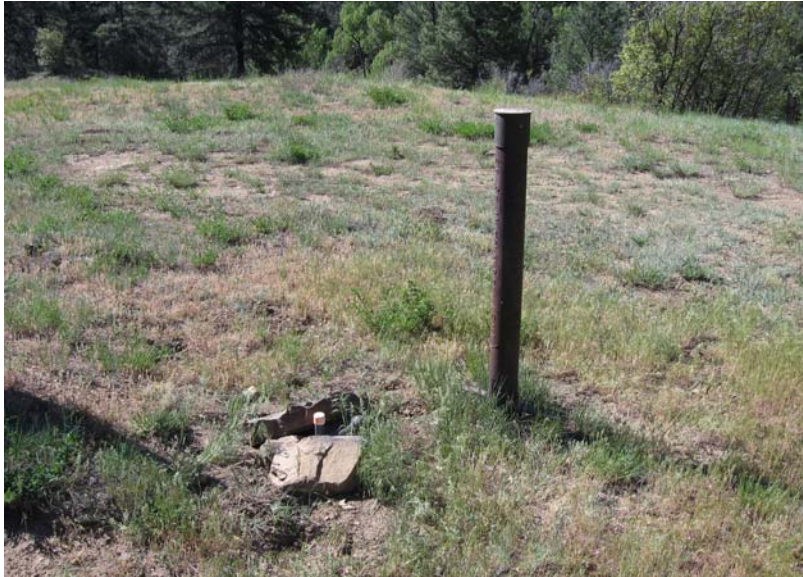
Schomburg #1
abandoned well
marker and
permanent gas
monitoring probe.

LTE conducted the most recent survey on May 26, 2006. LTE advanced seven temporary soil probes in the area to determine the presence or absence of methane. No methane was detected at any of the sample locations. In addition, LTE collected a gas concentration measurement from the permanent gas monitoring probe adjacent to the abandoned well marker. No methane was detected in the probe. Figure 6 illustrates the area surveyed at the Schomburg #1 well site.

LTE recommends annual monitoring of the Big Horn Schomburg #1 well site to assess the potential for methane seeps over time. Annual monitoring of the well is required by the Conditions of Approval for the Pargin Mountain 10U #3 permit.

Methane has not been detected in the shallow subsurface soil in the vicinity of the Schomburg #1 well site during the 2005 and 2006 field activities. It does not appear that the abandoned well is acting as a conduit for the seepage of methane gas at this time. LTE recommends the continued annual monitoring of the abandoned well site per the requirement of the Conditions of Approval for the Pargin Mountain 10U #3 APD.

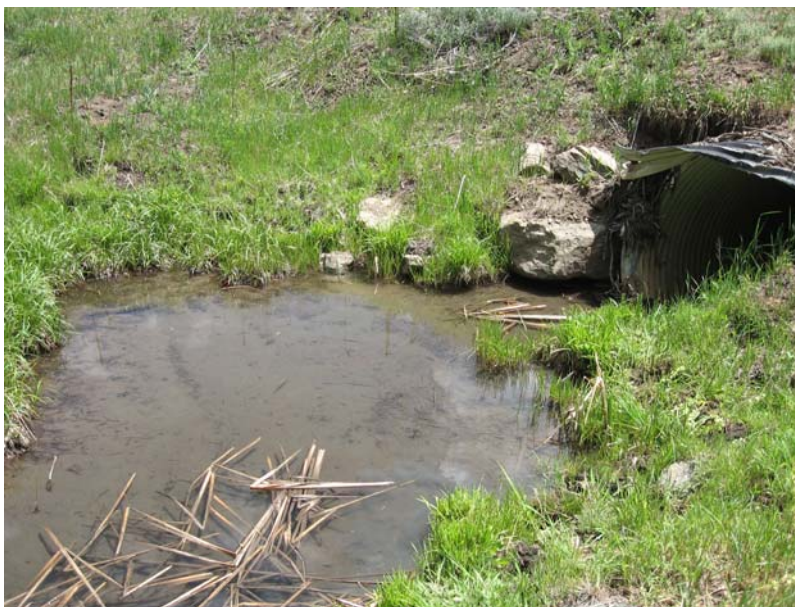
LTE conducted surface water drainage inspections on seven streams transecting the Kf outcrop in Archuleta County. Methane was detected above the surface water in one (Squaw Creek) of the seven streams inspected. LTE observed a relatively slow seep in a section of Squaw Creek on both sides of a culvert running beneath the Vance property driveway. In general, the stream in this area appeared to contain relatively stagnant water with a muddy, organic-rich stream bed. A funnel was placed over the seep area and a methane concentration of 1,000 ppm (2% LEL) was reported. A stick was used to probe the stream bed in this area and a funnel was placed over the surface water to collect escaping gas from the disturbed portion of the stream bed. Methane was detected using this method at concentrations ranging from 3,500 ppm (7% LEL) to 17,500 ppm (35% LEL).

Area of methane seepage in Squaw Creek.

LTE advanced three temporary soil probes on the stream banks adjacent to the seep area to determine the presence or absence of methane gas in the shallow subsurface soil. No methane was detected in this area.

Analytical results of the gas sample collected from Squaw Creek indicate that the gas is near-surface microbial gas (swamp gas) of biogenic origin. Table 3 presents the results of the gas composition and isotopic analyses. The laboratory analytical data is included in Appendix B. The following figure was used to determine the origin of the gas.

LTE recommends the annual monitoring of the seven surface water bodies transecting the Kf in Archuleta County per the requirement of the Conditions of Approval for the Pargin Mountain 10U #3.

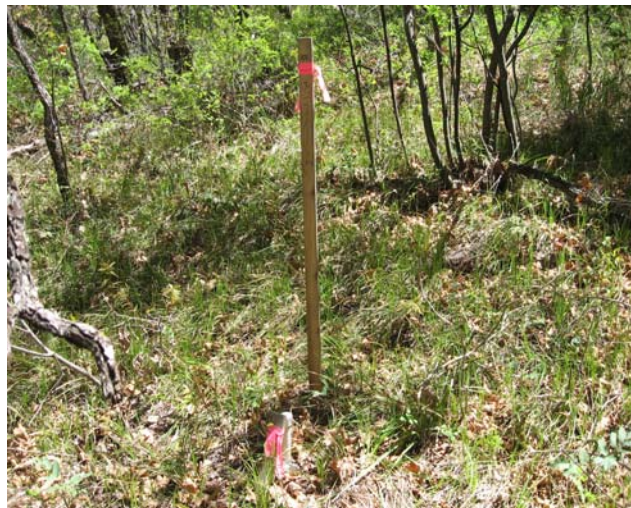
LTE collected subsurface gas measurements from four permanent gas monitoring probe lines transecting the Kf outcrop in Archuleta County. Methane was not detected in any of the permanent monitoring probes investigated by LTE during the 2006 field activities. LTE advanced two temporary soil probes to collect subsurface methane measurements in the vicinity of the Pole Gulch probe line. Methane was detected in one of the temporary soil probes at a relatively low concentration (20 ppm) near a coal seam.

BLM
permanent
monitoring
probe.

LTE recommends annual evaluation of data collected by the BLM from the four permanent gas monitoring probe lines located in Archuleta County.

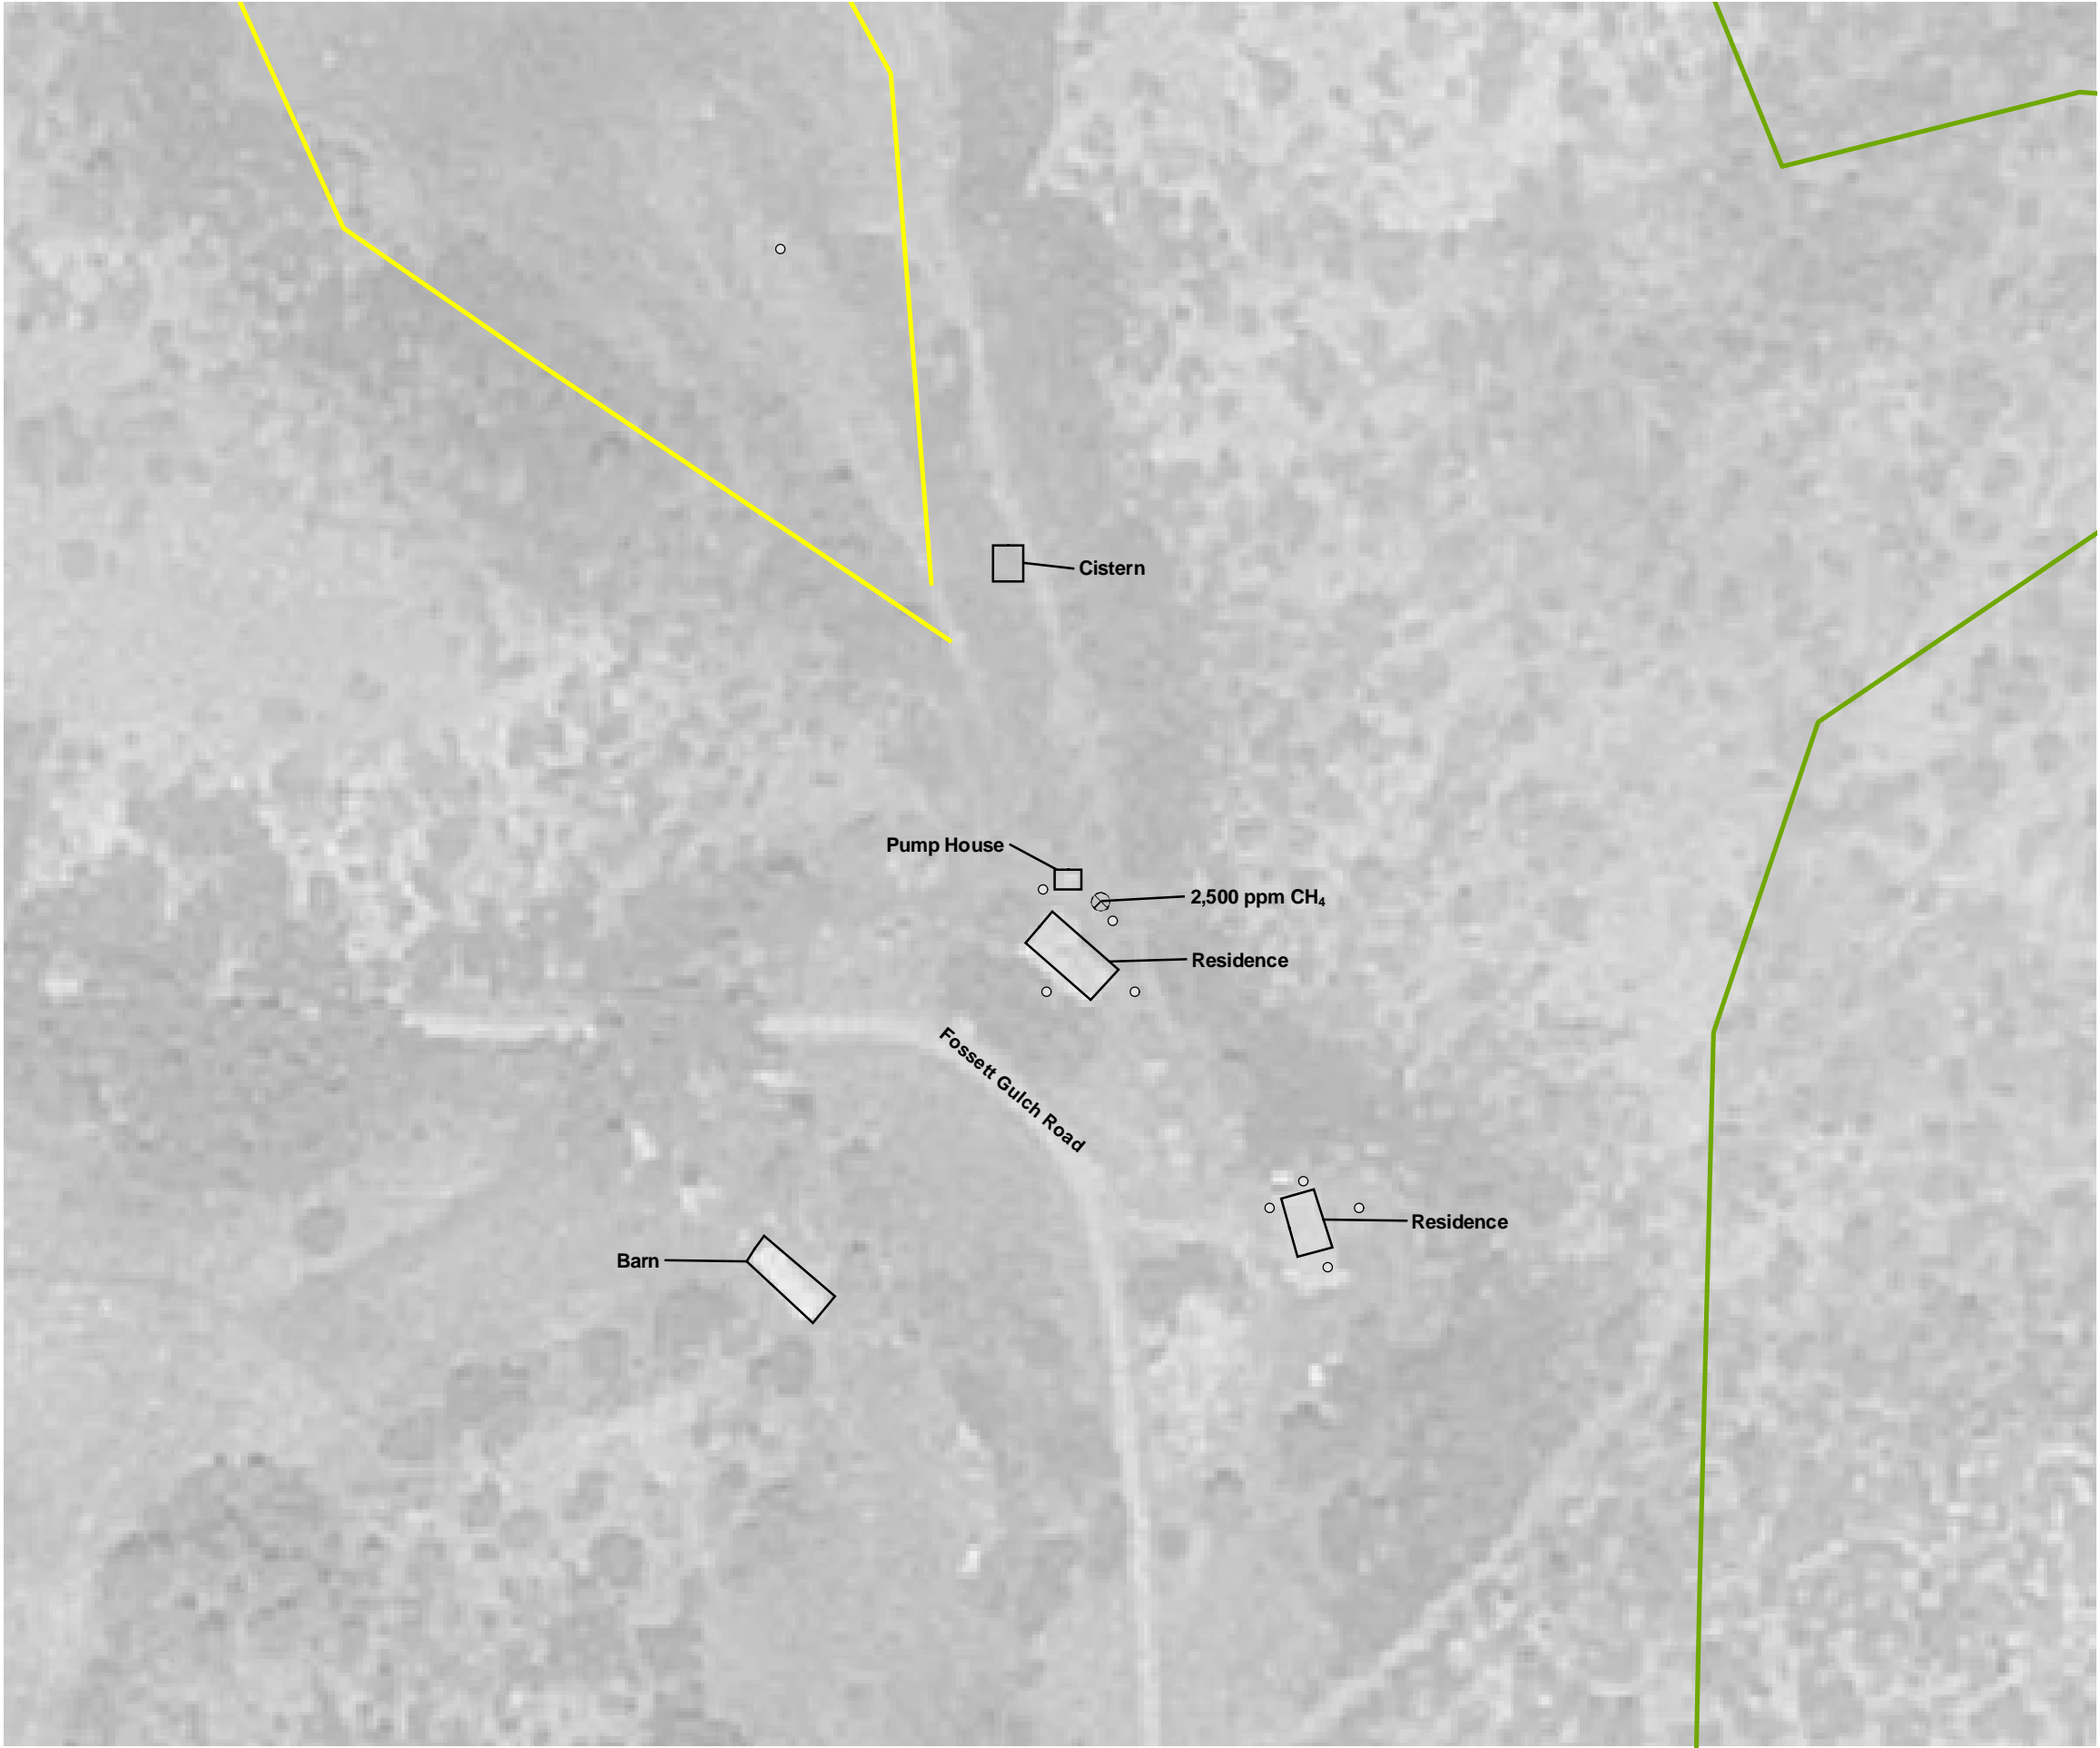
FIGURE 5
CANDELARIA RANCH DETAILED MAPPING
2006 FRUITLAND OUTCROP MONITORING
ARCHULETA COUNTY, COLORADO
ELM RIDGE RESOURCES AND PETROX RESOURCES

⊗ Candelaria Well (Inactive)
